In-flight structural breakup, Boeing 747-200 B18255, May 25, 2002 in the Taiwan Straits approximately 23 nm northwest of Makung

CI611 Accident Investigation

Factual Data Report

ASC-AFR-03-06-001

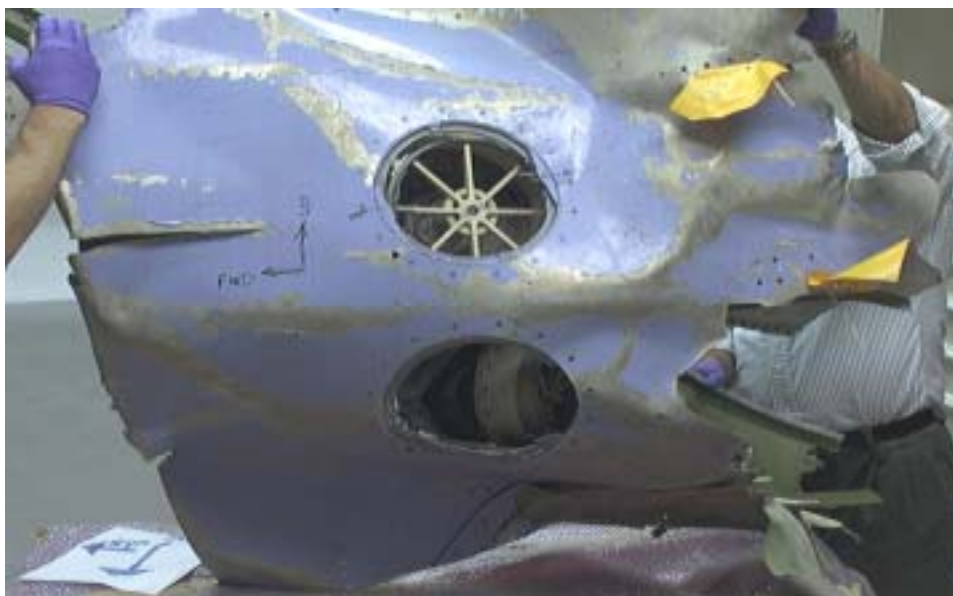
Figure 1.16-5 Pressure Relief Valves.

Two cabin pressurization relief valves are installed to relieve excessive pressure in the cabin. Both valves were recovered as shown in Figure 1.16-5. All flapper (blowout) doors (upper and lower for both valves) and some hinge pins are missing. The Lower Pressure Relief Valve was no longer attached to the structure. The structure between the upper and lower valves was buckled outward.

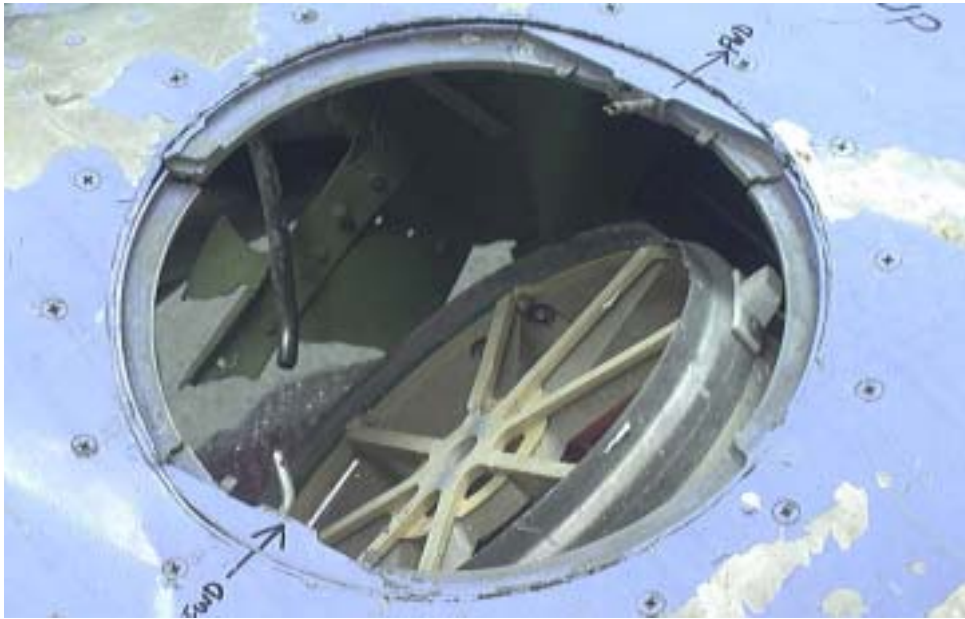
Figure 1.16-6 Upper Pressure Relief Valve

The visual inspection result shows the Upper Pressure Relief valve (Figure 1.16-6) has been deformed inward, the blowout doors are missing, the gate web fractured, FWD upper hinge pin is bent, lower hinge pin missing, AFT lower hinge pin is bent and all hinge pins are moveable.

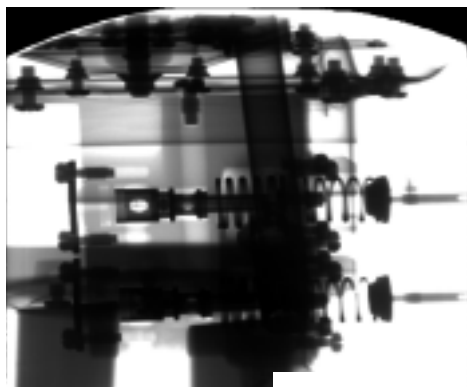
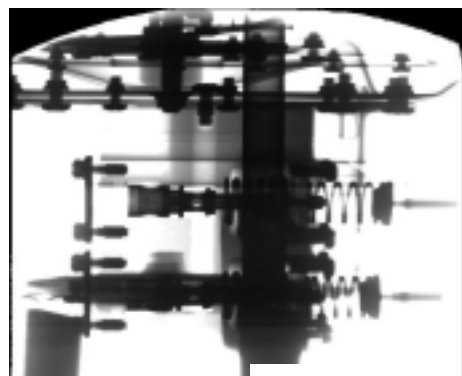
Figure 1.16-7 X-RAY Check Results

X-Ray check on the upper relief valve control switch was conducted. The result shows that the control sensor assemblies were deformed from its original setting. (Figure 1.16-7)

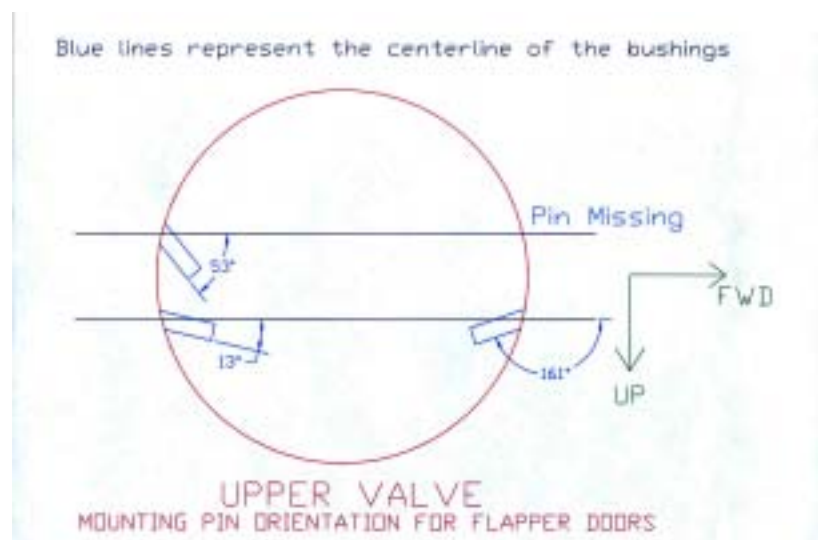
Figure 1.16-8 Upper Flapper Doors pins measurement results

Upper aft pin = 13°; Upper fwd pin = 161°; Lower aft pin = 53°

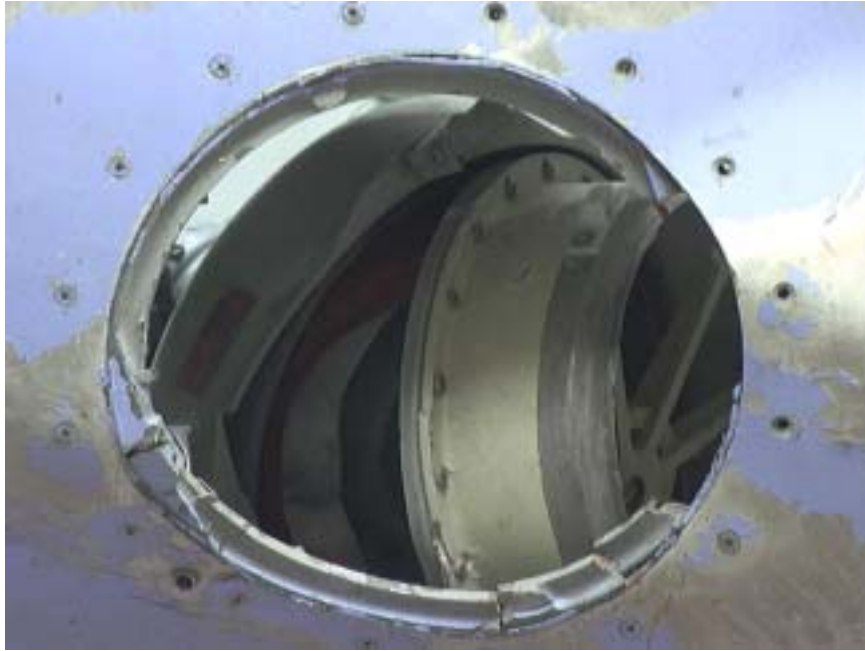
Figure 1.16-9 Lower Pressure Relief Valve

The visual inspection result shows the Lower Pressure Relief valve (Figure 1.16-9) had been rotated inward around 45°, the blowout doors were missing, the gate web broken, all hinge pins were missing, two AFT stop pads were missing. Approximately 25% of the mounting flange was missing.

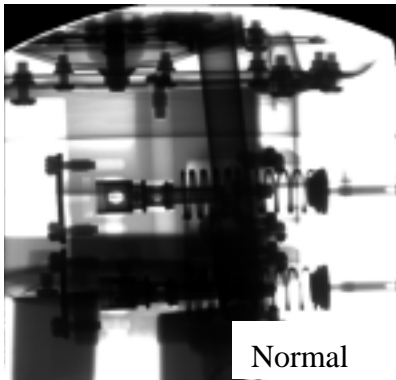
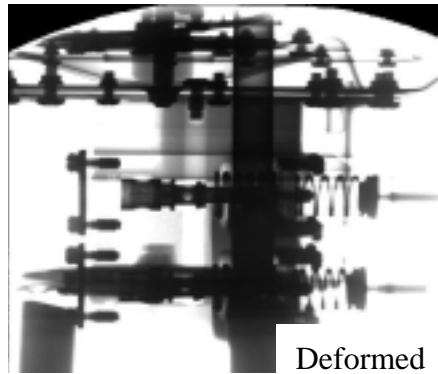
Figure 1.16-10 X-RAY Check Results (1)

Conducted X-Ray check on lower relief valve control switch. The result shows that the control sensor assemblies (Figure 1.16-10) and the switch circuit (Figure 1.16-11) both deformed from its original setting.

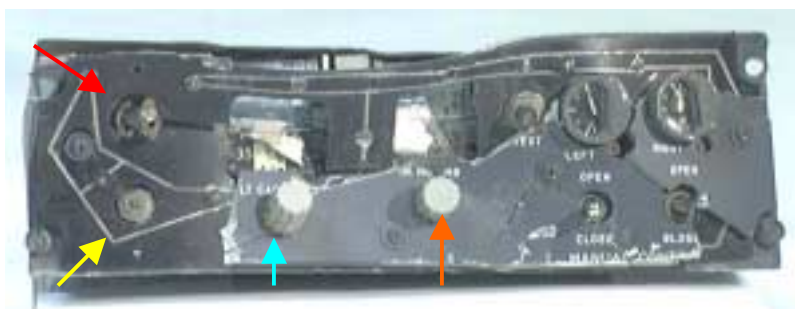
Figure 7: Flight Engineer's Cabin Pressure Control Selector Panel - (front view)

- OUTFLOW VALVES position indicators are both showing needle positions slightly below 9 O'clock (upon initial observations prior to taking photograph, fig. # 7).

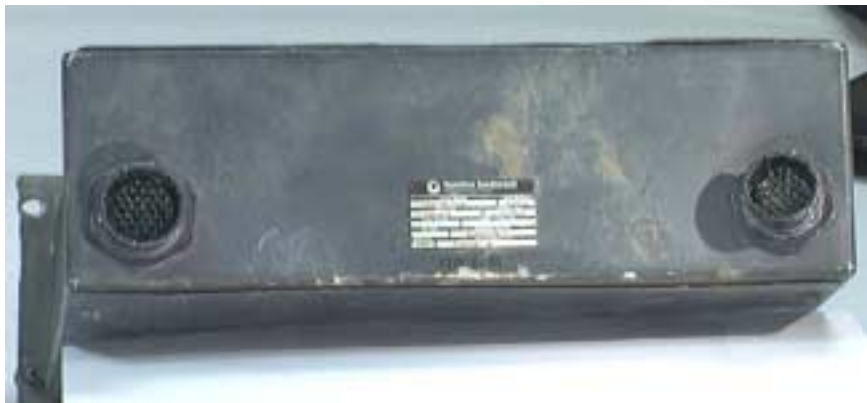
Figure 8: Flight Engineer's Cabin Pressure Control Selector Panel - (back view)

- J3 connector (right) misaligned due to deformation of rear chassis. Both connector (J3 and J4) pins are intact.
- Both connectors show contamination around multiple connector pins.

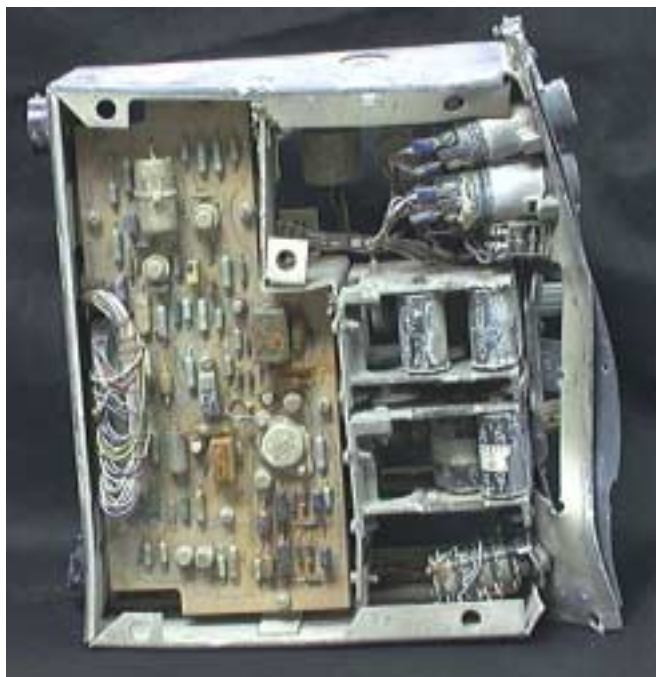
Figure 9: Flight Engineer's Cabin Pressure Control Selector Panel - (top view)

- Deformation of the face of the chassis.
- Broken spot welds and separation of face of chassis (lower right).
- Sedimentary deposits deposited throughout unit.
- Corrosion noted in multiple locations on multiple components.
- Slight deformation of rear chassis panel at the J3 plug (lower left).
- Flight ALTITUDE selection tape delaminated and partly missing.

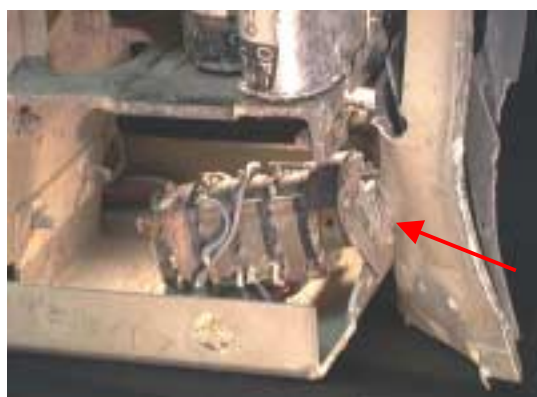
Figure 10: MODE SELECT Rotary Switch

- Rotary switch shaft slightly separated from front of chassis.

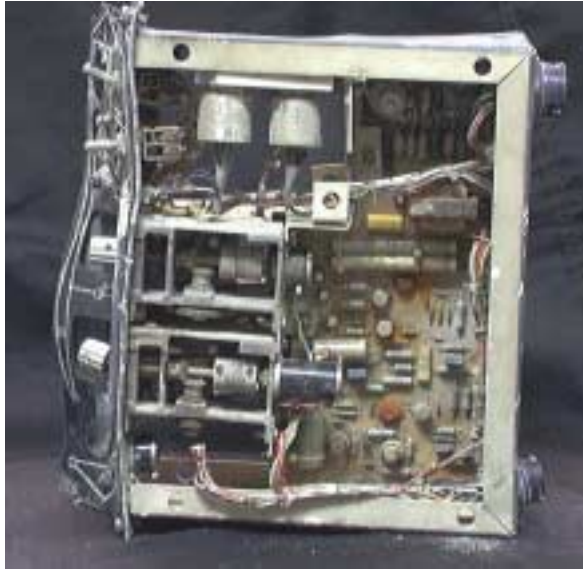
Figure 11: Flight Engineer's Cabin Pressure Control Selector Panel – (bottom view)

- Deformation of the face of the chassis.
- Sedimentary deposits deposited throughout unit.
- Corrosion noted in multiple locations on multiple components.

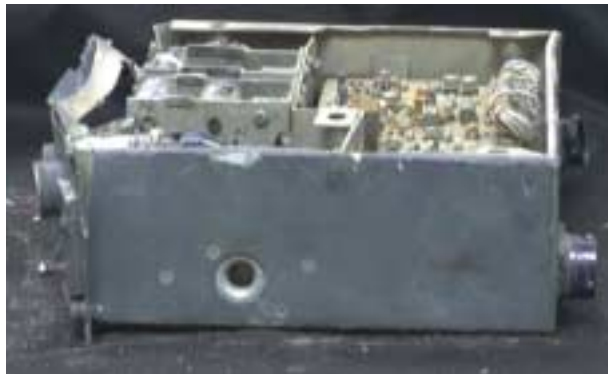
Figure 12: Flight Engineer's Cabin Pressure Control Selector Panel – (side view - cabin pressure port side).

- Deposits noted inside the sensor port.

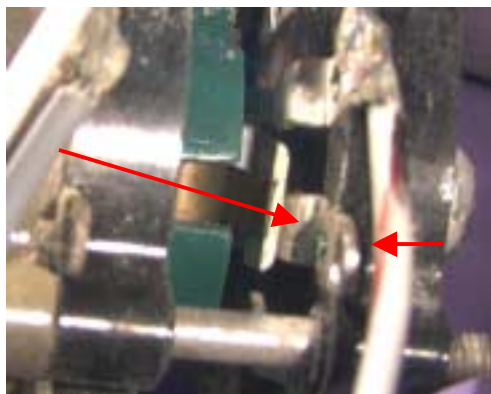
Figure 14: Panel, MODE SELECT Rotary Switch

- Continuity tests suggest setting was in manual (MAN) select mode, not AUTO.
- Confirmed wire continuity from J3 connector to rotary switch (S1)
- Initial visual inspection of the (S1) rotary MODE SELECT switch (reference, Figure 7) could not confirm switch setting because the shaft was bent (therefore inconclusive).
- X-ray of rotary switch (S1) could not verify MODE SELECT switch setting due to indistinguishable internal details.
- Disassembly of MODE SELECT rotary switch confirmed switch was set in manual (MAN) setting (Figure 14).

- Internal contact position verification (manual).

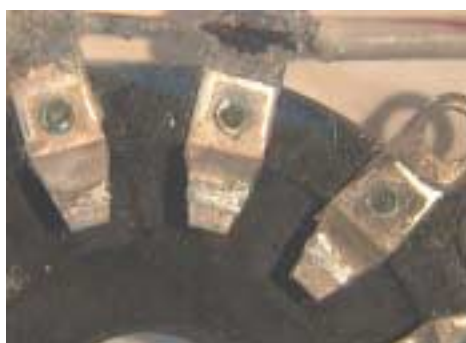
Figure 15: MODE SELECT Rotary Switch, Stationary contacts, deck 3, #1-2-3 (left to right).

- Contacts of rotary switch (S1), deck 3, #1-2-3, Wear marks on contacts appear to be normal.

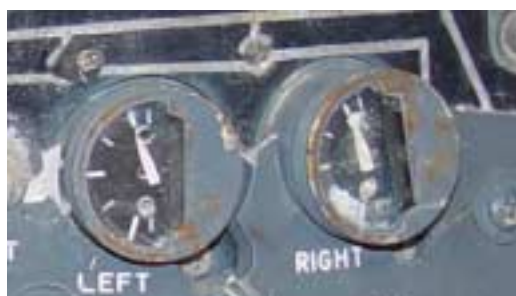
Figure 16: Panel, OUTFLOW VALVES Indicators.

- Internal surface of glass face: small surface anomaly observed as viewed from exterior.
- Case removed to inspect glass from inside. What appeared to be an anomaly on the inner side of glass was actually a debris deposit.
- No impact indications from needle impact were noted.

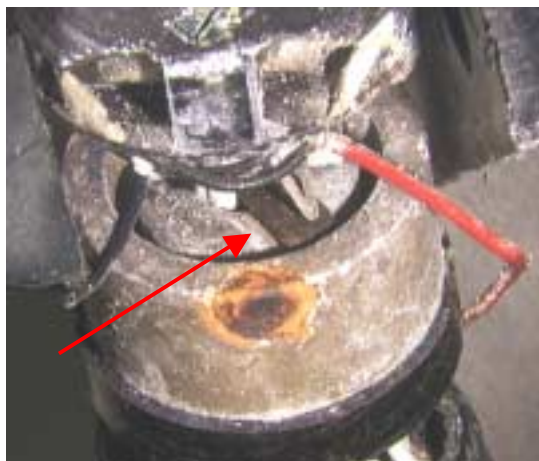
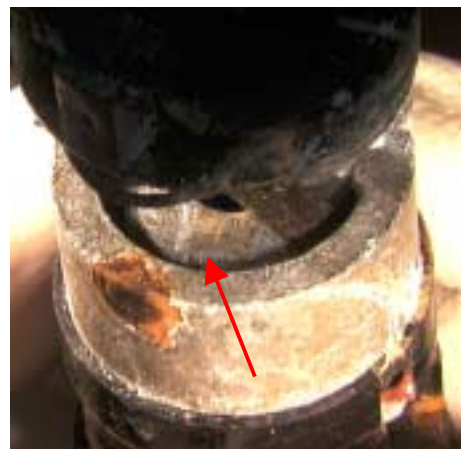
Figure 17: LEFT, OUTFLOW VALVES
Position Indicator witness mark

Figure 18: LEFT, OUTFLOW VALVES
Position Indicator showing witness mark
after moving armature.

- Moving armature/needle, mounting tab corresponds to a witness mark on underlying base. This position corresponds to needle positioned at approximately 25% open. The armature was moved from its location in Figure 17 to display the “witness” pattern underneath the movable armature, shown in Figure 18.

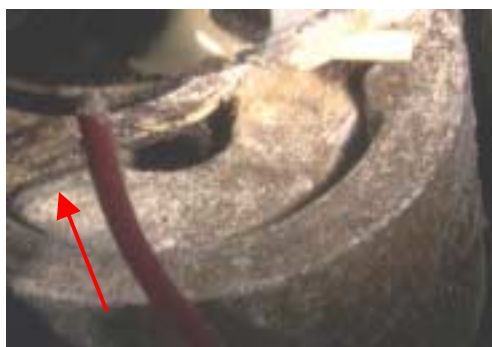
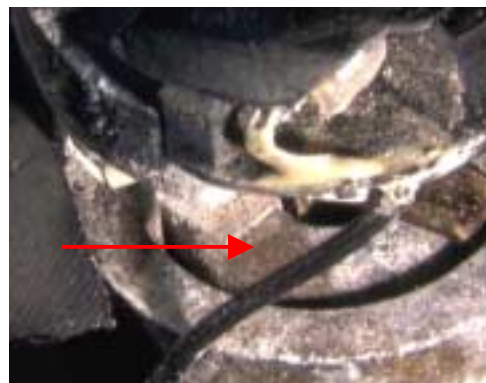
Figure 19: RIGHT, OUTFLOW VALVES
Indicator; armature is over
witness mark.

Figure 20: RIGHT, OUTFLOW VALVES
Indicator; armature moved to show
witness mark.

- Armature/wiper member corresponds to witness marks on base at two places (at both extreme ends of possible needle movement). It was inconclusive as to the exact corresponding location of needle position.
- Both LEFT and RIGHT, OUTFLOW VALVES Indicators' needles were detached from armature/needle mounting tabs and loose within the housings.

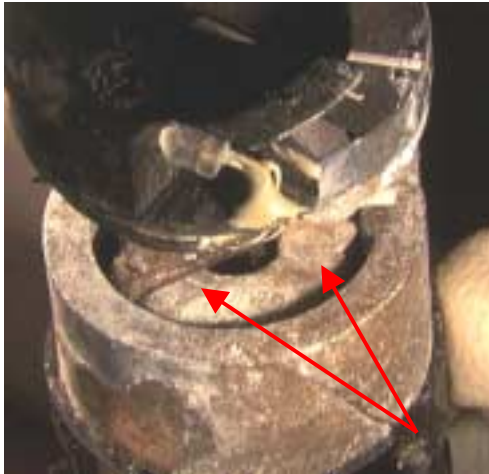
Figure 21: RIGHT, OUTFLOW VALVES

Position Indicator witness mark (right).

- There appeared to be two "witness" marks on the underlying base of this indicator. The one on the left appeared to be more distinct than the one on the right.

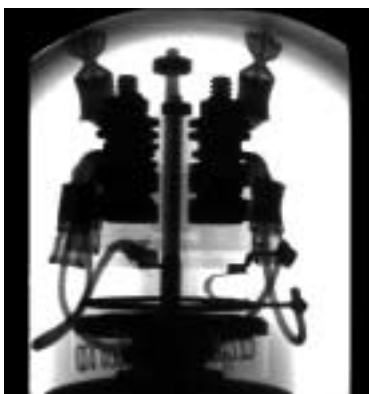
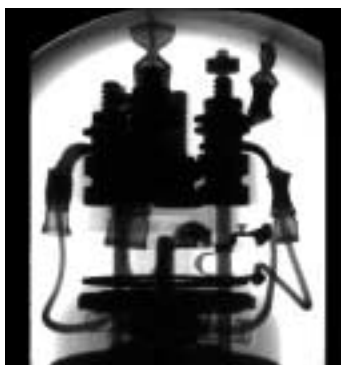
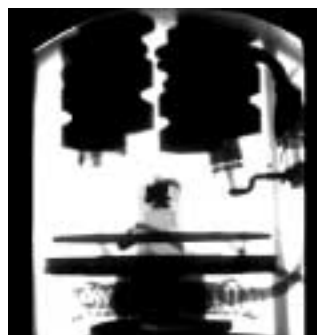
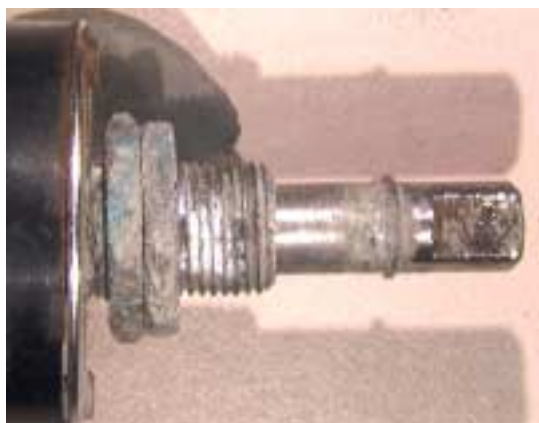
Figures 25a, 25b, 25c: X-rays of Pack Valve Switch #1

Figure 26: Detail of switch #1 shaft.

- Corrosion on all metallic parts
- Shaft can be pulled easily from switch body.
- Shaft is slightly bent relative to body.
- All wiring is intact, but no continuity.
- Terminals are significantly corroded.
- No cracking is apparent in the switch body.
- X-ray confirms that the valve-closed electrical contacts are aligned with each other.
- After removal of the switch, it was noted that the indexing ring tab to shaft was sheared or corroded away.

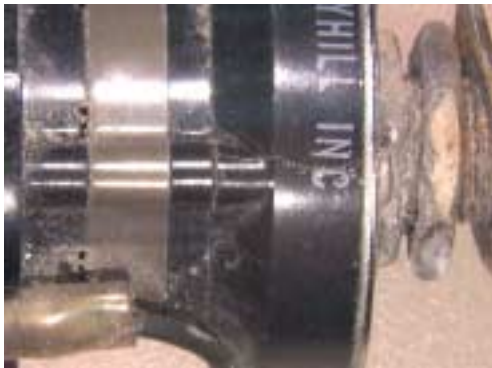
Figure 28: Detail view of switch #2, cracks in the body.

- Corrosion on all metallic parts
- Minor cracking of the switch body.
- No continuity could be attained.
- All external wiring appears intact.
- X-ray confirms that the valve-closed electrical contacts are aligned with each other.

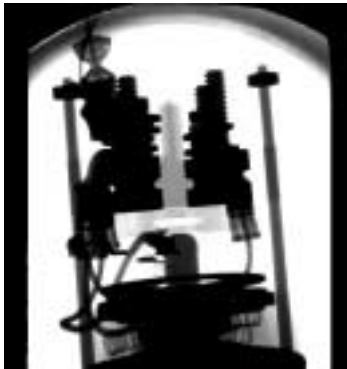
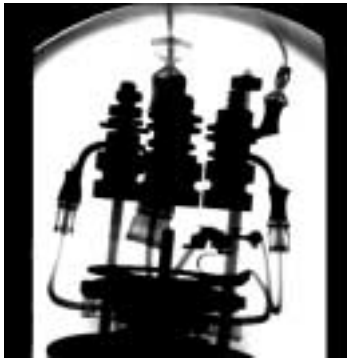
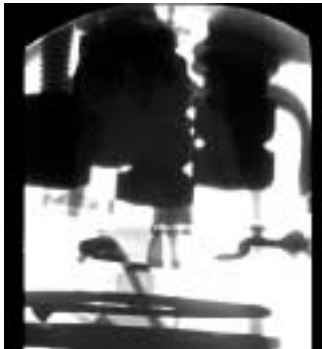
Figures 29A, 29B, 29C: X-rays of Pack Valve Switch #3

- Corrosion on all metallic parts
- Severe cracking of the switch body.
- No continuity could be attained.
- All external wiring appears intact.
- X-ray shows that the valve-closed electrical contacts are not aligned with each other. Misalignment approximately 10 degrees. The switch knob was not in the full closed position.

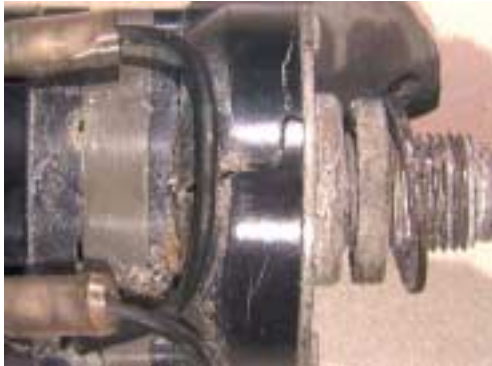
Figure 30: Switch #3 body crack detail

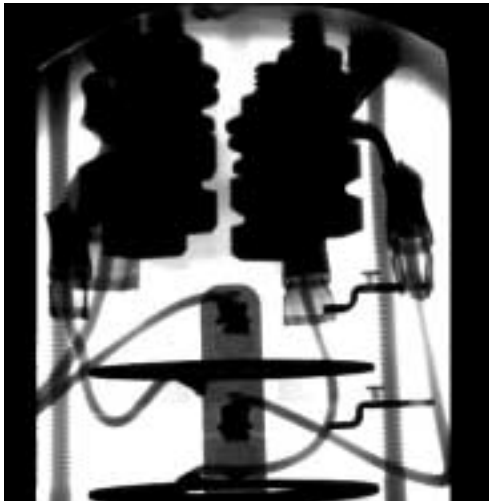
[Figure 32:](#) X-ray of Bleed Air Valve Switch #1.

- X-ray confirms that both sets of active electrical contacts are aligned with each other.

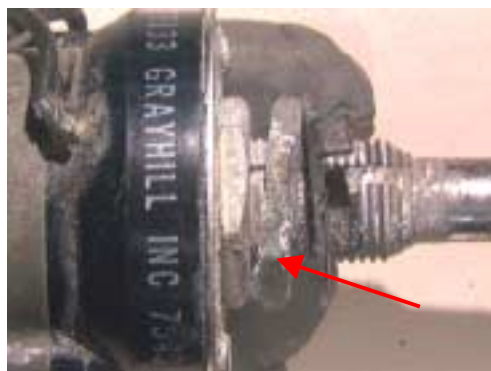
Figure 33: Bleed Air Switch #1

- Displaced nut
- Knob in OFF position
- Rear mounting nut has been displaced.
- Corrosion on all metallic parts

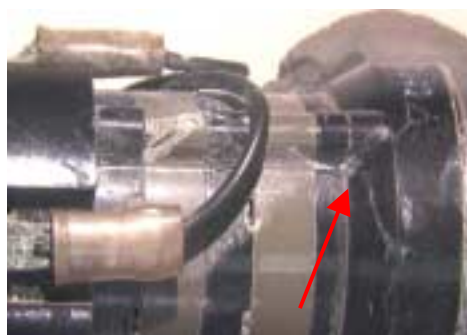
Figure 34: Bleed Air Switch #1.

- Minor cracking of housing is apparent.
- Crack detail.
- No continuity could be attained.
- All external wiring appears intact.

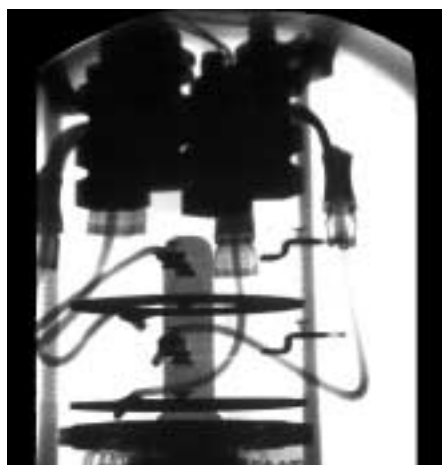
Figure 35: X-ray of Bleed Air Valve Switch #2.

- X-ray confirms that both sets of active electrical contacts are aligned with each other.

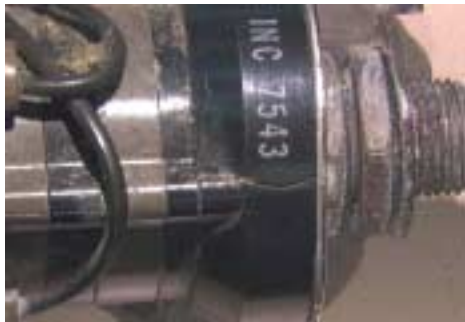
Figure 36: BLEED AIR switch 2.

- Minor cracking of housing apparent.
- Detail of cracks.
- No continuity could be attained.
- All external wiring appears intact.
- Knob in OFF position
- Corrosion on all metallic parts

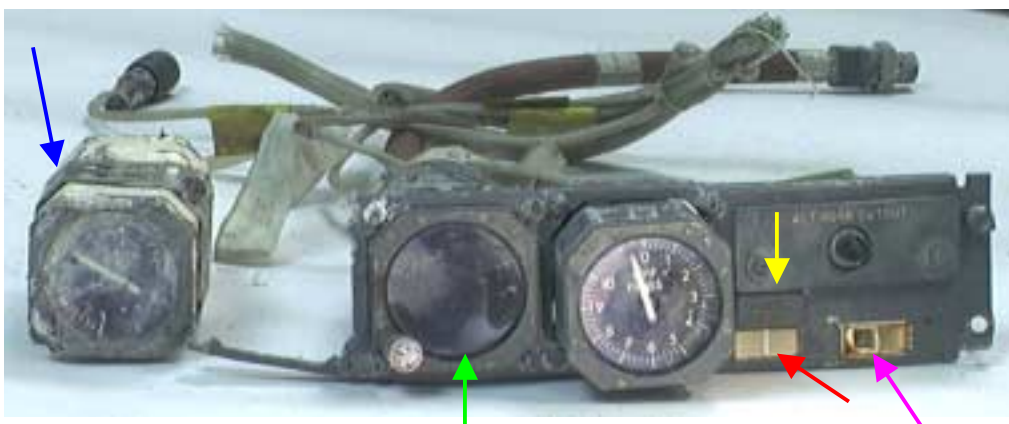
Figure 37: M188 panel. Note that the vertical speed indicator was detached from the module.

- Vertical Speed Indicator not attached to panel (blue arrow).
- Corrosion present on various surfaces with salt residue and sediment.
- AUTO FAIL legend plate is missing (purple arrow).
- PRESS RELIEF lower Indicator light cover is missing (red arrow).
- Panel frame is bent inward on left and broken at Vertical Speed Indicator frame.

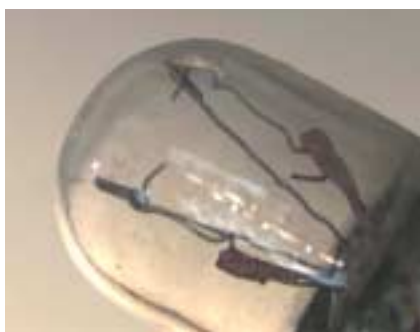
Figure 40: PRESS RELIEF light, lower left lamp.
• Filament is broken - (Ref. Figure 37, red arrow for lamp location).

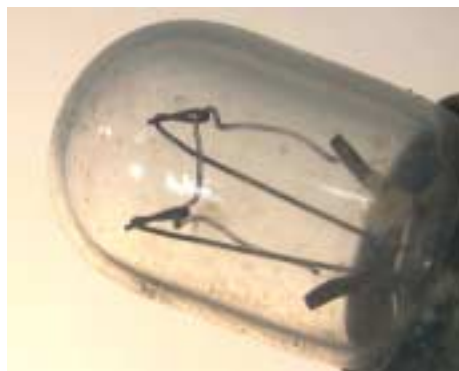
Figure 41: PRESS RELIEF light, lower right lamp.
• Filament appears to be intact.
• Legend plate missing, (Ref. Figure 37, red arrow for lamp location).

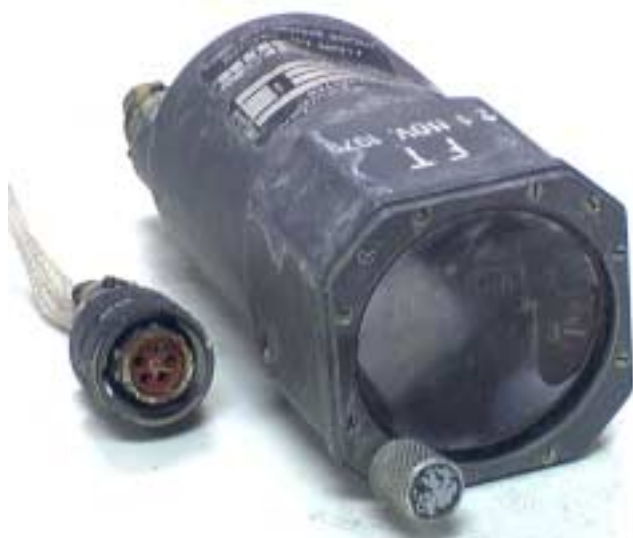
Figure 42: CABIN ALT Indicator (Ref. Figure 39, green arrow for location on module)

- 50% of face obscured by opaque discoloration inside of glass.
- BARO set knob bent upward.
- Dent in rear, top side of case.
- Dent on bottom side of case.
- Corrosion on sense line connection.
- Barrel Indicator reads approximately 13,000.
- Needle and barometric setting obscured by discoloration.
- Electrical connector appears undamaged.

- X-ray examination of internal parts revealed distorted bellows. No other observations made due to indistinguishable details.

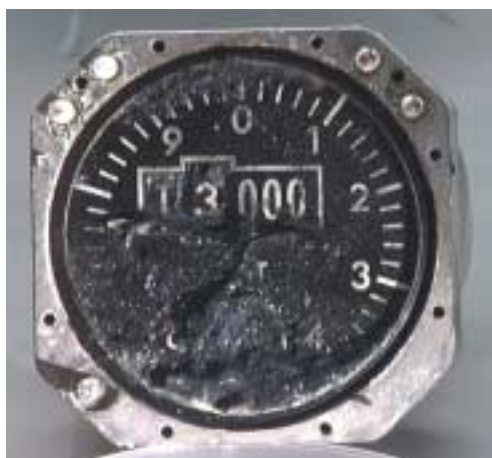
Figure 43: Cabin Altimeter Indicator, glass bezel removed

- Heavy coating of unknown sedimentary type debris on face of indicator (unknown black glutinous contaminant).
- After cleaning off debris, altimeter indicator reading confirmed to be 13,765 +/- 5.
- Microscopic examination of inner side of bezel shows no sign of impact damage.

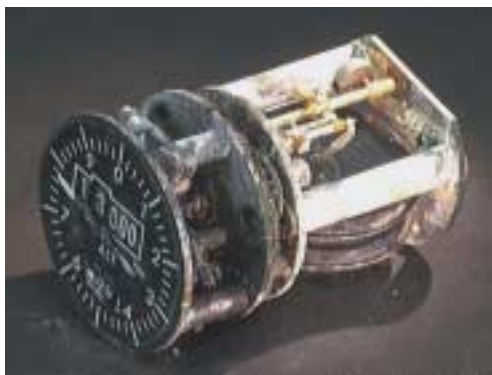
Figure 44: Cabin Altitude Indicator, housing removed.

- Removed back of Altimeter housing to observe internal mechanism. Large amount of sedimentary type debris noted internally.
- No observable damage to internal mechanical parts. It did not appear that the physical damage to the outer case caused the case to come into contact with inner components.
- Significant amount of sedimentary type debris noted on internal parts.

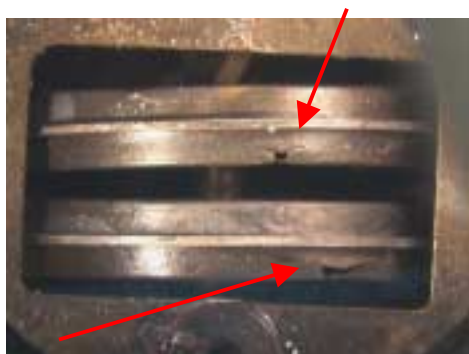
Figure 46: Cabin Altimeter Indicator, bellows, visible damage

- Both bellows have fractures along the outer circumference of the bellows. Those fractures appear on a portion of the bellows at the back of the instrument. The fractures are on the lower half of each of the bellows. The edge features, at the fractures, are oriented outward from the inside of the bellows.

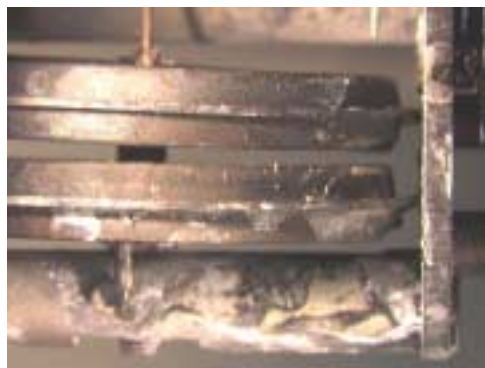
Figure 47: Cabin Altimeter Indicator, bellows displacement

- The upper bellows is tilted with respect to its axis. The lower bellows is also tilted, but to a lesser degree.
- The upper bellows is in contact with the gear mounting plate. The lower bellows flange is deformed at the point nearest the gear mounting plate, but doesn't contact the plate.

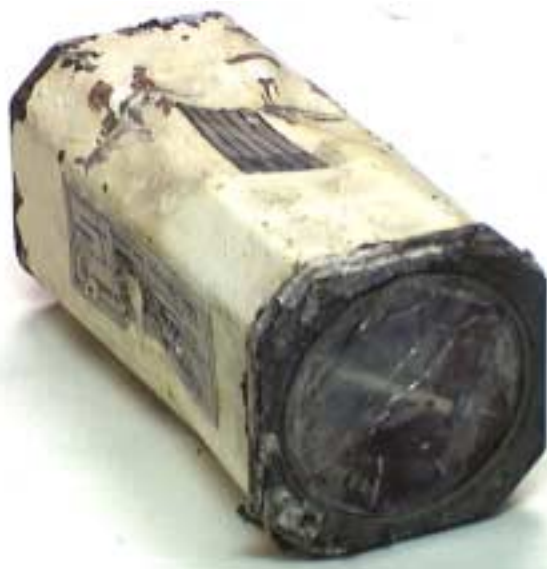
Figure 48: Cabin Vertical Speed Indicator

- Glass is broken.
- Numerous dents are on case.
- Needle is frozen at 500 FPM climb.

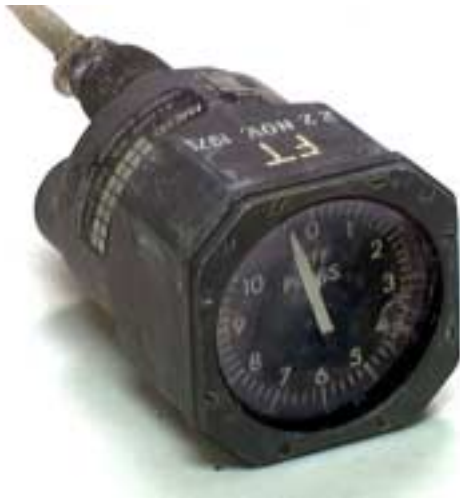
Figure 50: Cabin DIFF PRESS Indicator

- Water stains inside glass face.
- Needle is indicating below zero.

- Removal of the bezel did not reveal any abnormal markings on inside of glass.
- Dial indicated less than zero (at approximately 0.6 - 0.8 psi).
- Casing was removed. Cabin pressure line was cut to remove indicator from case. When pressure line was cut, the indicator dial returned to zero.
- No apparent damage was visible to internal parts.
- Minimal corrosion was present on internal surfaces.
- Red scale mark on face at approximately 9.25 – 9.3 (mechanism is physically limited at that point).

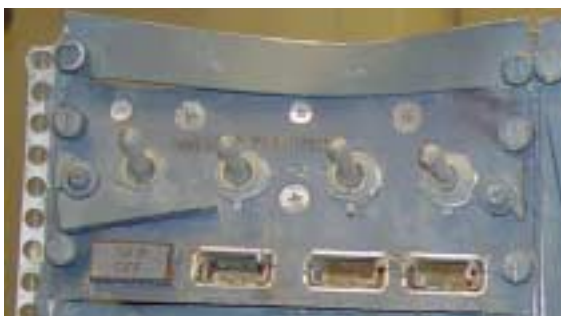
Figure 52: Galley Power control panel M179

- Light plate is missing.
- All switch toggles are in up position.
- TRIP OFF indicator lights, numbers 2, 3 & 4 legend plates, bulbs and retaining assemblies are missing.

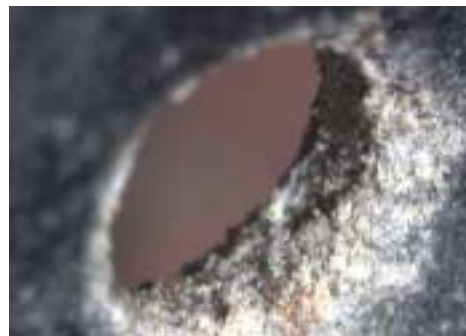
[Figure 64](#): Switch safety wire (breakaway wire) tab hole.

- Observed sediment contamination on inside diameter of hole, recess.

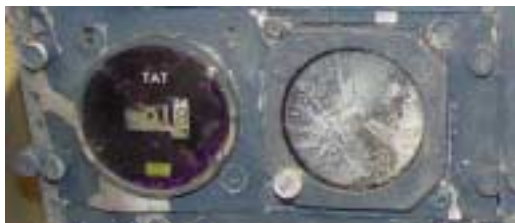
Figure 65: Clock Panel, module M184

- Clock glass is fractured.
- Hands set at approximately 0825, partially obscured by broken glass.
- TAT partially obscured by discoloration.
 - Reads 1.8 deg. C and **OFF**
- After removal from Flight Engineer's Panel, slight impact damage to top rear of case was noted.

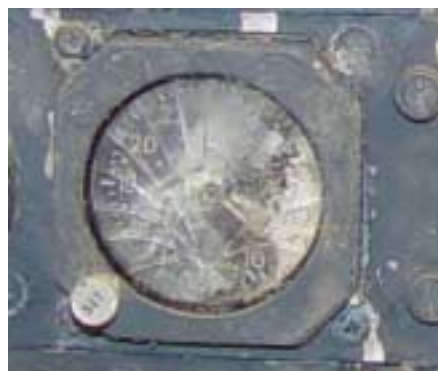
Figure 66: M184 Clock, face glass fractured heavily.

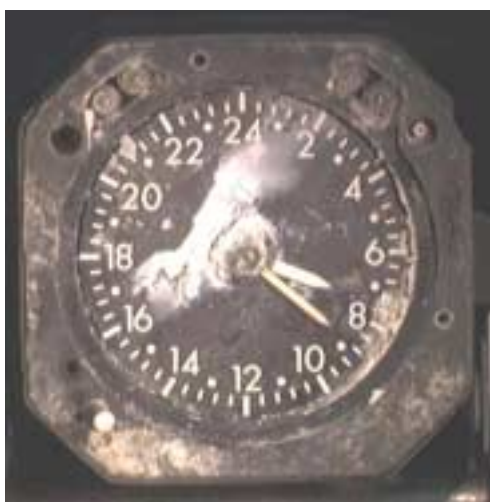
Figure 66a: M184 Clock, face glass removed.

- After removal of bezel, actual time on clock reads 0722

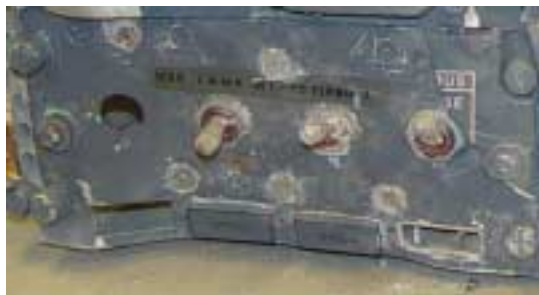
Figure 67: DC BUS ISOLATION panel, module M557

- Light plate is missing.
- All three switches' toggles are in up (CLOSE) position.
 BUS 3 and BUS ESS toggles are bent upward.
- ESS BUS, & OPEN indicators legend plates, bulbs and retaining assemblies are missing.

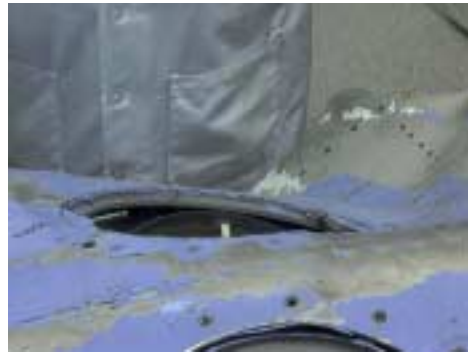
Figure 77: Upper pressure relief valve, (center of picture) distorted exterior skin.

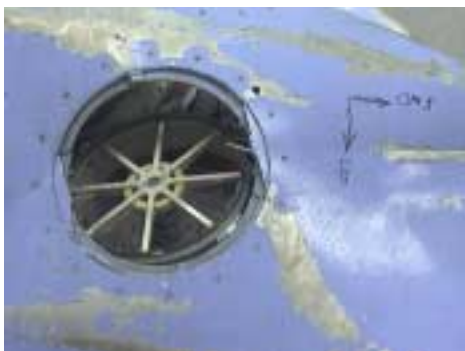
Figure 81: Upper Pressure Relief Valve, showing orientation, note that blowout doors are missing.

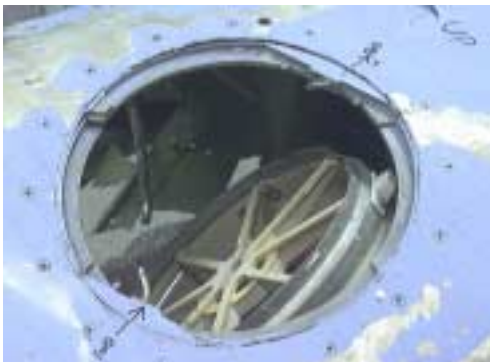
Figure 90: Exterior view of opening with valve not yet removed.

- Hinge pins are movable (free to rotate); aft/upper hinge pin is only one difficult to rotate and is bent outboard.

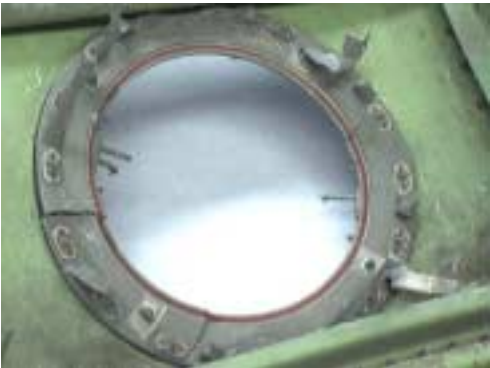
Figure 91: Interior view of opening with valve removed (looking inside to outside).

- Forward/lower hinge pin missing.

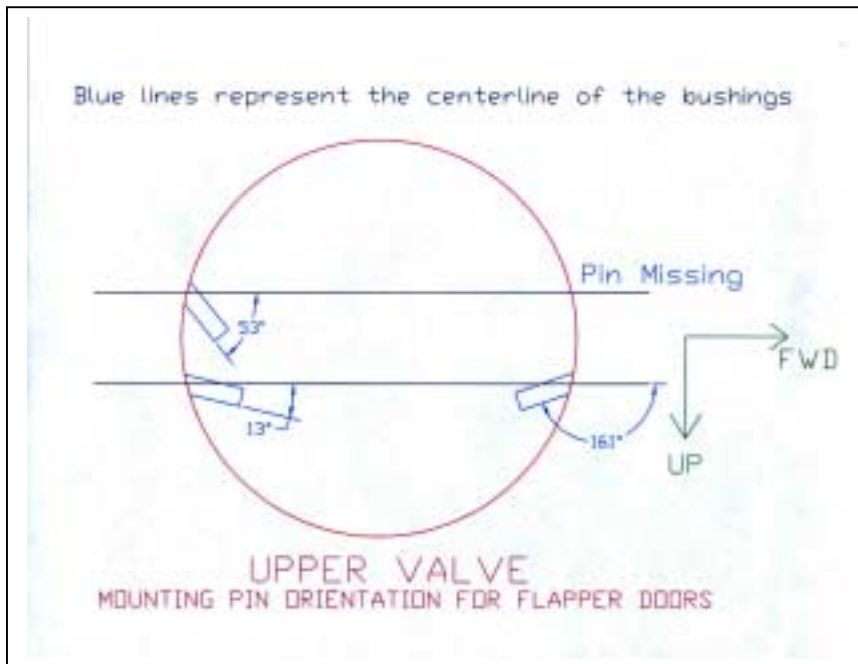
- Performed **measurement** of pin angles using a flat reference plane (outer skin of aircraft); using two imaginary reference lines running between the centerlines of the pin mounting holes (upper fwd to upper aft) & (lower fwd to lower aft). All angular measurements were based from these two imaginary lines. (See: diagram. Upper Valve, flapper doors' pins, orientation, Figure 96).
- Results of measurements (approximation):
Upper aft pin = 13°; Upper fwd pin = 161°; Lower aft pin = 53°

Figure 96: Upper Pressure Relief Valve, flapper valve doors, pin orientation.

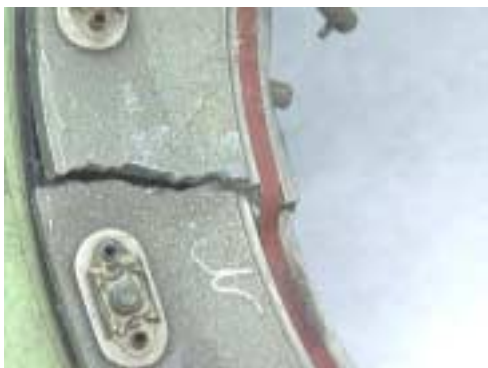
Figure 97: Non-metallic washer (gate seal) - continuous ring.

- Slight impression of knife-edge on seal.

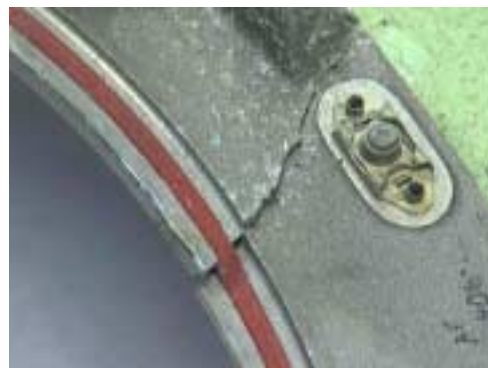
Figure 98: One slight cut adjacent to housing fracture.

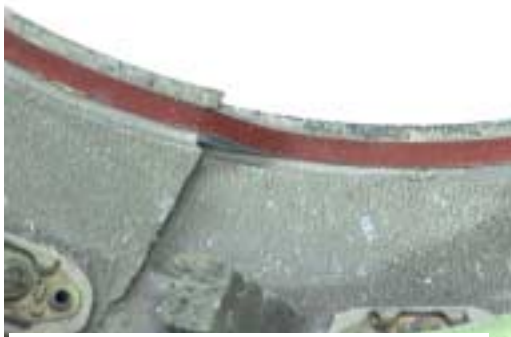
Figure 99: Another cut on the seal.

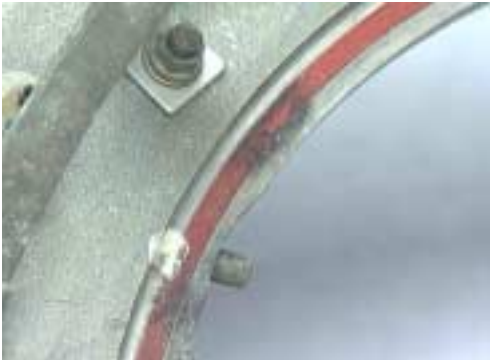
Figure 100: Discolored region of gate seal.

- Unknown white colored contaminant on seal.

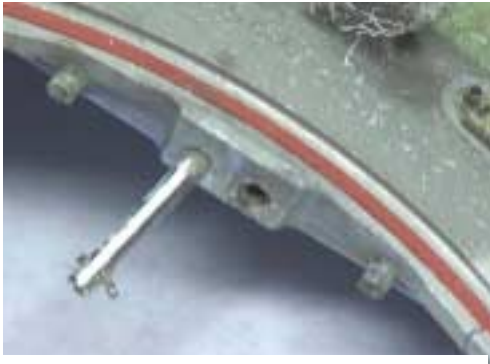
Figure 101: Forward stops & hinge pin, (looking from inside to outside).

- Forward/lower hinge pin is missing.

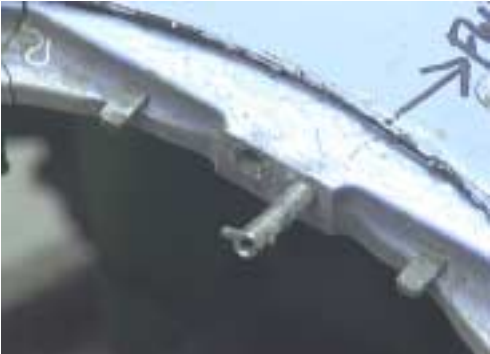
Figure 102: Forward stops and hinge pins, (looking from outside to inside).

- Forward/upper hinge pin can rotate freely.
- Stop pins look normal and unbent.

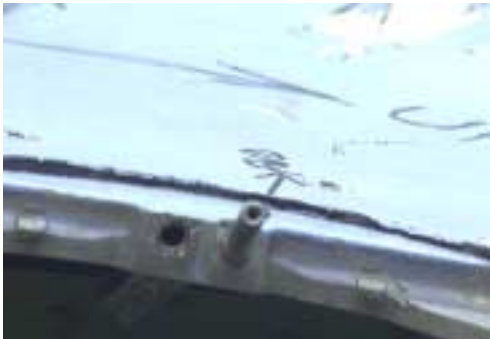
Figure 103: Forward/upper hinge pin, physically rotated by hand so that bent portion was oriented outboard.

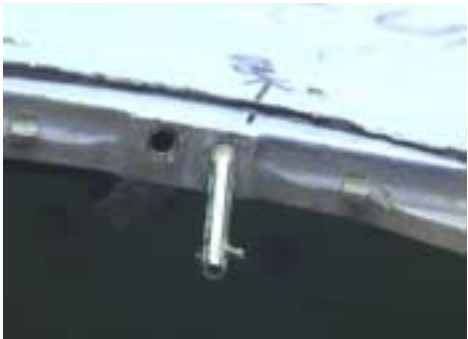
Figure 104: Forward/upper hinge pin, physically rotated by hand to bend inboard.

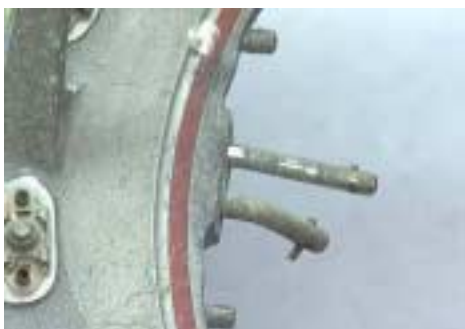
Figure 106: Aft hinge & stop pins (looking from inside to outside).

- Aft/lower stop pin appears to have a rust mark and can rotate.

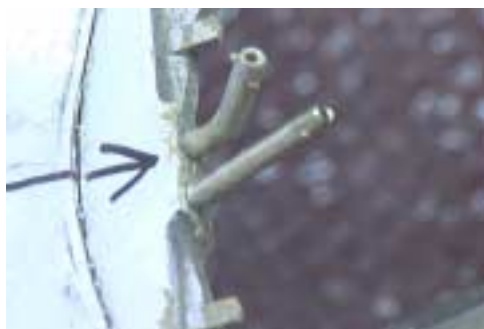
Figure 107: Aft hinge & stop pins, (looking from outside to inside)

- Aft/upper hinge pin (lower pin in photo) is difficult to rotate.
- Aft/lower hinge pin (upper pin in photo) rotates.

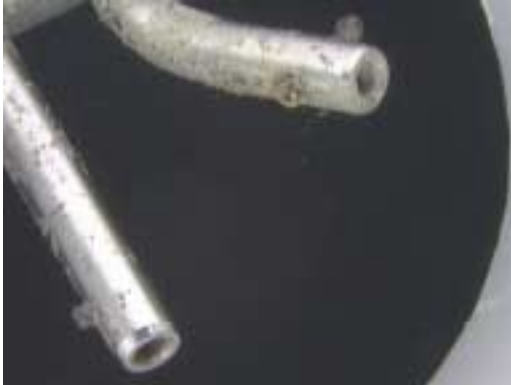
Figure 110: Aft hinge pins, upper & lower. Aft/lower pin is rotated to non-closed door position.

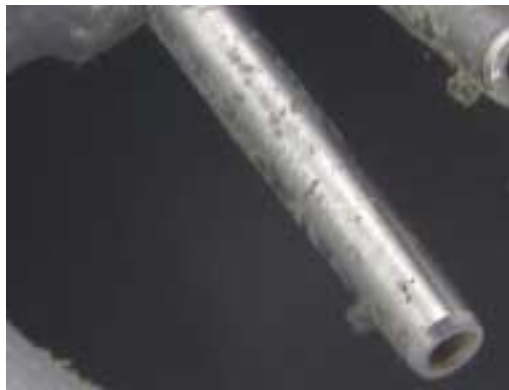
Figure 112: Aft/upper hinge pin, cotter pin is broken.

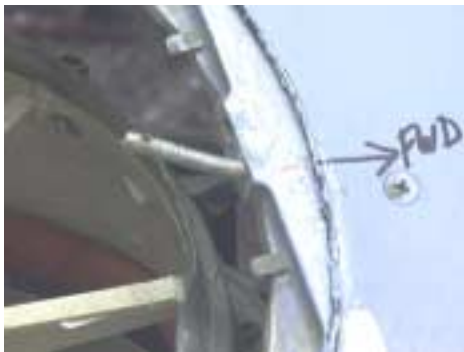
Figure 113: Forward/upper hinge pin, upper door (forward/lower hinge pin is missing).

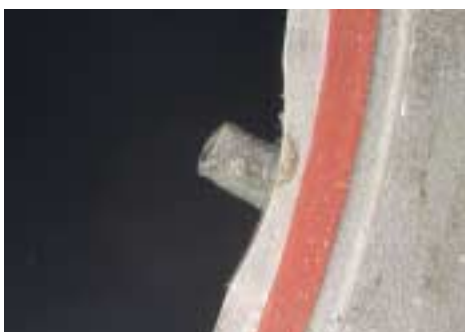
[Figure 117](#): Overview of forward/upper stop pin as viewed from inside.

- Pin is relatively straight.

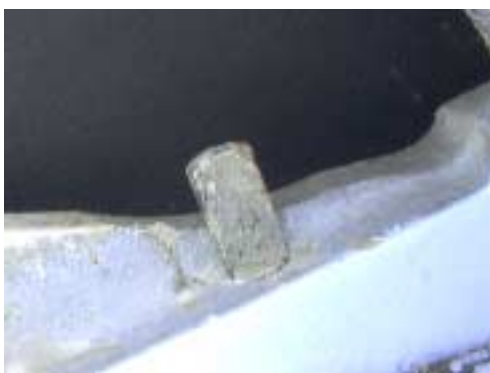
[Figure 119](#): Overview of forward/upper stop pin, as viewed from outside.

- Pin is relatively straight, paint missing.

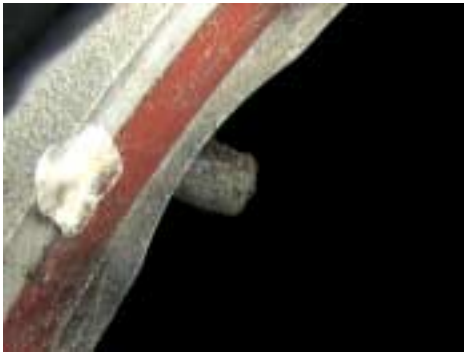
[Figure 122](#): Overview of aft/upper stop pin, as viewed from inside.

- Pin is relatively straight.

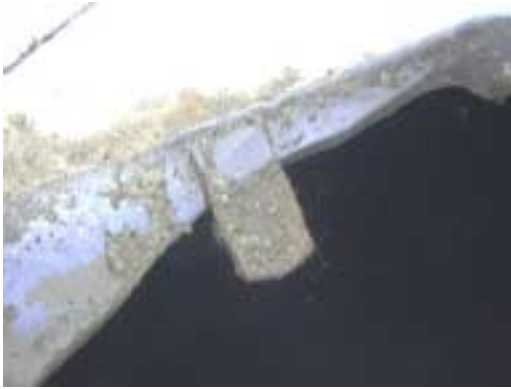
Figure 125: Overview of aft/upper stop pin as viewed from outside.

- Pin is relatively straight.

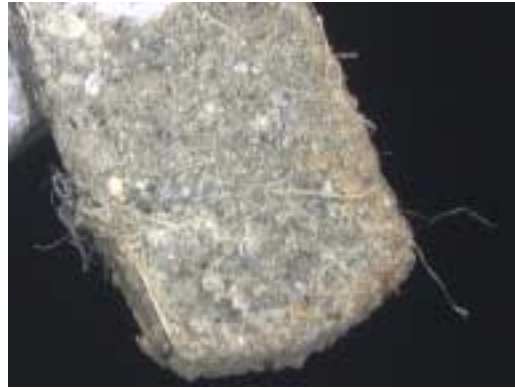
Figure 126: Aft/upper stop pin, close-up of figure #125.

- Paint is chipped.

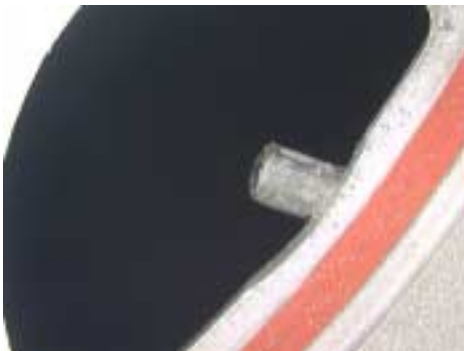
Figure 129: Overview of forward/lower stop pin, as viewed from inside.

- Pin is relatively straight.

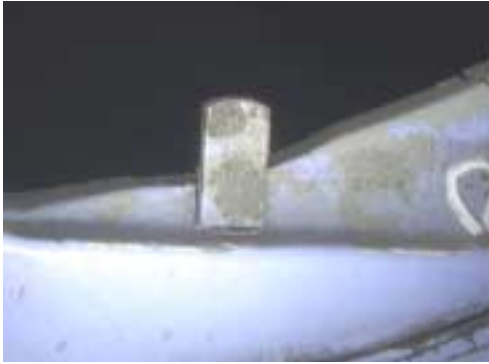
Figure 131: Overview of forward/lower stop pin, as viewed from outside.

- Pin is relatively straight.

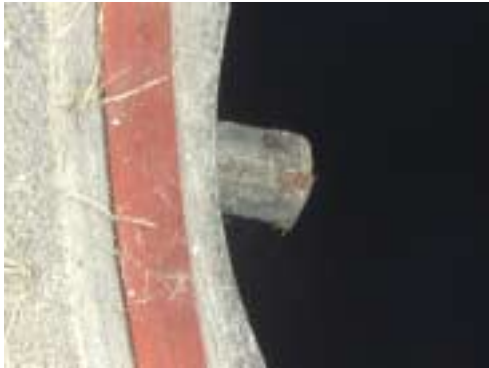
Figure 133: Overview of aft/lower stop pin, as viewed from inside.

- Pin is relatively straight.

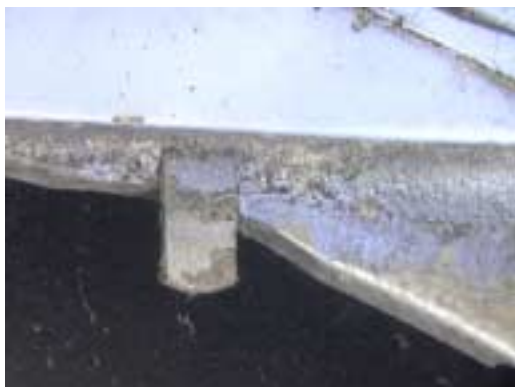
Figure 136: Aft/lower stop pin.

- Overall, pin is relatively straight.

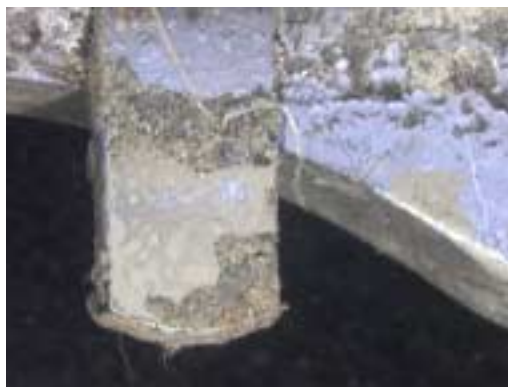
Figure 137: Aft/lower stop pin, close-up of figure #136.

- Paint is chipped.

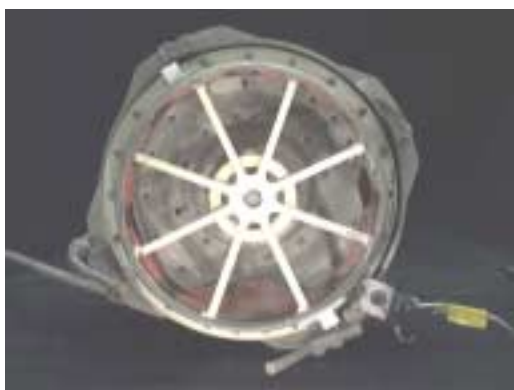
Figure 138: Overview of valve face.

- Knife-edge has some rolled over areas and some bent edges.
- In general, reasonably round.
- 2 gate spacers, HS P/N 727407-30 are missing, remaining 2 spacers on top and bottom as shown.

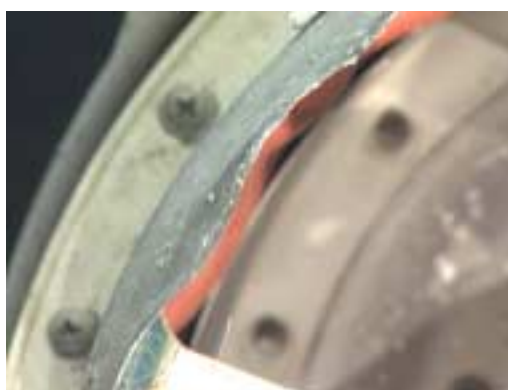
Figure 139: Close-up of knife-edge damage.

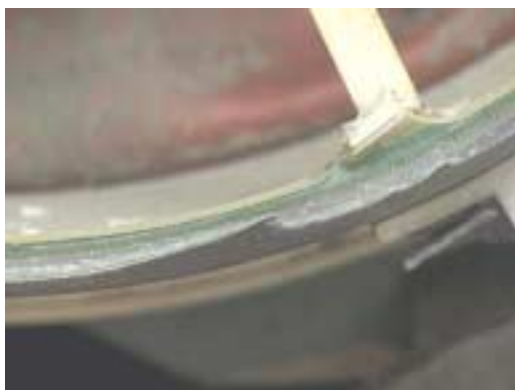
Figure 140: Close-up of knife-edge damage.

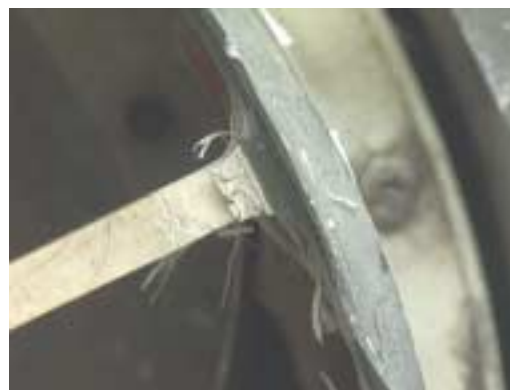
Figure 141: Close-up of knife-edge damage.

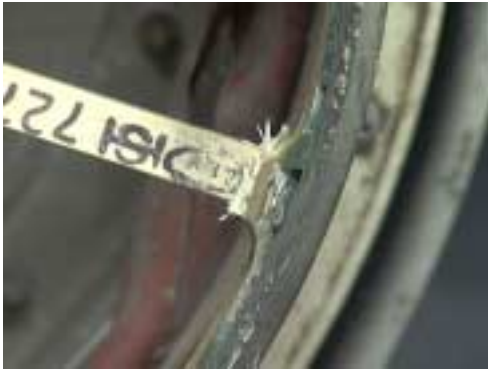
Figure 142: Overview, close-up of typical web fracture.

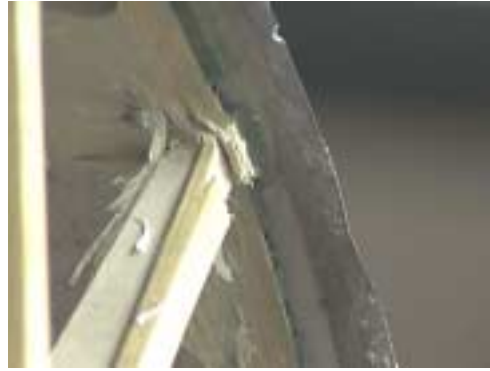
Figure 143: Close-up of web, representative of web fractures at gate ID.
