In-flight structural breakup, Boeing 747-200 B18255, May 25, 2002 in the Taiwan Straits approximately 23 nm northwest of Makung

CI611 Accident Investigation

Factual Data Report

ASC-AFR-03-06-001

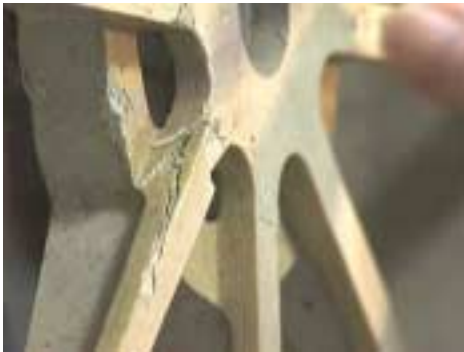
Figure 144: Worst of the center web cracks. 2 of 8 appear to be intact, remaining exhibit various degrees of cracking.

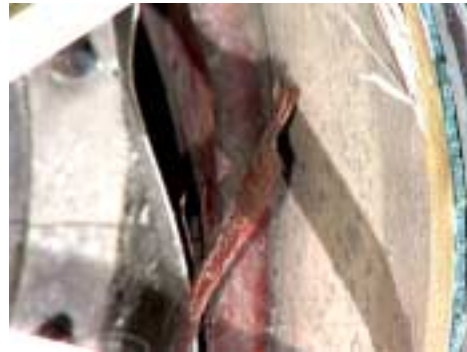
Figure 145: Diaphragm, 75 % of outer circumference is torn/split.

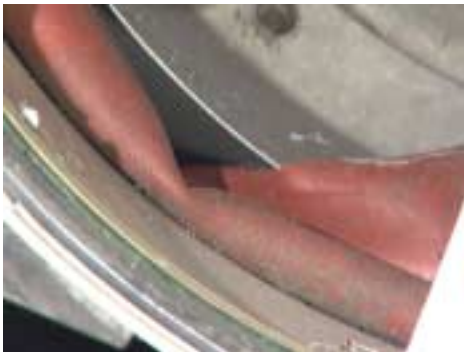
Figure 146: Diaphragm, showing typical tear.

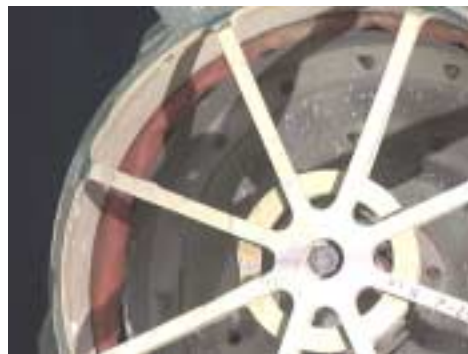
Figure 147: Diaphragm, apparently intact portion.

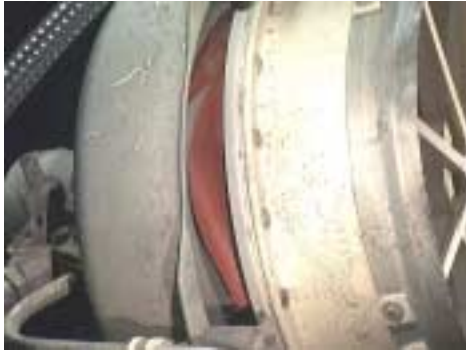
Figure 148: Diaphragm, circumferential tear.

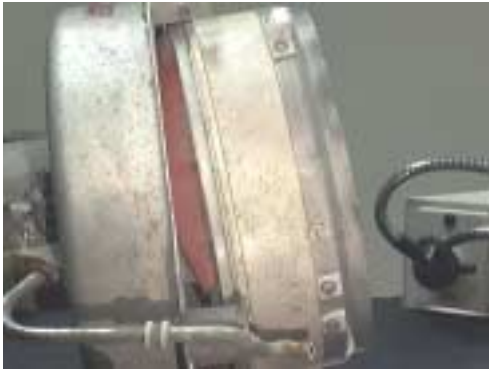
Figure 149: Offset angle between valve housing and gate.

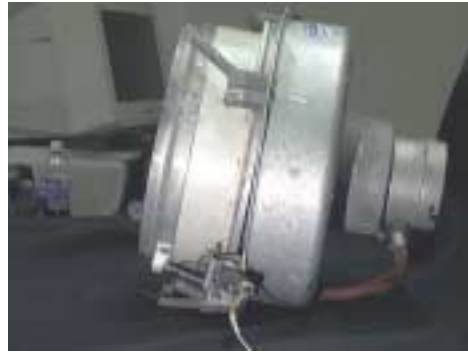
Figure 150: Offset angle (same as in figure #149) from the opposite side.

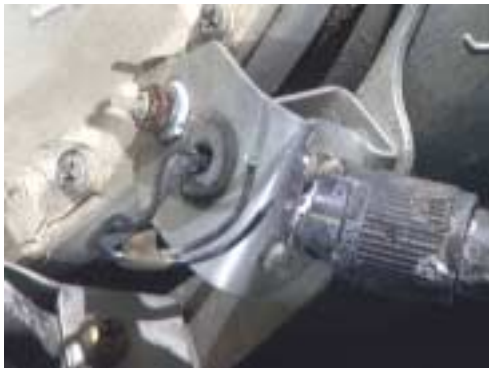
Figure 151: Switch mounting bracket, gate is against bracket.

- The switch actuator is intact but the basic switch is missing.
- The (electrical connector and plug) mating is intact.

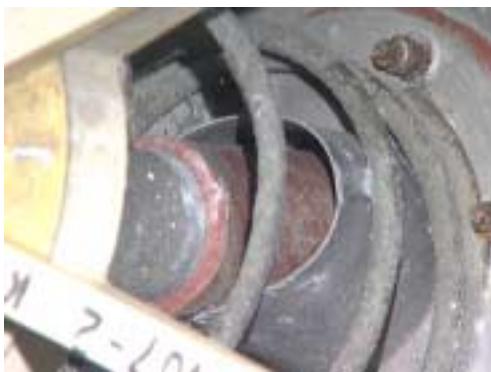
Figure 153: Center diaphragm & return spring.

- Diaphragm is intact and spring is unseated from valve cover.

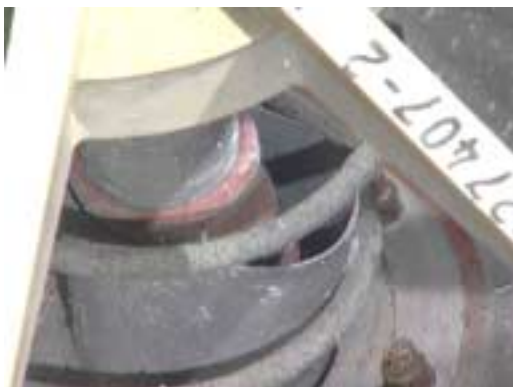
Figure 154: Center diaphragm guide, HS P/N 727411-1, showing distortion of guide itself.

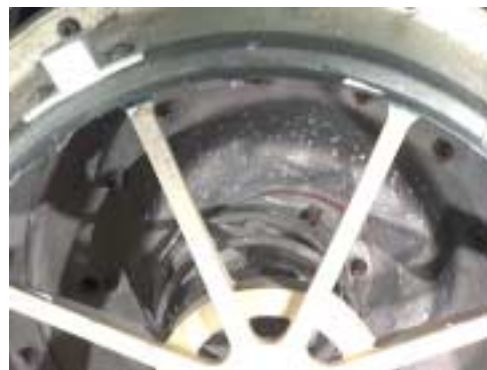
Figure 155: Gate return spring, showing unseated spring.

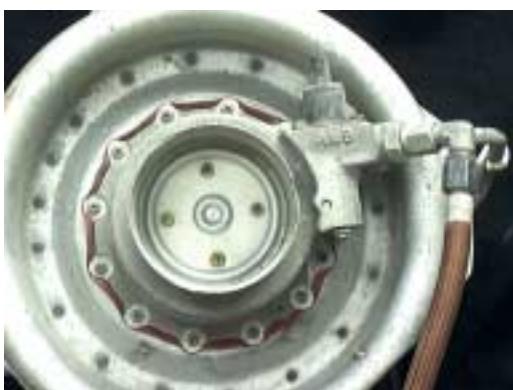
Figure 156: Overview of control and filter assemblies.

- The filter (HS P/N 715942-1), cover (HS P/N 727423-1) and spring (HS P/N 727430-1) – are all missing.
- Control orifice shown in bottom of filter housing looks clean.
- Exterior of sensors exhibit light deposits of contamination.

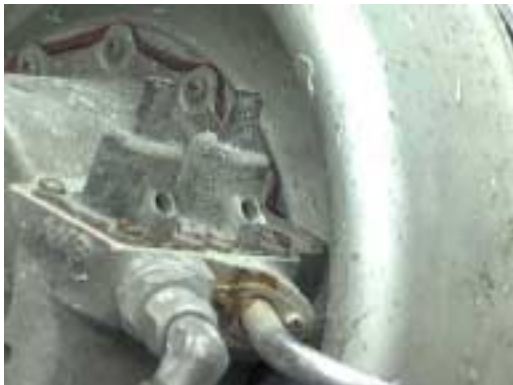
Figure 157: Exterior view of sensors, showing some apparent corrosion on the integral ambient sense tube.

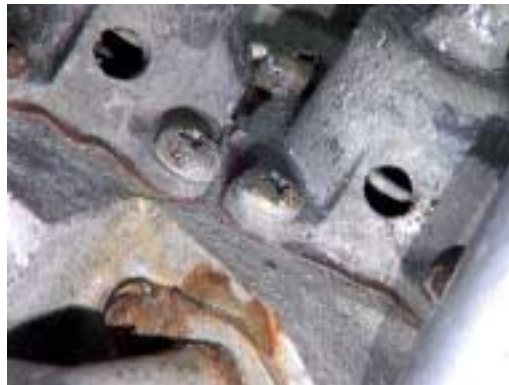
Figure 158: Cabin pressure sense ports on sensor adjustment springs.

- Holes look clear.
- Corrosion on tube retainer plate (HS P/N 727417-2).

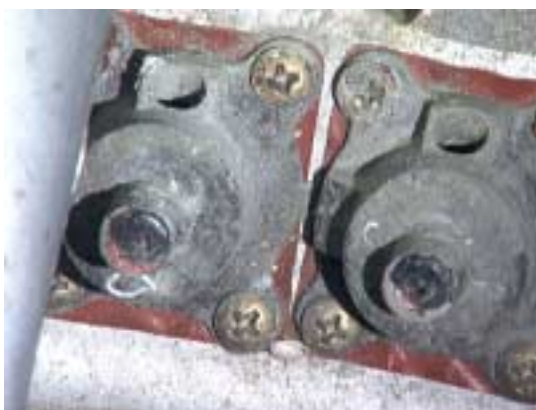
Figure 159: Control adjustment screws.

- Tamper proof seals are in place.

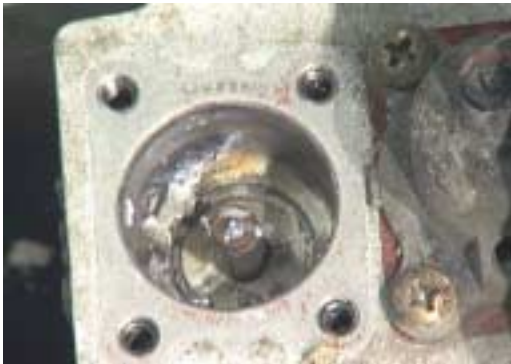
[Figure 165](#): Remote ambient sensor housing bore.

- Salt & moisture present.
- Poppet is frozen.

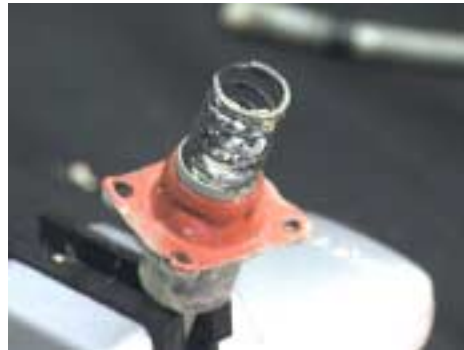
[Figure 166](#): Diaphragm appears to be intact.

- Salt deposits on spring.
- Heavy corrosion on spring seat (one-third).

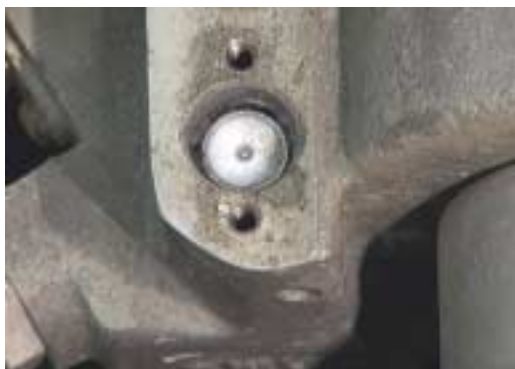
Figure 167: Remote ambient sensor poppet and guide, opposite side - relatively clean.

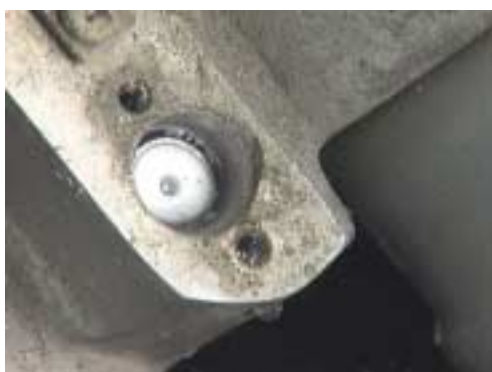
Figure 169: Shows water in plug area.

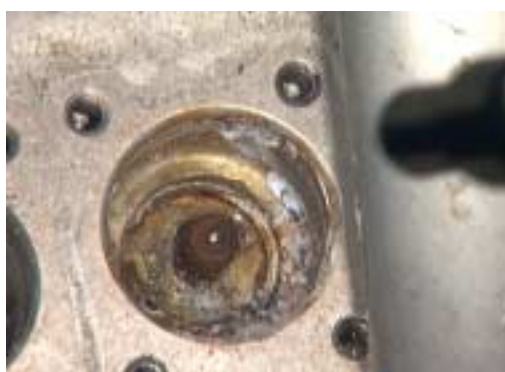
Figure 170: Integral ambient sensor poppet housing bore.

- Poppet was free.

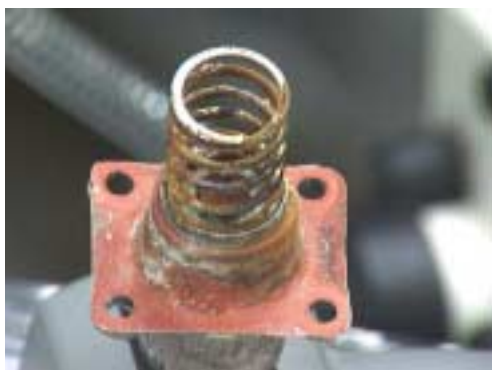
Figure 171: Integral ambient sensor spring & diaphragm.

- Heavy hardened corrosion on spring and diaphragm in localized areas.
- Corrosion on spring seat almost all the way around.

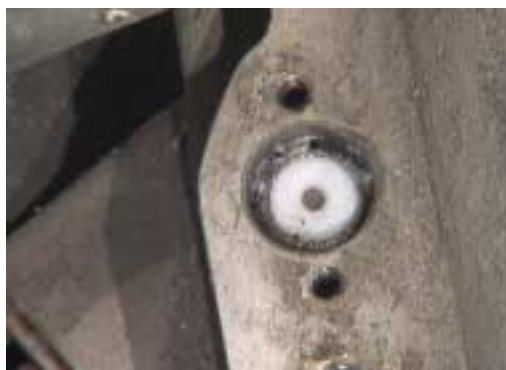
Figure 172: Opposite end of integral ambient sensor poppet and guide.

- A little moisture is present.

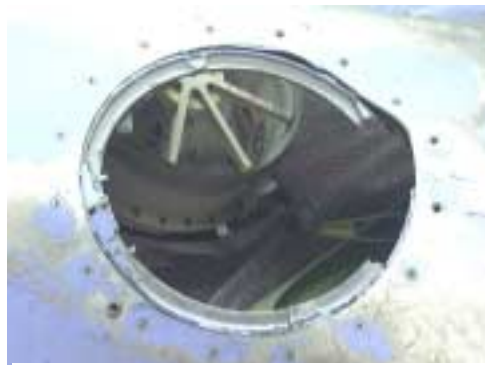
Figure 179: Exterior opening for Lower Pressure Relief Valve (valve still inside).

- External view shows the heads of 5 attachments screws to the skin, are missing and about 25% of mounting flange is missing.

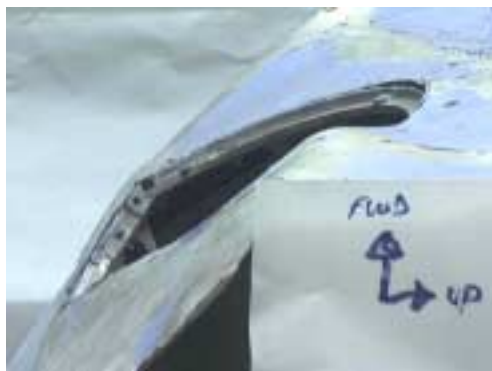
[Figure 183](#): Skin distortion at valve mounting location.

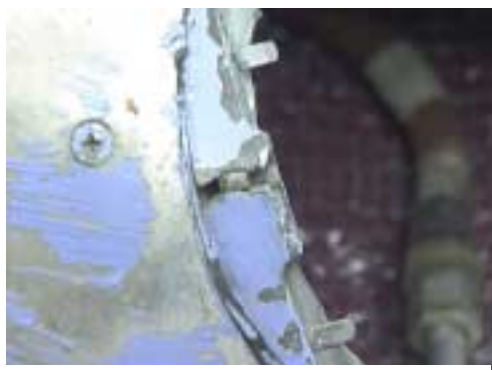
[Figure 184](#): Exterior opening, close-up of fracture of valve housing at forward/upper hinge pin.

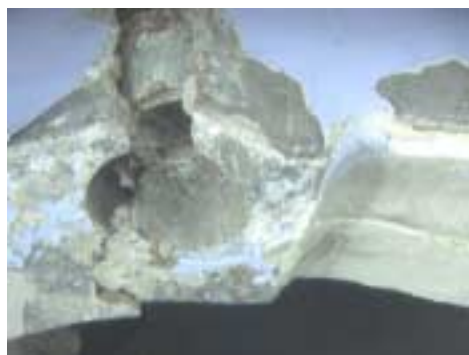
[Figure 185](#): Exterior opening, close-up, another view of figure #184

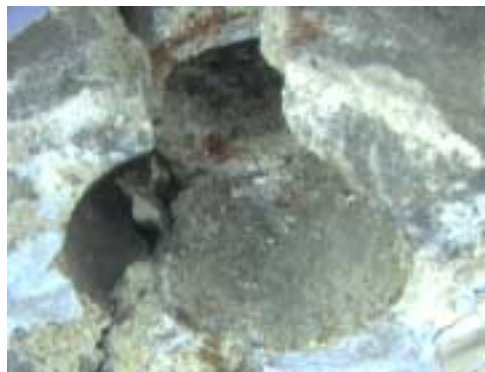
[Figure 186](#): Forward/upper hinge pin bushing hole.

- Housing is cracked and contains partial bushing.

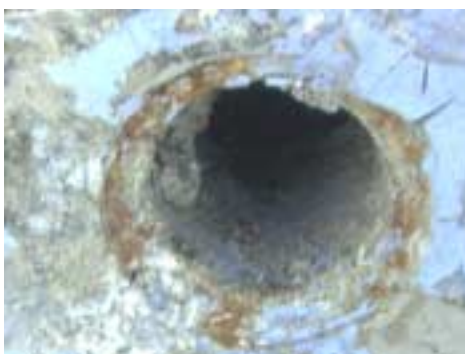
[Figure 187](#): Forward/upper hinge pin, close-up of partial bushing.

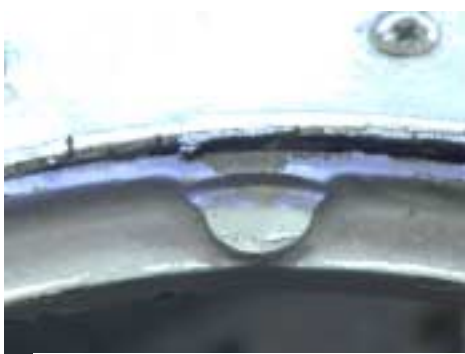
[Figure 188](#): Forward/upper hinge pin, close-up view of partial bushing in hole.

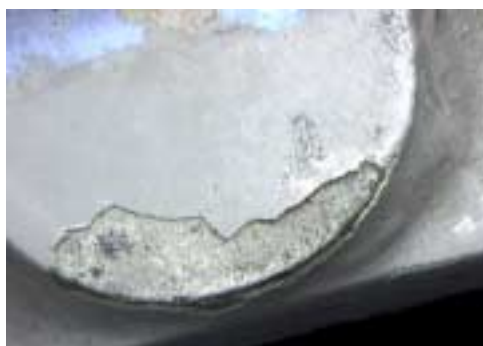
[Figure 191](#): Upper stop pad; paint chipped.

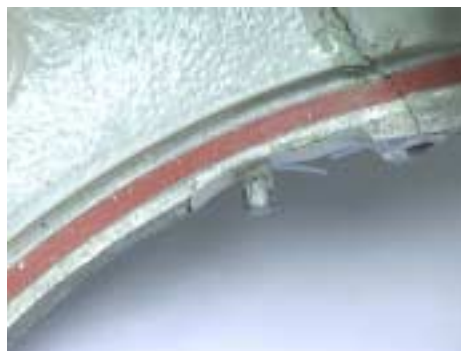
Figure 193: Non-metallic washer (gate seal), HS P/N 527355-13, as viewed from inside.

- Approximately 25% of seal is missing.
- Slight impression of gate knife-edge on seal surface.
- No abnormal cuts on seal surface.

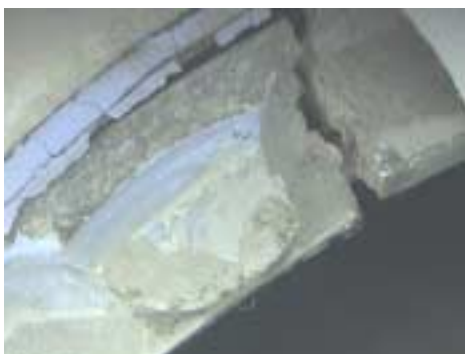
Figure 199: Forward/upper stop pin, close-up of figure #198.

- Paint is chipped.

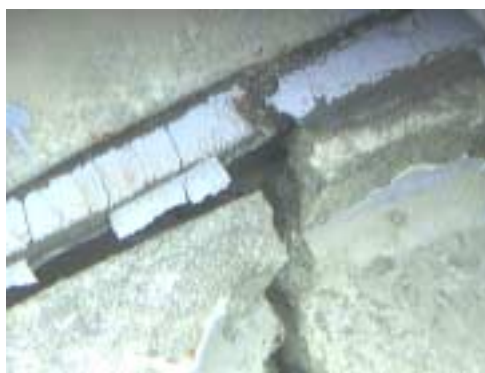
Figure 200: Lower stop pad, with adjacent crack on housing.

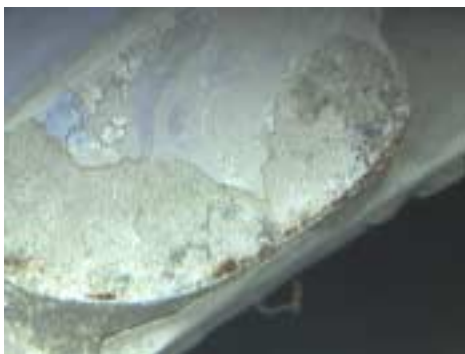
Figure 201: Detail of lower stop pad.

- It is broken away from housing (housing cracked).

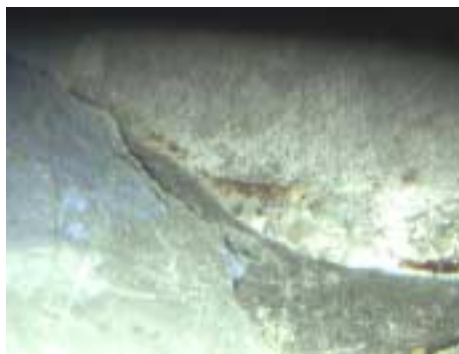
Figure 202: Close-up of figure #200, paint chipped.

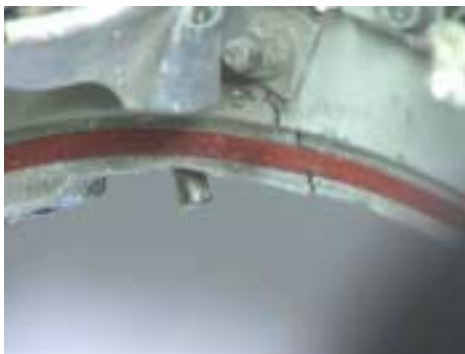
Figure 203: Close-up of figures #200 and #202, slight dent on pad, paint chipped.

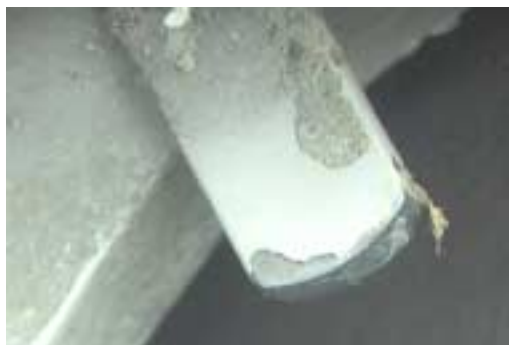
Figure 207: Forward/lower, stop pin as viewed from outside.

- Pin is relatively straight.
- Paint is chipped.

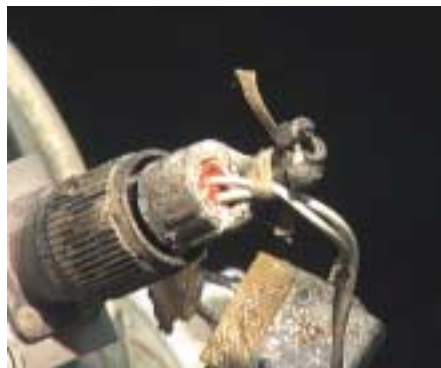
Figure 209: Hole penetrating support housing, HS P/N 727405-1.

- Hole is approximately 0.365 inch x 0.560 inch.

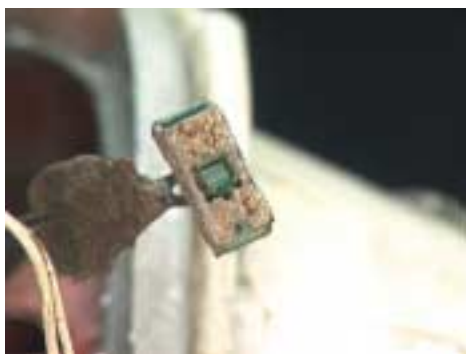
Figure 210: Electrical switch connector interface appears to be intact.

- Wires are intact exiting plug.
- Strain relief on backshell is broken.

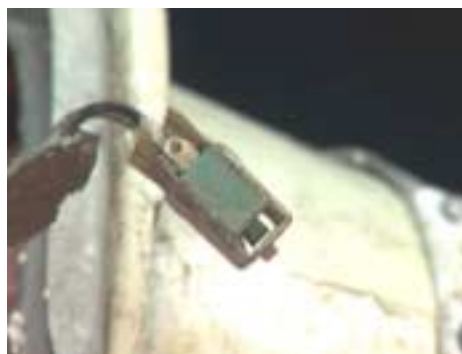
Figure 211: Switch plunger, part of HS P/N 727415-1.

- Switch appears to be intact but switch actuator is missing.

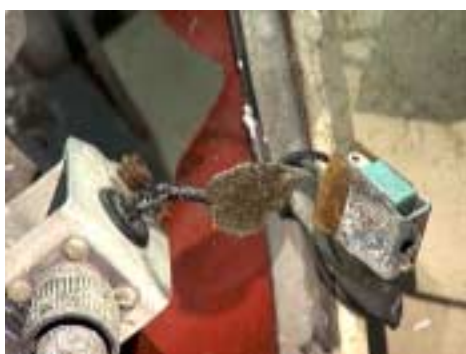
Figure 212: Switch (side view): actuator is missing from switch housing.

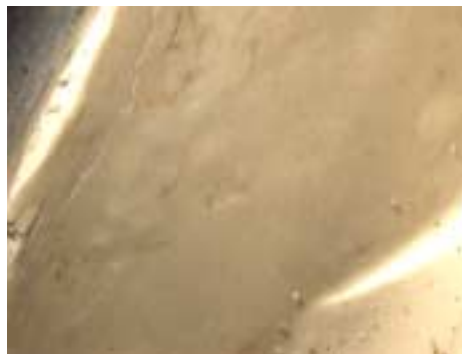
Figure 213: Switch lead wires showing bond detached from housing.

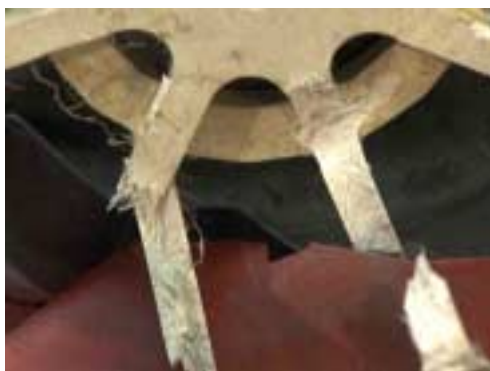
Figure 215: Overview of removed valve.

- Gate adapter is out of round.
- Web members have rotated approximately 45° in relation to case.
- Approximately 50% of edges were curled & torn.
- Light salt deposits.
- At attachment to gate HS P/N 727407-11, 50% of sealant is cracked.
- All 8 rivets (attaching gate to gate adapter) are intact.
- 2 of 4 spacers HS P/N 727407-30, are broken off at flanges.
- HS P/N 727407-11, gate – all 8 of center body webs are broken (7 of 8 at the inside diameter [ID] of the gate).

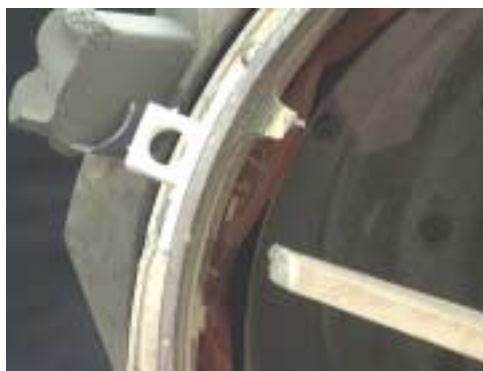
Figure 216: Gate webs, detailed view of broken web members.

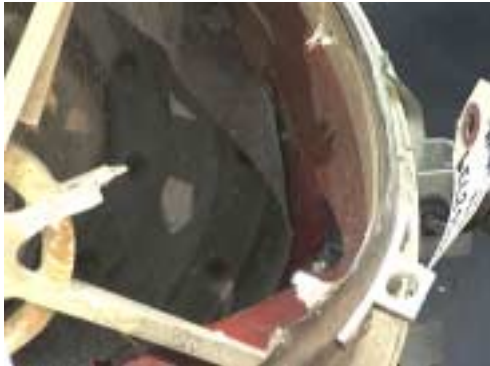
Figure 217: Broken web detail.

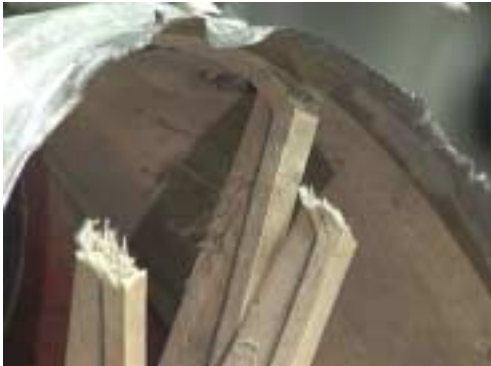
[Figure 218](#): Web damage.

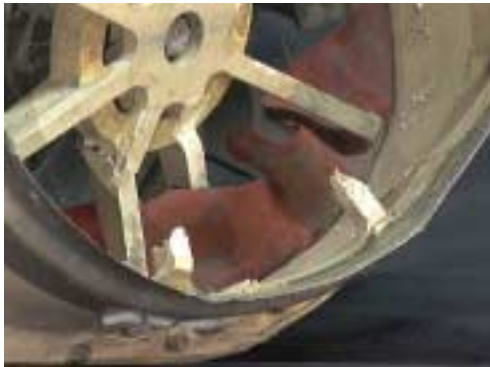
[Figure 219](#): Web damage.

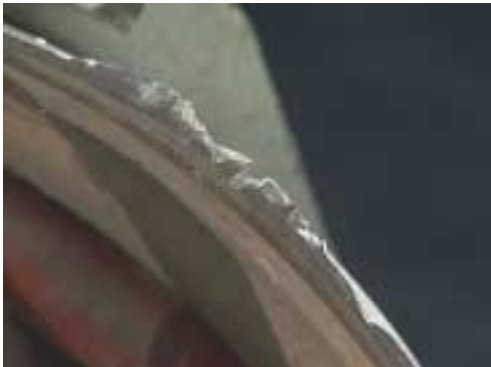
[Figure 220](#): Detail of more broken webs.

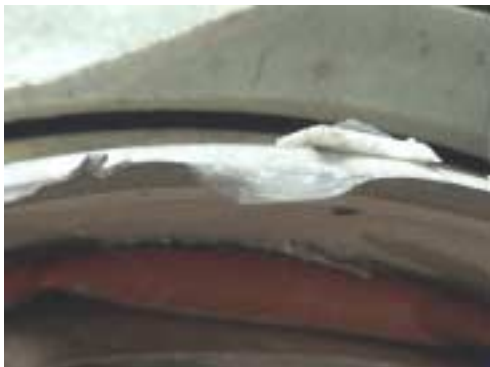
[Figure 221](#): Knife-edge close-up of damage.

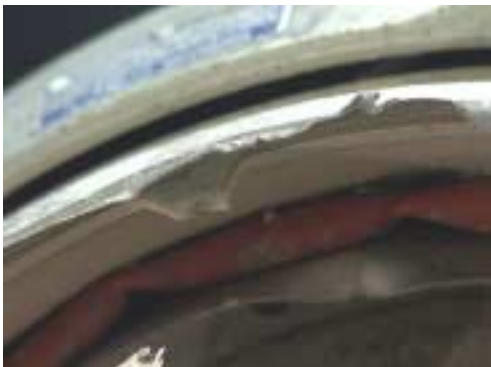
[222](#): Knife-edge damage.

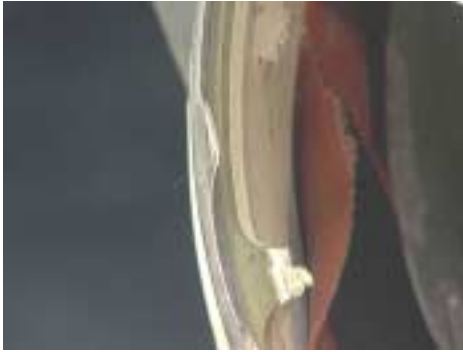
[Figure 223](#): Knife-edge damage.

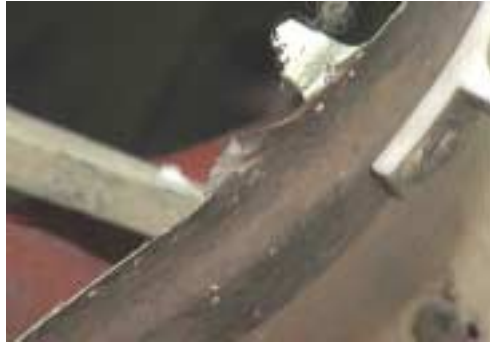
[Figure 225](#): Knife-edge damage.

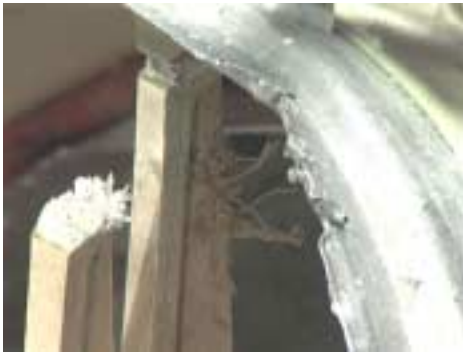
[Figure 226](#): Knife-edge damage.

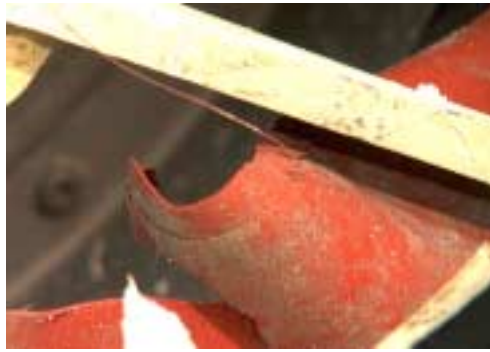
[Figure 227](#): Outer diaphragm HS P/N 727403-1, torn location.

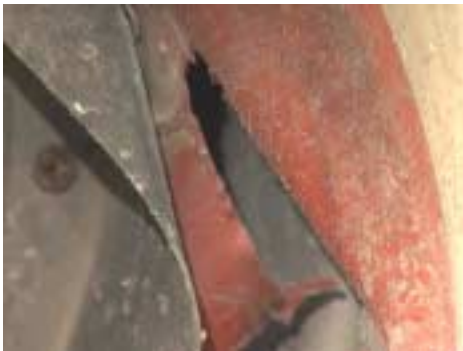
[Figure 228](#): Outer diaphragm, approximately 60% of circumference is torn.

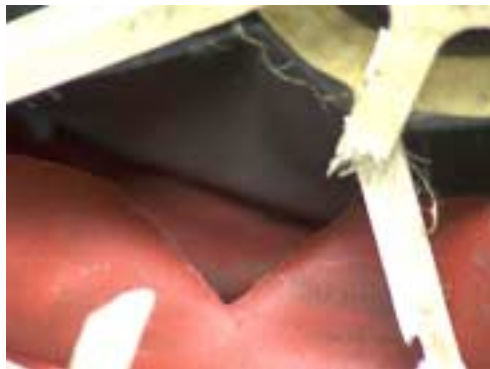
[Figure 229](#): Outer diaphragm, torn location.

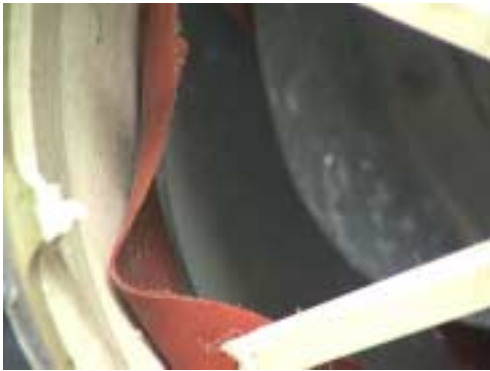
Figure 230: Outer diaphragm damage.

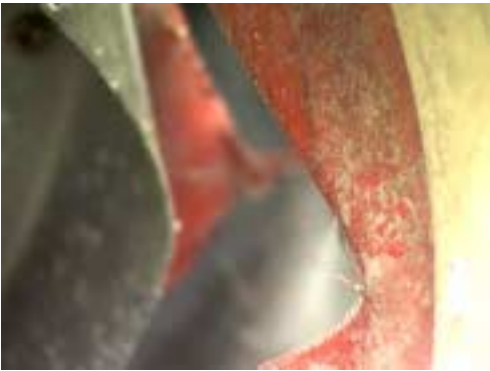
Figure 231: Outer diaphragm damage.

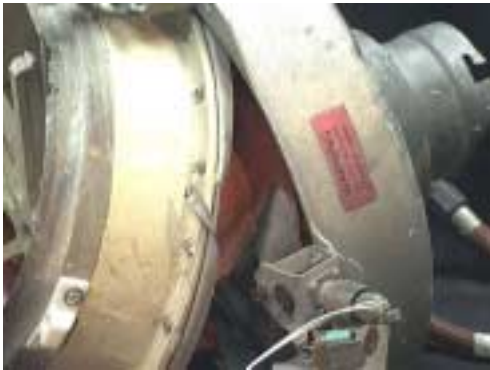
Figure 232: Side view of gate assembly & valve cover, showing the approximate 30° angle between gate assembly & valve cover.

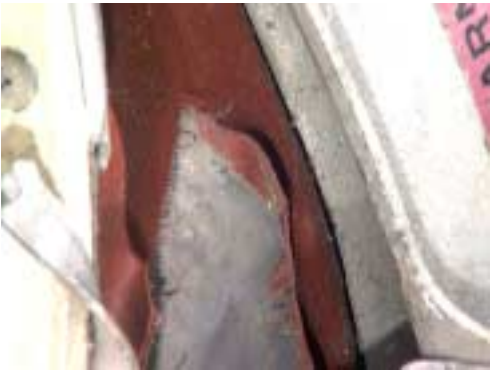
Figure 233: Outer diaphragm, close-up of tear origin.

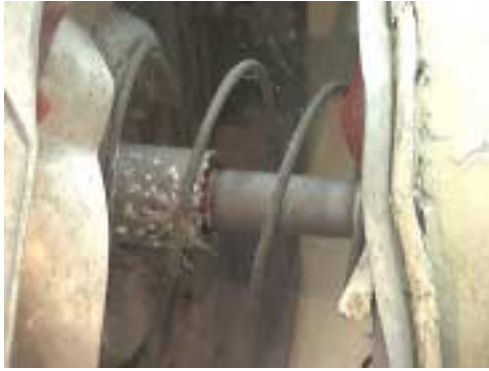
Figure 236: Gate return spring, HS P/N 727414-2 appears to be intact.

- Some unknown surface accumulation is present.

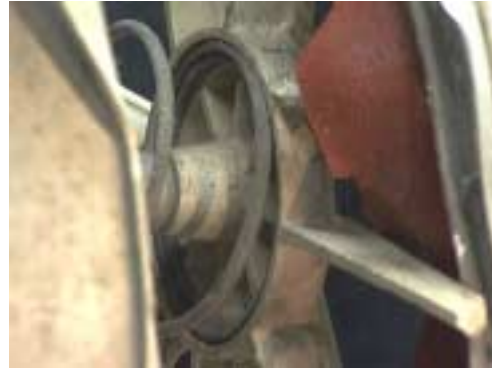
Figure 237: Gate return spring is seated in the gate. The end coil appears to be inside the last active coil.

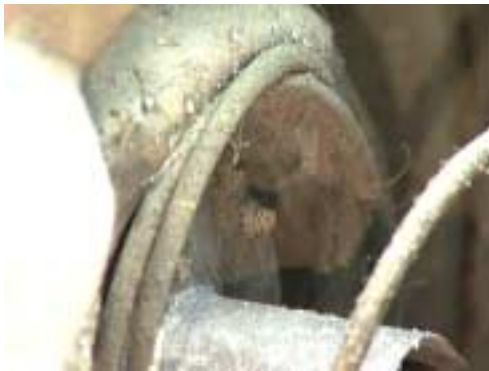
Figure 238: Gate return spring is over end showing intertwining of end coil and the active coil.

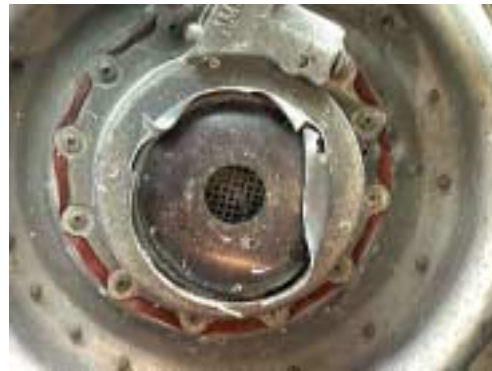
Figure 239: Overall of control, filter end.

- Filter cover HS P/N 727423-1 & spring HS P/N 727430-1 are missing.
- Filter housing HS P/N 727426-1 is bent over holding filter in place.

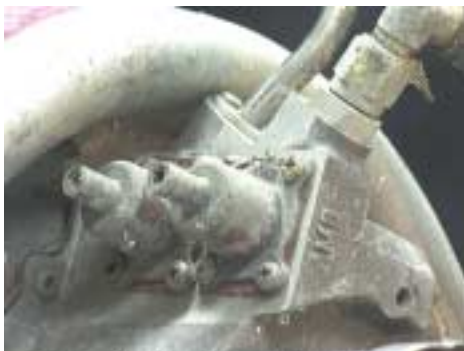
Figure 240: Control assembly area (sense housing area), overview.

- Intact, some surface accumulation.
- Nothing looks out of place.
- Integral ambient sensing tube attachment looks normal.
- Remote tube attachment looks normal.

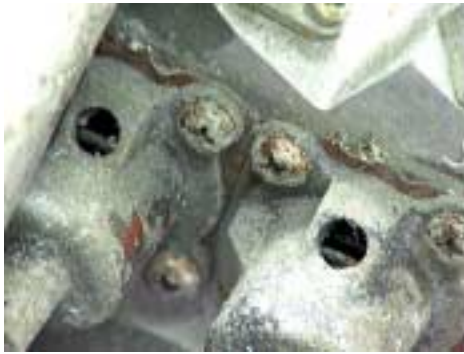
Figure 241: Cabin pressure sense ports.

- Ports appear to be un-plugged.
- Some accumulation deposits.
- Springs appear to be in place.

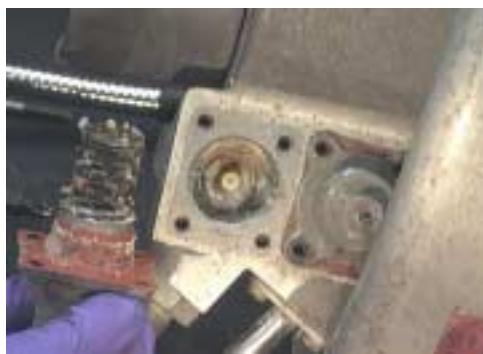
Figure 250: Showing remote ambient sensor removed.

- Heavy salt deposits on spring & housing bore.
- Diaphragm appears to be intact, poppet moves freely.

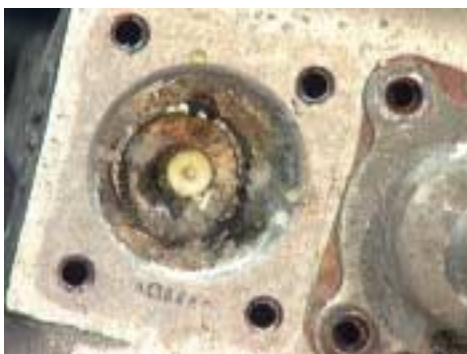
Figure 251: Close-up of salt deposits inside housing bore.

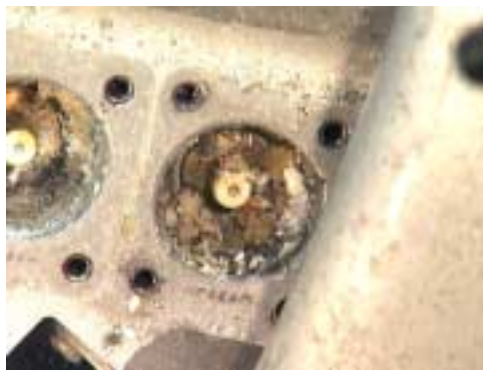
Figure 254: Integral sensor housing bore.

- Heavy deposits.
- Poppet appears to be frozen.
- Salt deposits on end of poppet.

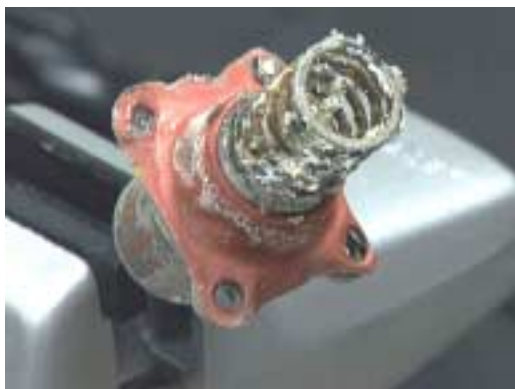
Figure 255: Integral sensor spring and diaphragm.

- Heavy salt deposits.
- Diaphragm intact.
- Spring has heavy salt deposits and possibly salt corrosion.

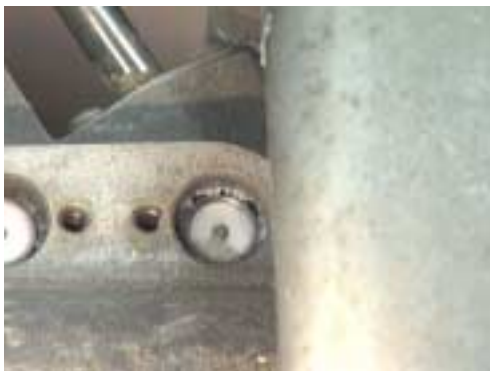
Figure 256: Opposite end of integral sensor poppet and guide; heavy salt deposits.

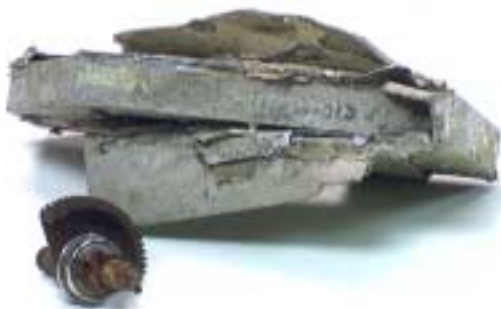
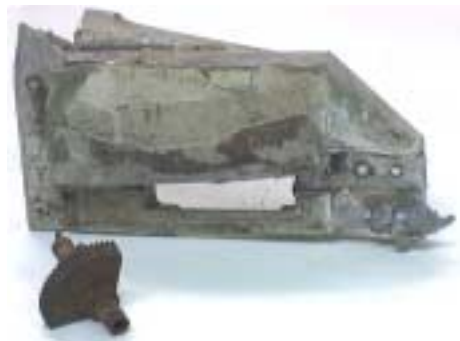
Figure 274. Appears to be a portion of a gear/cam assembly and structure.

Figure 275. Appears to be a portion of a gear/cam assembly and structure, different view from figure #274.

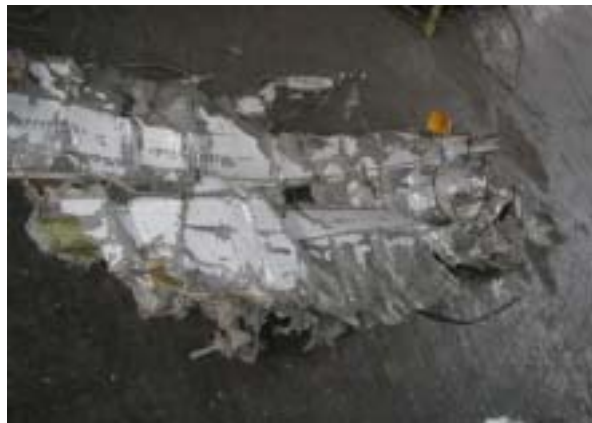
In sections 41 and 42, the portions of structure in the crown region were less fragmented (larger segments) than portions of structure recovered from the lower fuselage. The largest piece of structure recovered in the crown area (item 487) extended from below the main deck window belt on the Left Hand Side (LHS) to below the upper deck floor on the RHS. Most of the frame and upper deck floor beam segments were still attached. While the upper deck floor beams were fractured and the skin was folded in the crown region, the majority of the panel retained its original contour. The cockpit structure (item 545 [Figure 1.12-3(a)]) was found to be relatively intact aft to STA 500 and essentially retained its original shape. Much of the structure below these two items was found in smaller segments and with greater distortion (see items 655, 656, and 705 [[Figure 1.12-3(b)]]). Many belly segments showed general upward deformation of the skin panel between stringers and frames (see items 876 [[Figure 1.12-3(c)], 969, 973, and 1088).

Figure 1.12-3 (c) Item 876 belly skin with upward deformation

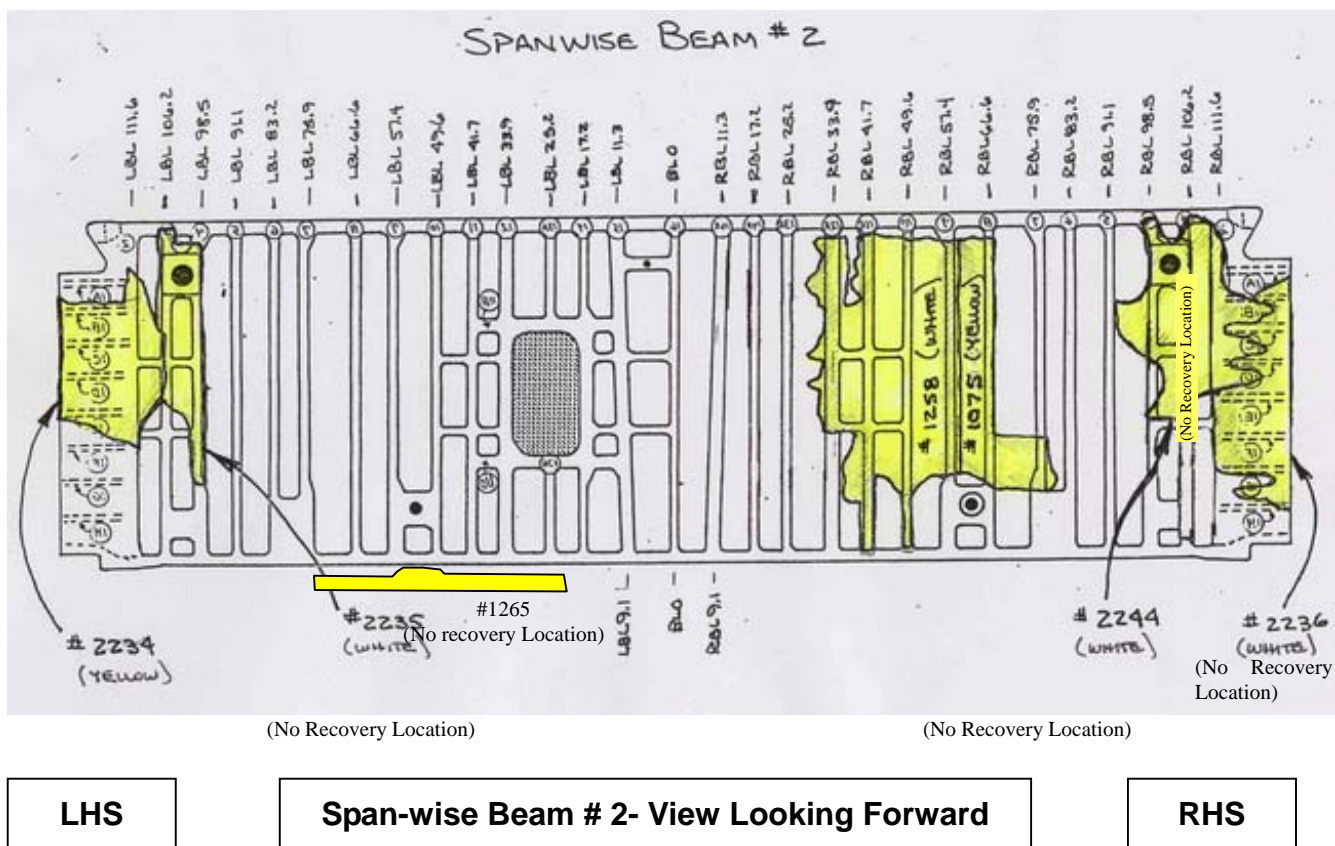
Figure 1.12-16 The recovered and identified portions of SWB #2

The small portion of the lower chord attached to the lower skin panel item #1265 remains on the panel. The forward face of this lower chord segment has vertical witness marks extending from the lower edge of the chord to just below the lower fastener row common to the web.

There was no evidence of any soot accumulations or fire damage on the recovered portions of SWB #2.

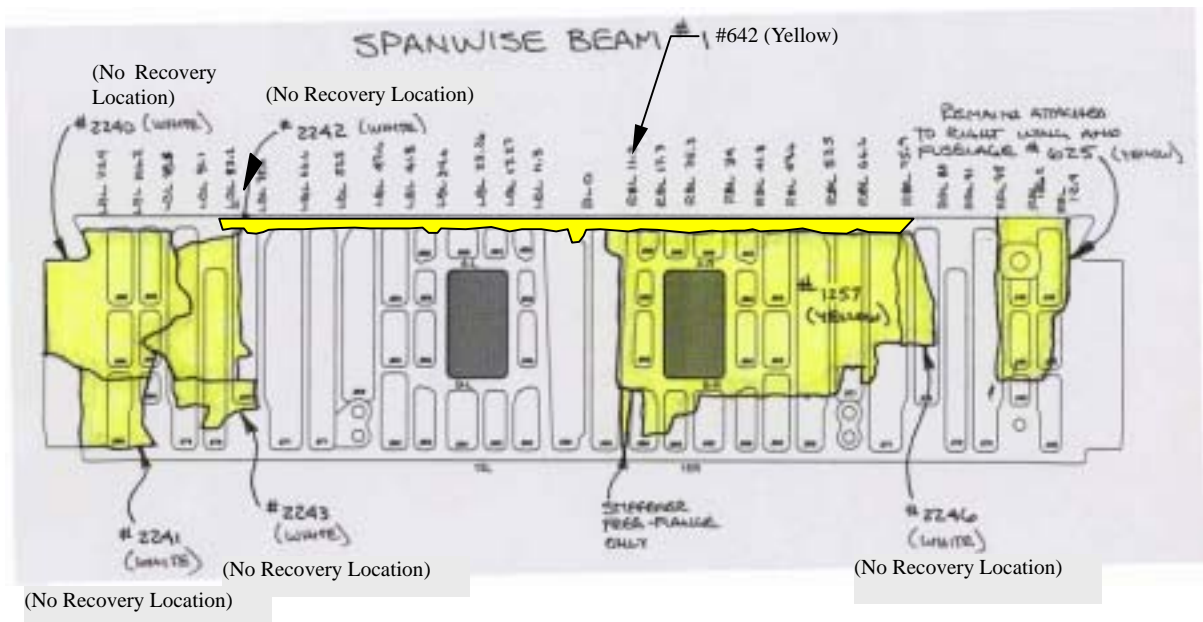
Figure 1.12-20 The recovered and identified portions of SWB #1

None of the lower chord remained attached to the skin but some of the stiffener shear ties remained attached to lower panel item #1256 and #836. For the shear ties on item #1256, the fastener holes that would have been common to the SWB stiffener web have been deformed on the lower edge of the hole or slightly off center from the lower edge of the hole.

There was no evidence of soot or fire damage on SWB #1.

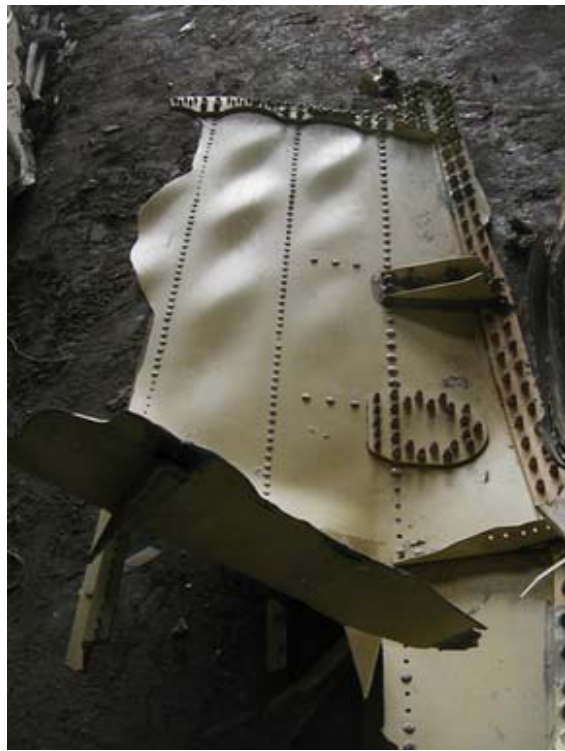
Two of the segments (item #1264 and #1019) had evidence of diagonal web buckling between the vertical stiffeners. The direction of the buckling pattern was from the lower/aft to upper/fwd direction (See Figure 1.12-31).

Figure 1.12-31 (a) Left S.O.B Rib Item #1264 showing web buckling

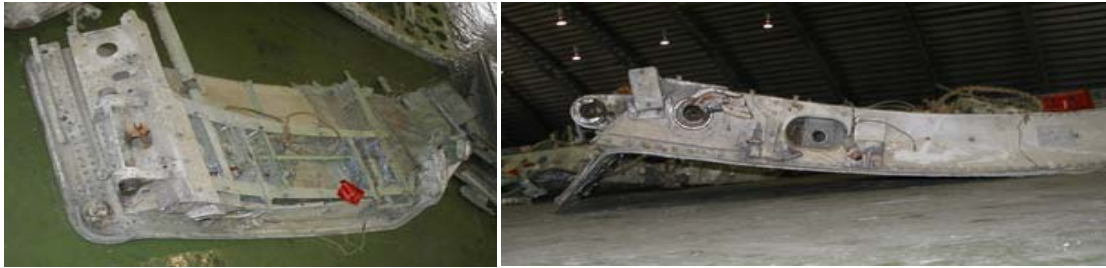
Figure 1.12-37 Item 2019

The deformation common to the lower portion of item 2019(See Figure 1.12-36) indicates that this segment of the door rotated outboard about the aft latch pair. This deformation is only evident on item 2019, indicating that this aft portion of the door was still attached at the lower aft latch pair after it was separated from the forward portion of the cargo door. The fracture along the forward edge of item 2019 shows that this separation occurred due to loads transferred through the latch pair (loads from lower edge of door segment). The remaining door segments (items 723 and 741) were still intact and separated at a later time.

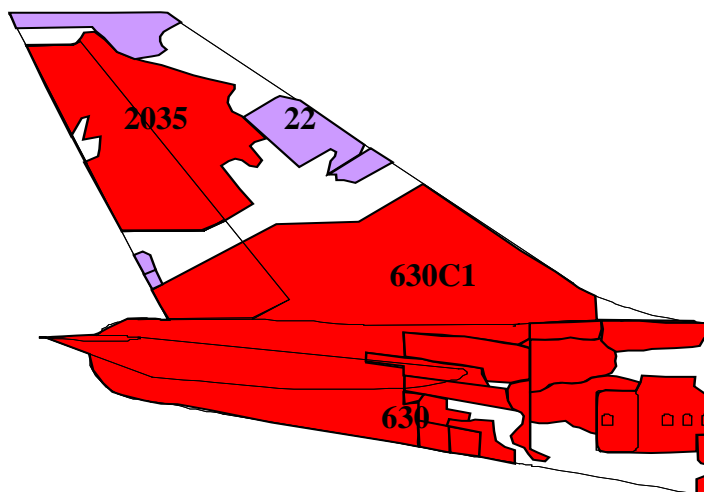
Figure 1.12-45 Vertical Fin

The majority of the upper portion of the vertical fin (item 2035) was found separate from the remaining section 48 debris, but also in the red zone. The forward edges of item 2035 were deformed to the left side indicating the leading edge portion was struck by a large object on the right side. The lower edge of this piece exhibited signs of bending and separation to the left side. At the upper forward edge of item 2035, there was significant tearing damage from fore to aft and right to left.

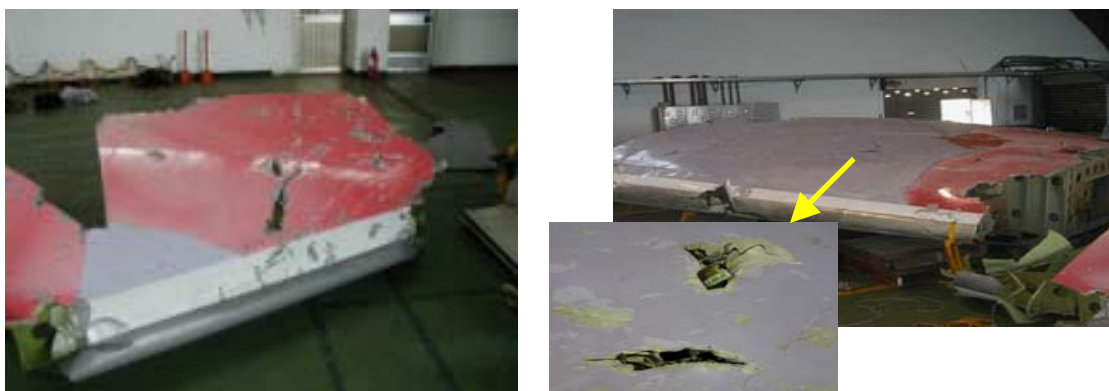
The middle portions of the vertical fin leading edge (items 22 [See Figure 1.12-46(a)], 23, 170, 350, and 392) were found floating. There were puncture marks evident on the RHS of these pieces. The vertical fin cap (item 960) was also found floating.

The lower portion of the vertical fin remained attached to the majority of section 48 and is now identified as item 630C1 [See Figure 1.12-46(a)] after being cut near the base to facilitate transportation. Two small stringer segments were found inside the leading edge portion of the fin adjacent to two punctures on the RHS. These stringer segments (items 630C4 and 630C5) originated from a section 46 fuselage belly panel. Item 630C4 is confirmed to be from STA 2170 at S-38R and the characteristics of item 630C5 indicate it is from STA 2170 at either S-42R or S-44R. Residue on the forward fracture face of these stringer segments indicates they entered the fin forward end first. The fractures and

adjoining skin on item 630C1 contained deformation consistent with the upper portion of the vertical fin bending to the left.

The lower portion of the fin (item 630C1), the upper portion of the fin (item 2035), and several of the floating pieces (item 22) show similar evidence of impact damage on the right side.

Figure 1.12-46 (a) Item 22- left photo, (b) Item 630C1 penetrations with 630C4 and 630C5 stringer segments placed- right photo

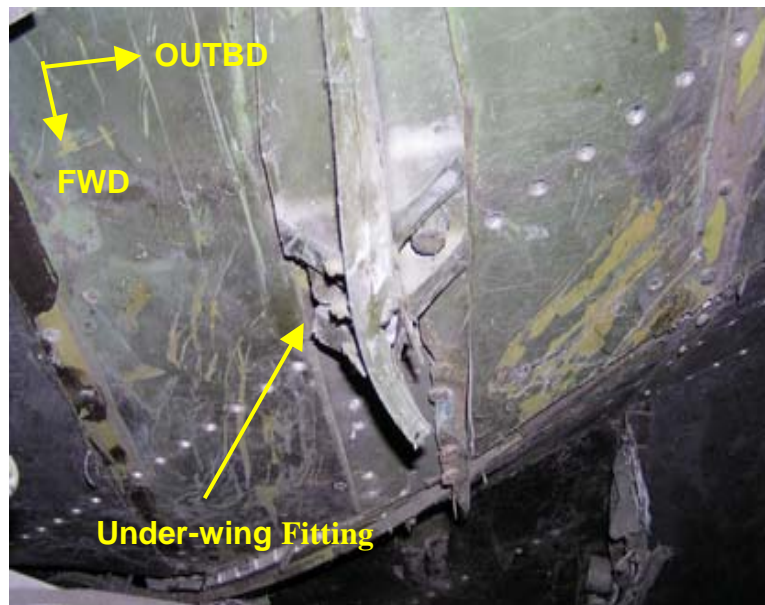
Figure 1.12-58 The diagonal brace under-wing fitting was found fractured

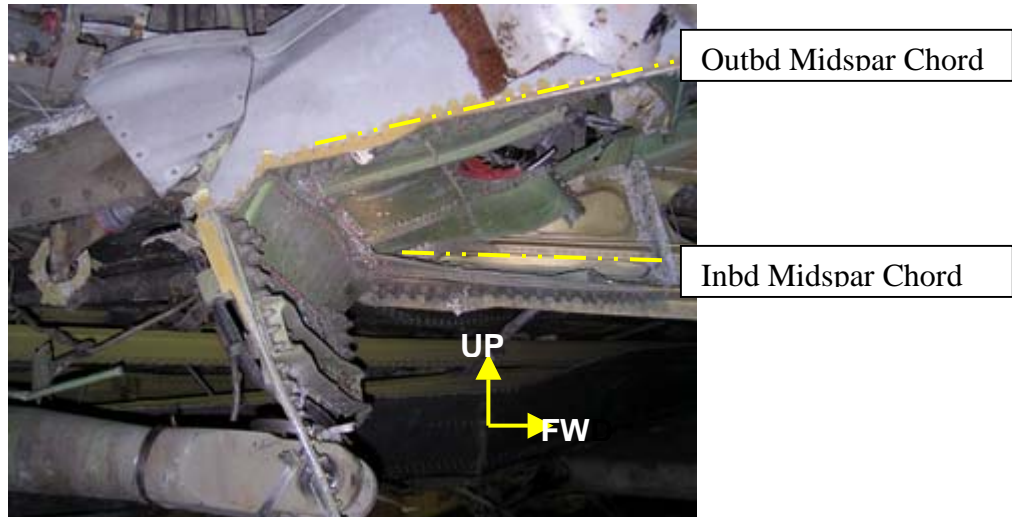
Figure 1.12-60 The outboard mid-spar chord is bent up relative to the inboard mid-spar chord

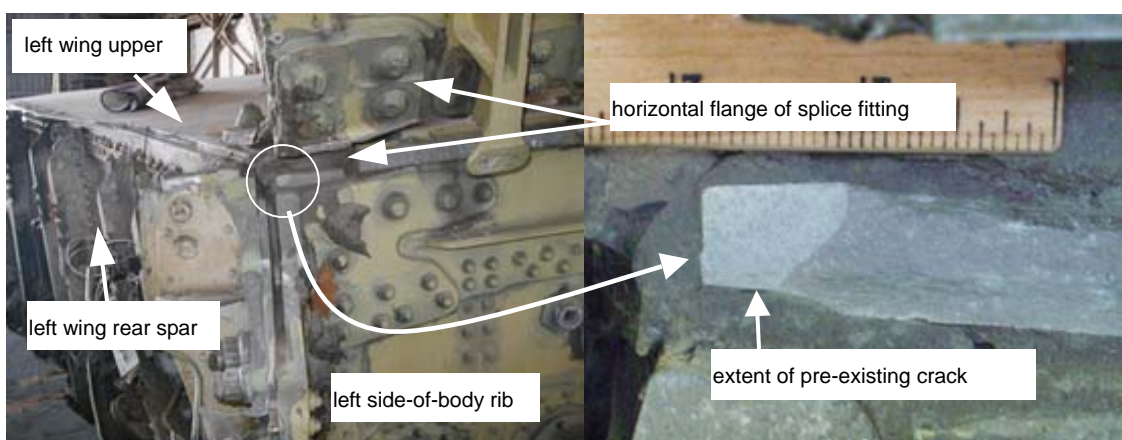
Figure 1.12-61 Left Wing Upper Internal Splice Fitting - Left SOB, Rear Spar on item #547C2

Visual examination revealed what appears to be a pre-existing crack on the outboard flange of the Left Wing Upper Internal Splice Fitting common to the left SOB and Rear Spar on item #547C2. The feature appears to be a fatigue crack that initiated on the upper surface of the flange near the aft edge and propagated through the flange thickness and forward to a length of approximately 0.75 inch, where the fracture displayed an abrupt transition from light color associated with a flat profile to a dark colored, slanted profile. The total forward and aft length of the fracture at this location was measured to be approximately 4.0 inches.

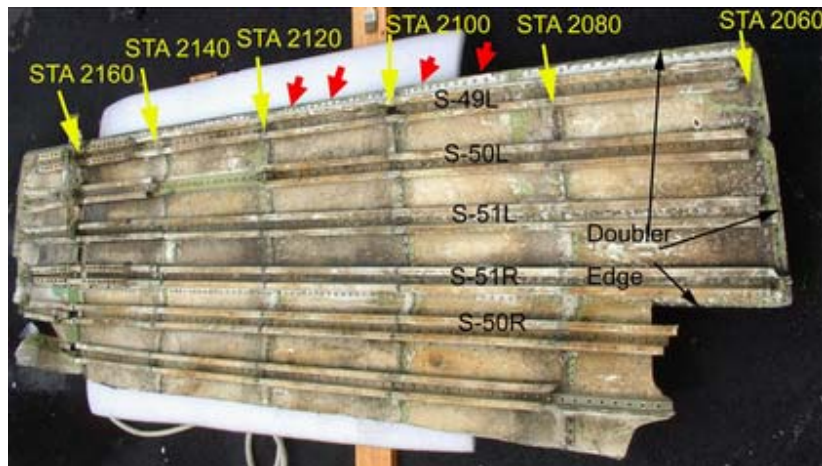
Figures 1.16-13 (a) and 1.16-13 (b), shows both sides of 640C1 and indicates where a repair doubler was attached to the outboard fuselage skin. The range of doubler was approximately within the area between frames STA 2060 and 2180 and stringers S-49L and S-51R, respectively. Figure 1.16-13 (a) indicates that all the frames came off of the skin and were missing except at STA 2160 where a partial frame was attached. However, aside from the section between STA 2120 and STA 2140 of stringer S-50L, almost all stringers were still attached to the fuselage skin. By way of visual examination, the fuselage skin was found to have suspected evidence of fatigue cracking (fracture surface normal to the surface of skin) that was close to, and parallel with, stringer S-49L. This portion of the skin fracture is marked with red arrows in Figure 1.16-13 (a).

Figure 1.16-13 (a) Inboard side of item 640 indicates that all the frames came off of the skin and were missing except at STA 2160 where a partial frame was attached

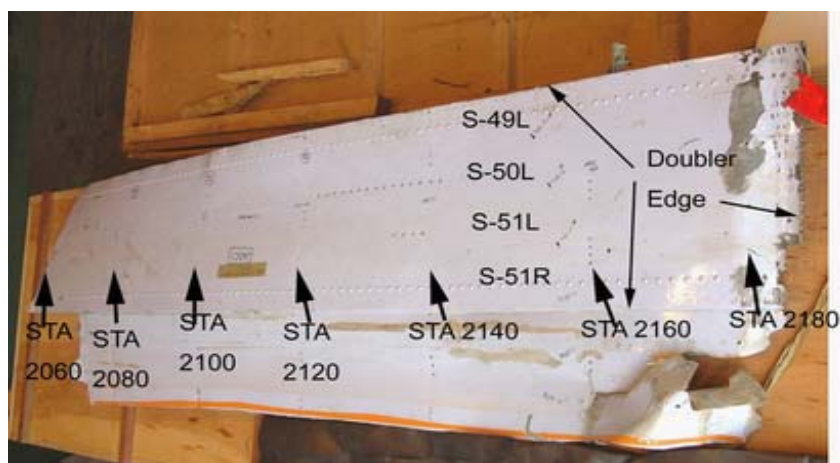
Figures 1.16-13 (b) Out board side of item 640 repair doubler was attached to the outboard fuselage skin
