In-flight structural breakup, Boeing 747-200 B18255, May 25, 2002 in the Taiwan Straits approximately 23 nm northwest of Makung

CI611 Accident Investigation

Factual Data Report

ASC-AFR-03-06-001

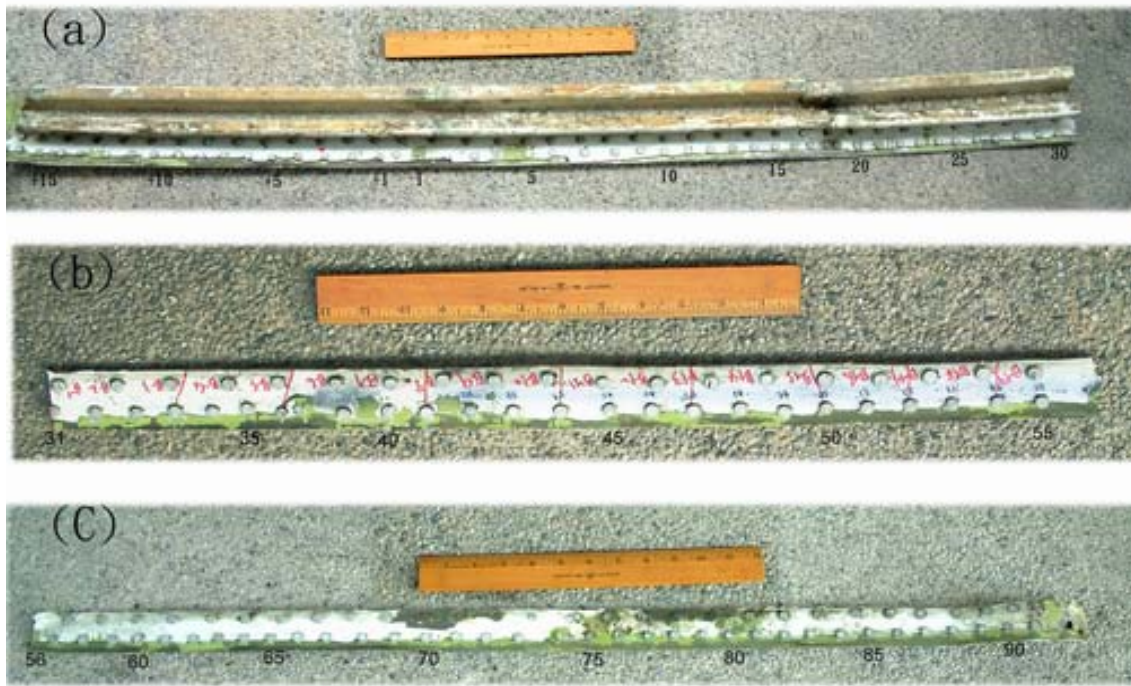
The fracture surfaces near the rivets from +17 to 91 in Figure 1.16-14 were examined by low-magnification optical (light) microscopy for suspected evidence of fatigue cracking. Three sections of the skin fracture incorporating rivets and doubler sections were removed by saw cutting for macroscopic examination and are shown in Figure 1.16-15. Macro examination using low power optical method was performed at the AMD laboratory while the fracture surfaces were cleaned with a soft bristle brush and acetone during examination. The NTSB Boeing China Airlines (In part from +17 to 38) AMD and ASC representatives participated in macroscopic examination of fracture surface.

Figure 1.16-15 Three sections of the skin fracture incorporating rivets and doubler sections were removed by saw cutting

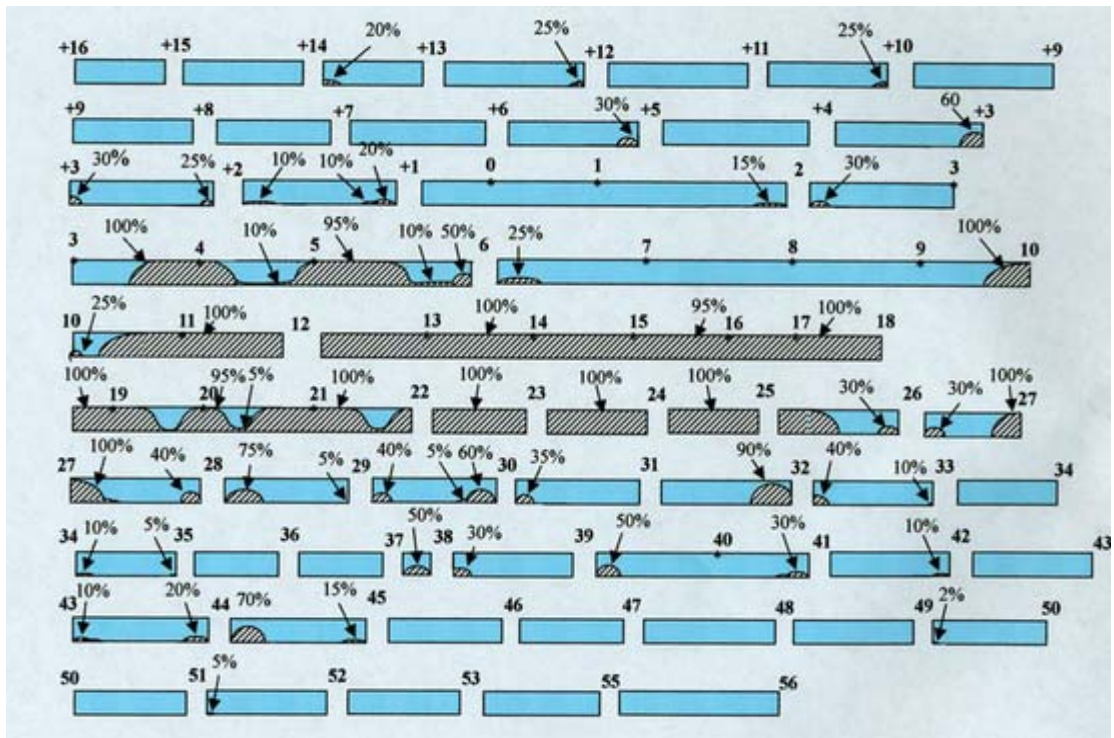
The majority of the fatigue cracking was associated with frame STA 2100, in the area corresponding to the region of rivets from 10 to 25. Figure 1.16-23 is a drawing (not to scale) indicating the fatigue cracking on the skin fracture surface from rivets +16 through 56.

Figure 1.16-23 A drawing (not to scale) indicating the fatigue cracking on the skin fracture surface from rivets +16 through 56.

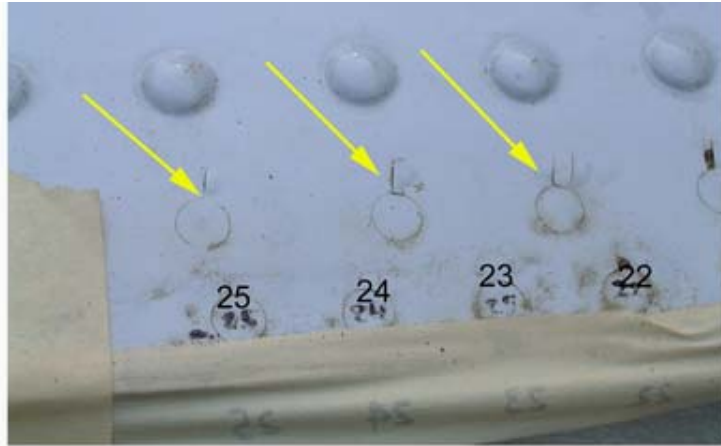
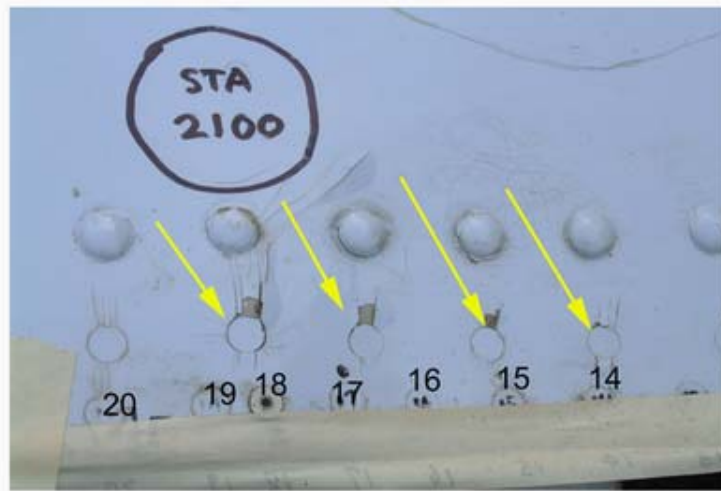
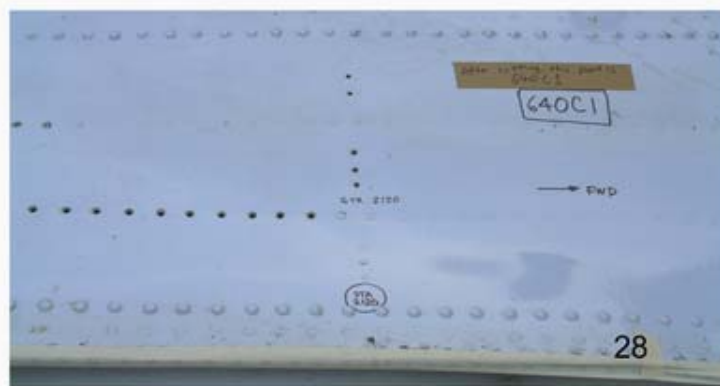
(10) Figure 1.16-32 shows the exterior appearance of the doubler in the area of the local deformation illustrating that the paint around the rivet heads was cracked in some areas. The cracked paint occurred at the location from rivet 14 to 25, which corresponded to the fracture area with the intensive fatigue crack. In the areas with little evidence of fatigue cracking, the exterior paint surface of the doubler was intact around the rivets, such as the locations of rivets beyond number 28.

Figure 1.16-32 Show the exterior appearance of the doubler

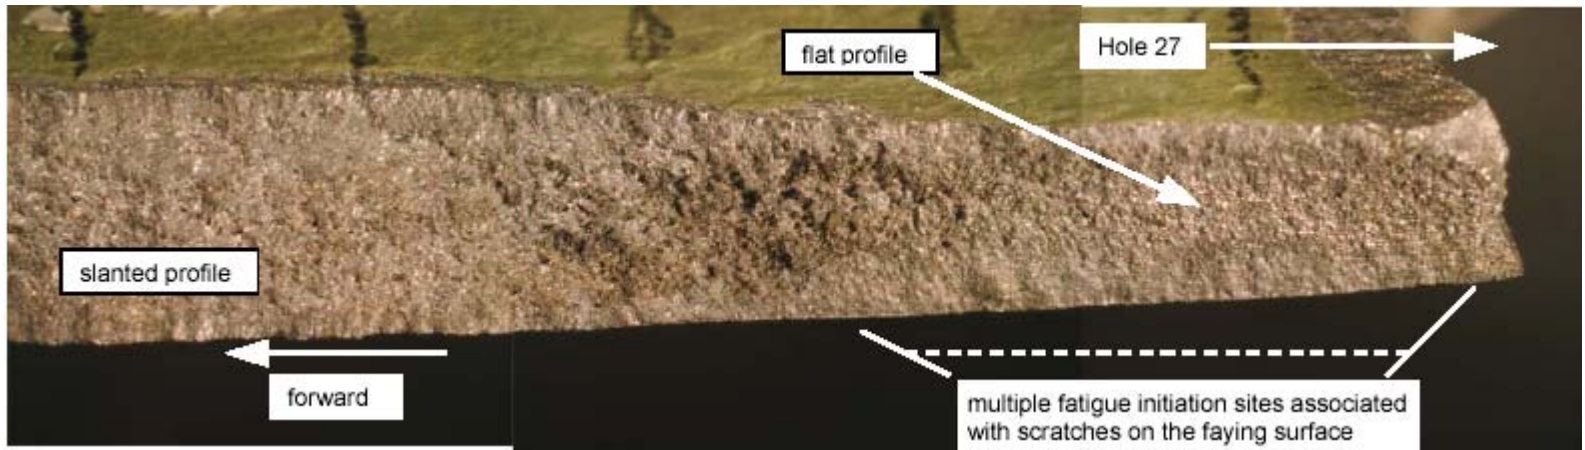
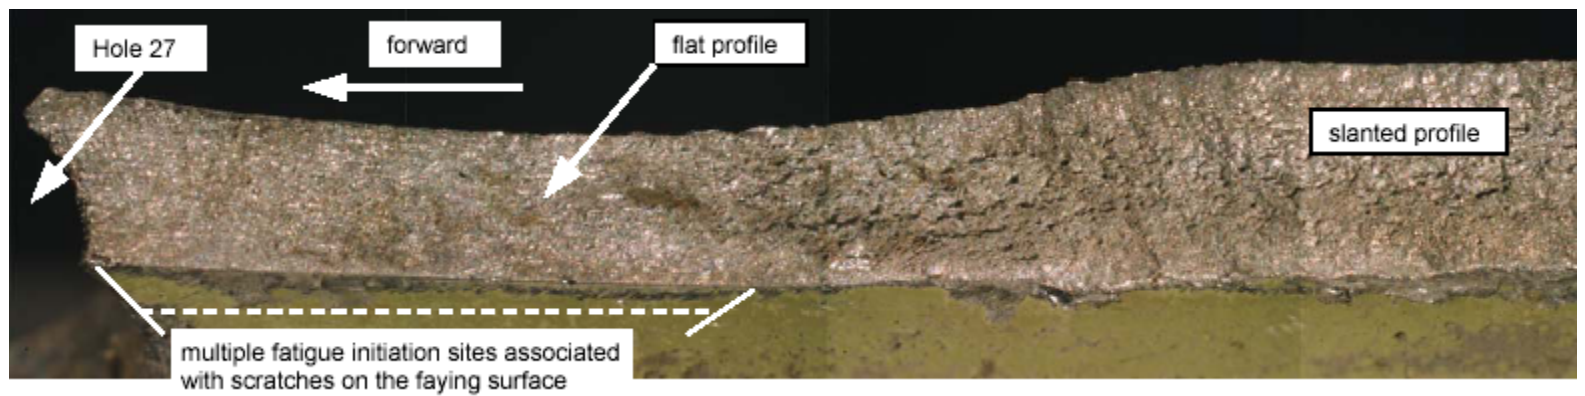
Figure 1.16-44 Photographs showing the transition regions from flat fracture profiles to slanted profiles at fastener Hole 27 in the forward direction (top) and the aft direction (bottom).

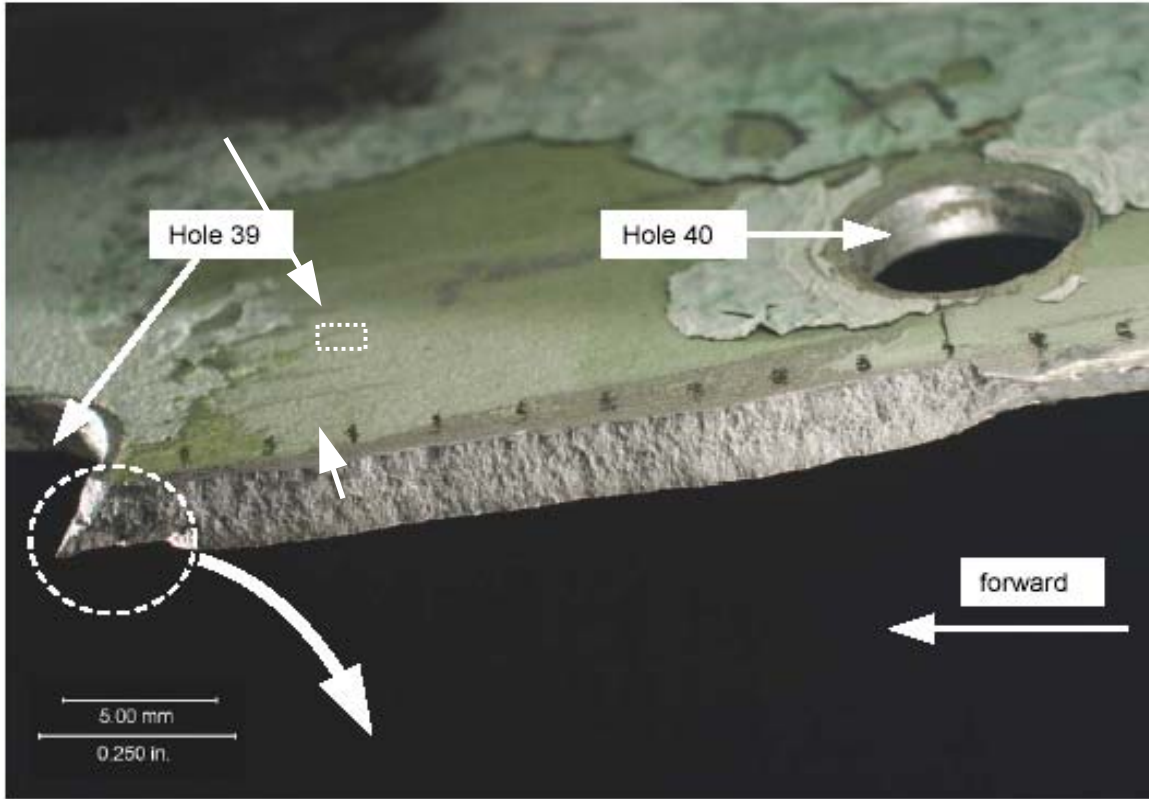
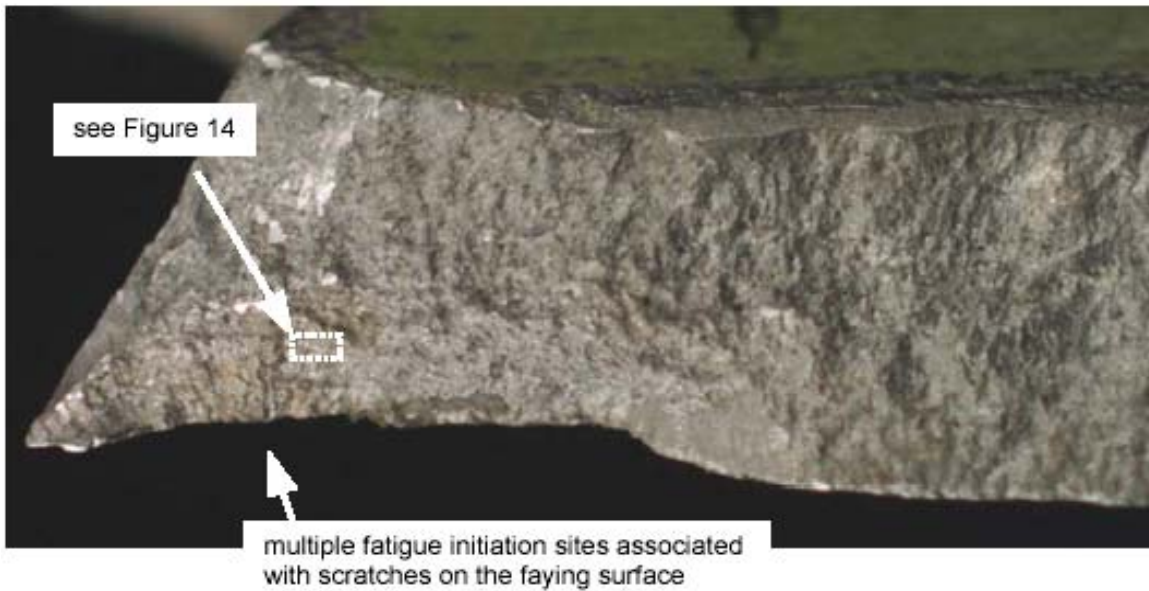
Figure 1.16-47 Photographs of the fracture segment extending from Hole 39 to 40 (top), and closer view of the flat profile fatigue region and short transition zone on the aft side of Hole 39 (bottom). SEM photographs showing an increase in striation spacing near the extent of the flat fracture thumbnail (indicated area) are shown below in Figure 1.16-48.

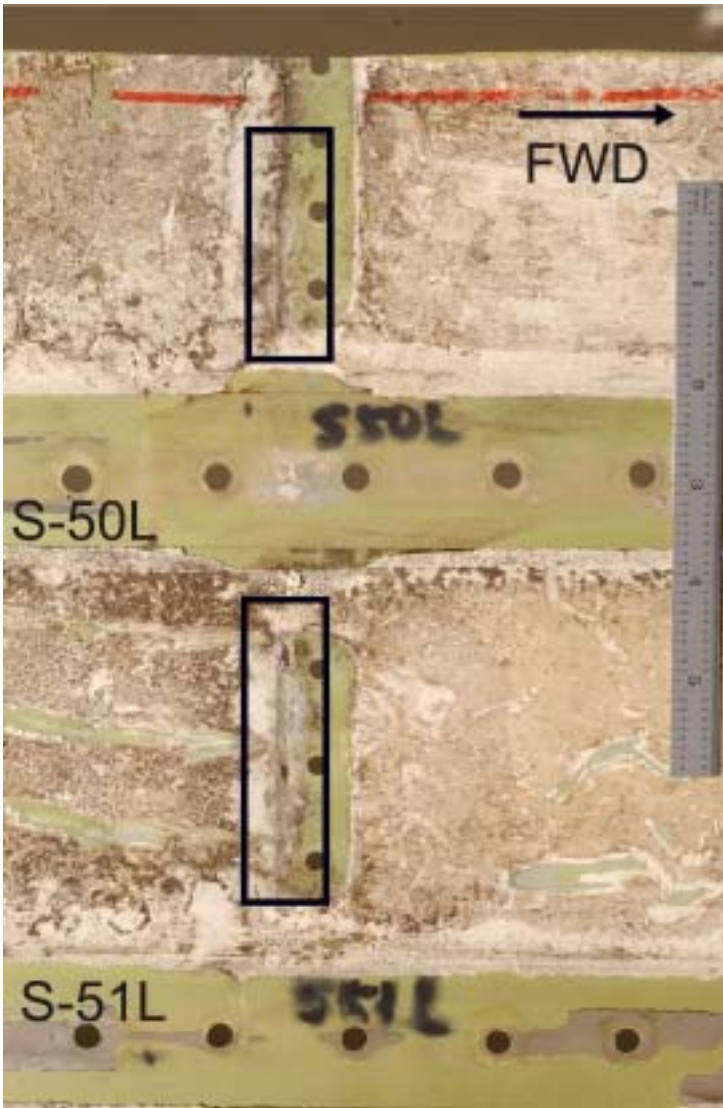
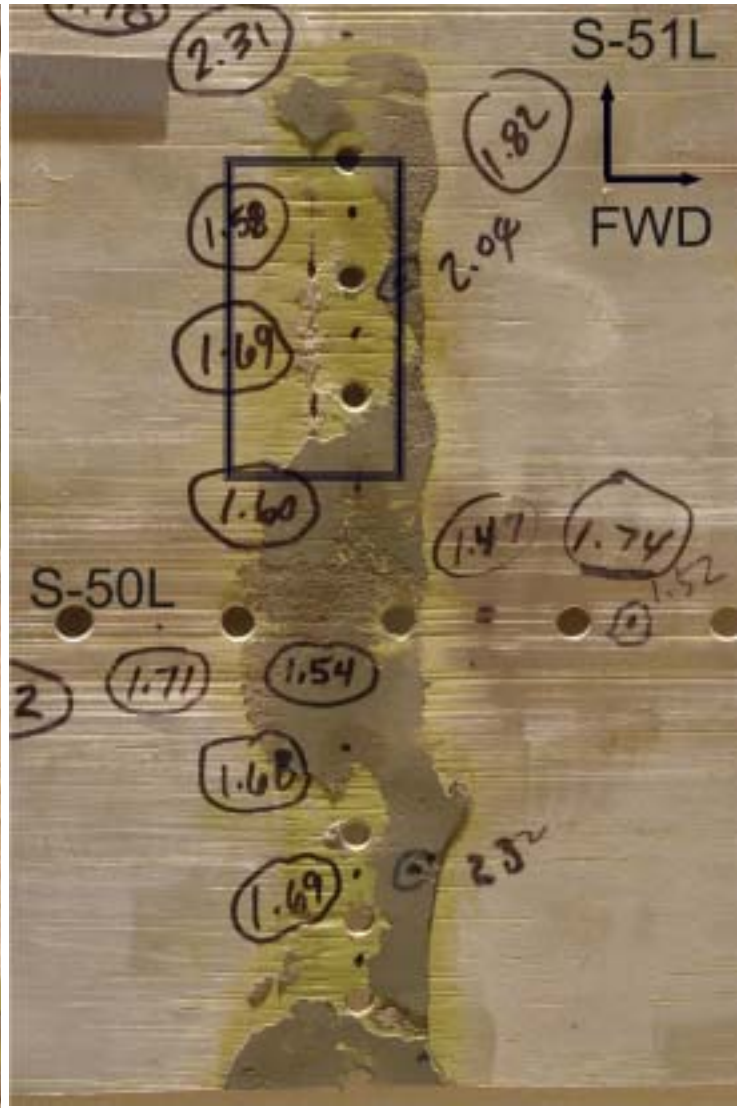
Figure 1.16-81 Skin corrosion features at STA 2080 - Areas of corrosion are identified with rectangles above. Corrosion penetrated completely through the skin thickness at the shear tie located between S-50L and S-51L.

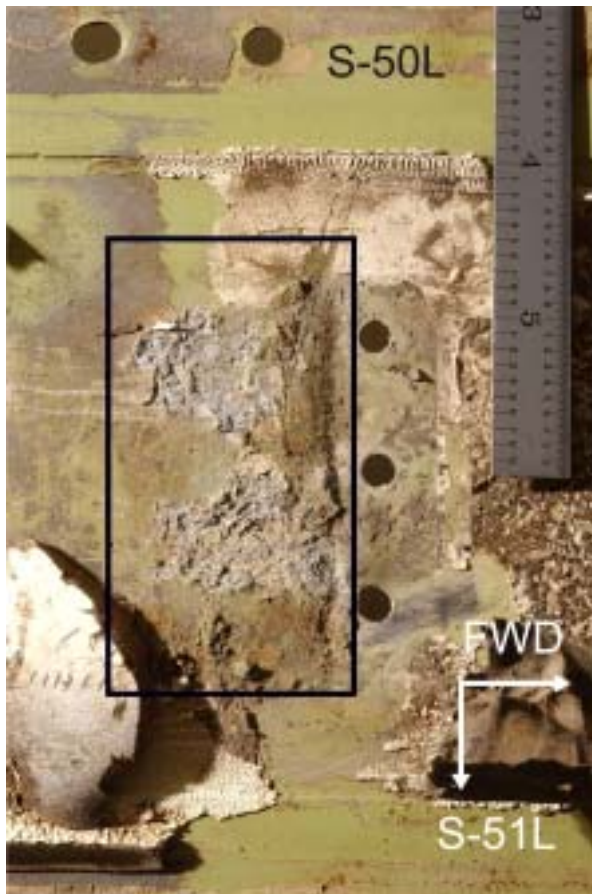
Figure 1.16-83 Corrosion features at STA 2160, inboard surface - The area of corrosion is identified with a rectangle above. A crack noted on the skin faying surface may have been the result of exfoliation corrosion penetrating from the skin inboard surface.

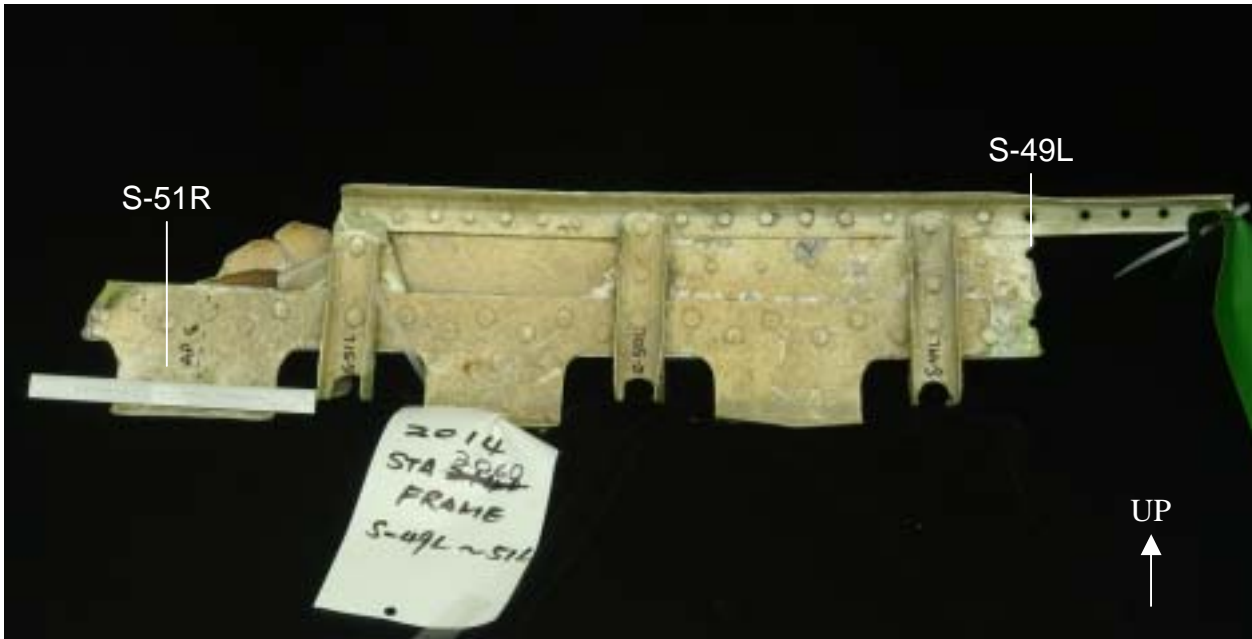
Figure 1.16-115 As received condition of the STA 2060 frame segment. The forward surface is shown in this view.

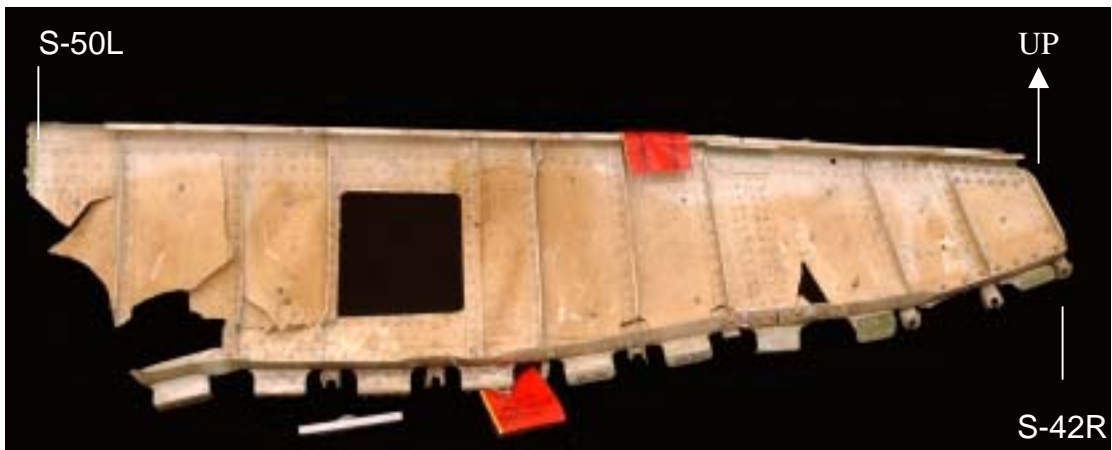
Figure 11.16-118 As received condition of the STA 2040 frame segment submitted for examination. The aft surface is shown.

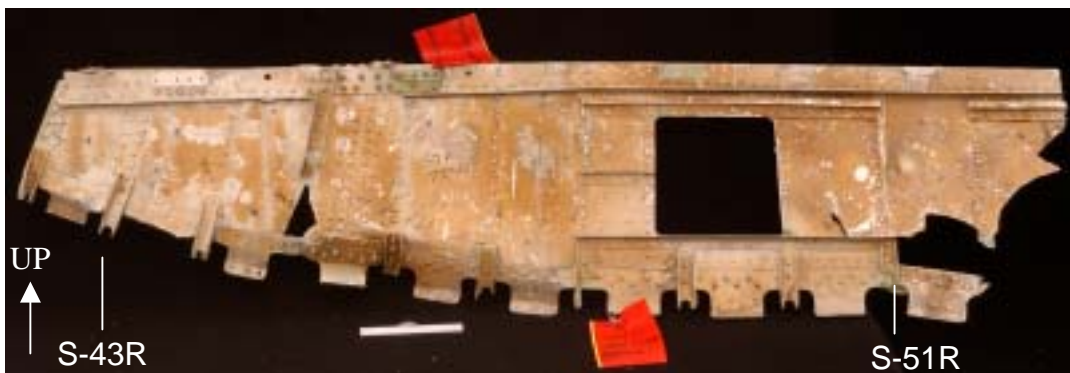
Figure 1.16-119 As received condition of the STA 2040 frame segment submitted for examination. The forward surface is shown in this view.

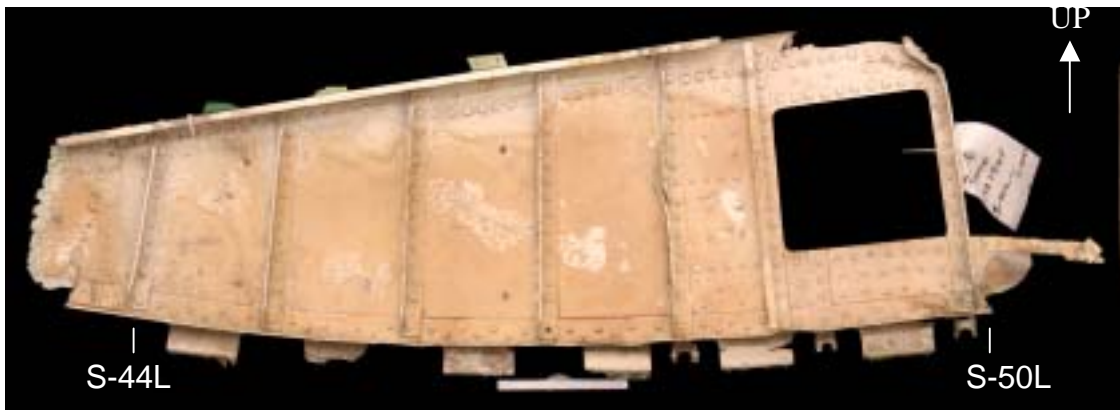
Figure 1.16-123 As received condition of the STA 1940 frame segment submitted for examination. The aft surface is shown in this view.

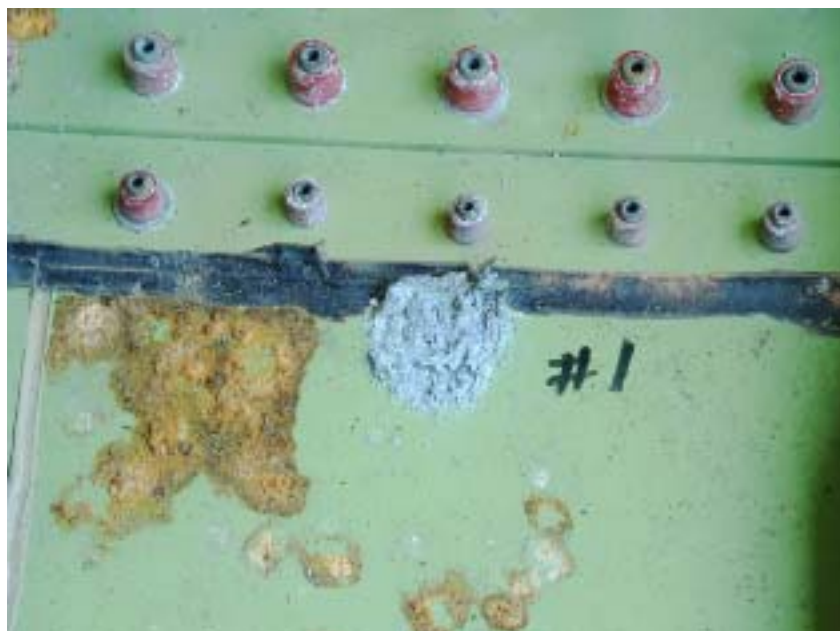
- (1) Macro Observation and photograph Figure 1.16-133 showed that the overall appearance of item 626 C1, there are 6 corrosion pits as arrows indicate. Those initial site of corrosion evidences were occurred at the interface of sealant and splice plate as in Figure 1.16-134 through Figure 1.16-138. It is believed that this is typical of morphology of crevice corrosion as in Figure 1.16-134 through Figure 1.16-138.

Figure 1.16-134 Higher magnification of #1 corrosion pit, before cleaning (0.71X)

Figure 1.16-135 Higher magnification of #2 corrosion pit, before cleaning (1.52X)

Figure 1.16-136 Higher magnification of #3 corrosion pit, before cleaning (1.56X)

Figure 1.16-137 Higher magnification of #4 corrosion pit, before cleaning (1.27X)

Figure 1.16-138 Higher magnification of #5 corrosion pit, before cleaning (1.46X)

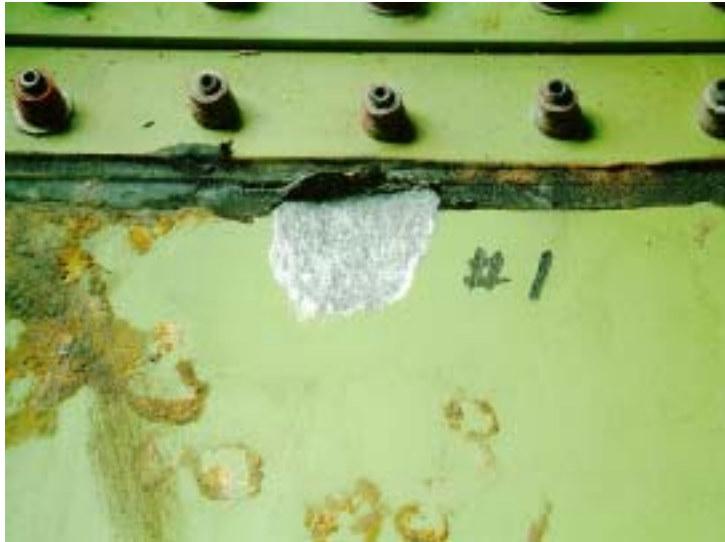
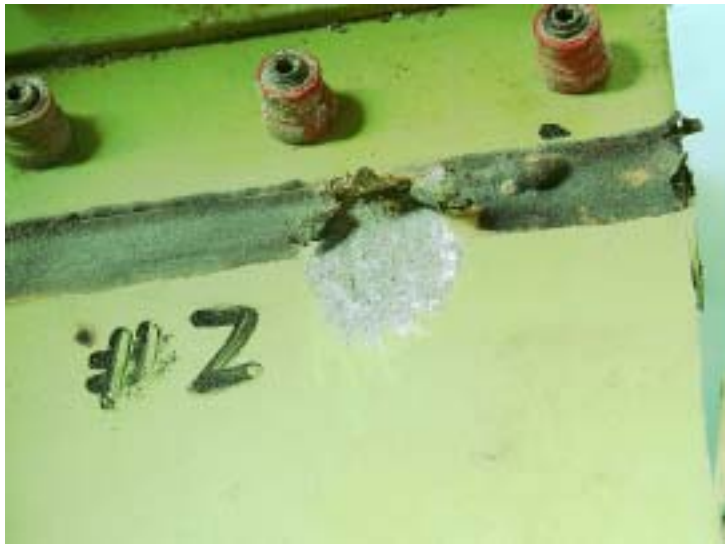
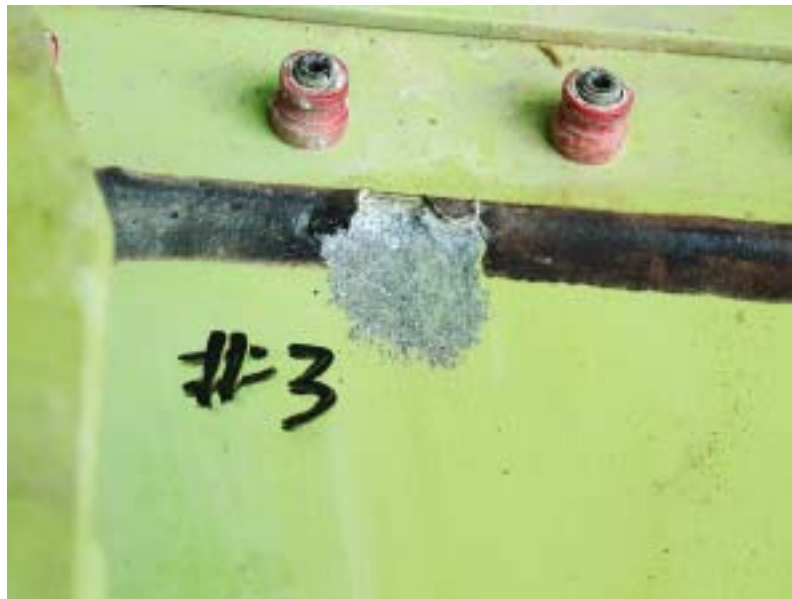
- (2) Dimensional measurement and examination of corrosion pit Figure 1.16-139 through Figure 1.16-143 showed that the higher magnification of corrosion pit after cleaning by acetone and steel ruler, which were taken from area #1 through #5 as in Figure 1.16-133, respectively. The corrosion was not observed by 6X magnifier to extend under the splice plate, therefore no further inspection was required. Figure 1.16-144 through Figure 1.16-148 showed that the dimensional measurement of corrosion, which were taken from area #1 through #5 as in Figure 1.16-139 through Figure 1.16-143, respectively.

Figure 1.16-139 Higher magnification of #1 corrosion pit, after cleaning (0.99X)

Figure 1.16-140 Higher magnification of #2 corrosion pit, after cleaning (1.40X)

Figure 1.16-141 Higher magnification of #3 corrosion pit, after cleaning (1.73X)

Figure 1.16-142 Higher magnification of #4 corrosion pit, after cleaning (1.22X)

Figure 1.16-143 Higher magnification of #5 corrosion pit, after cleaning (1.44X)

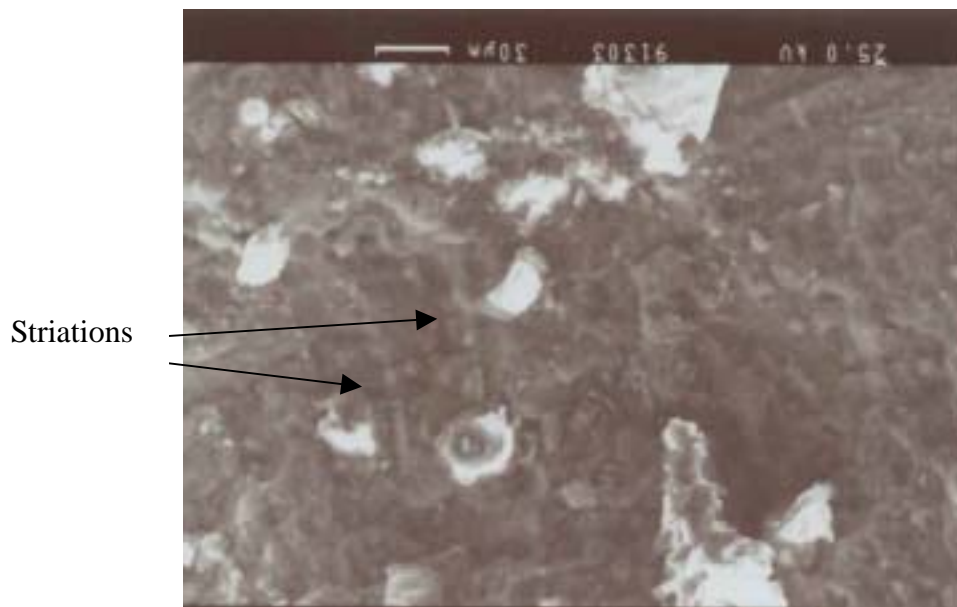
Figure 1.16-160 SEM photograph of upper door reveal (LH), which was taken from suspicious fatigue fracture area as in figure 6.(21X)

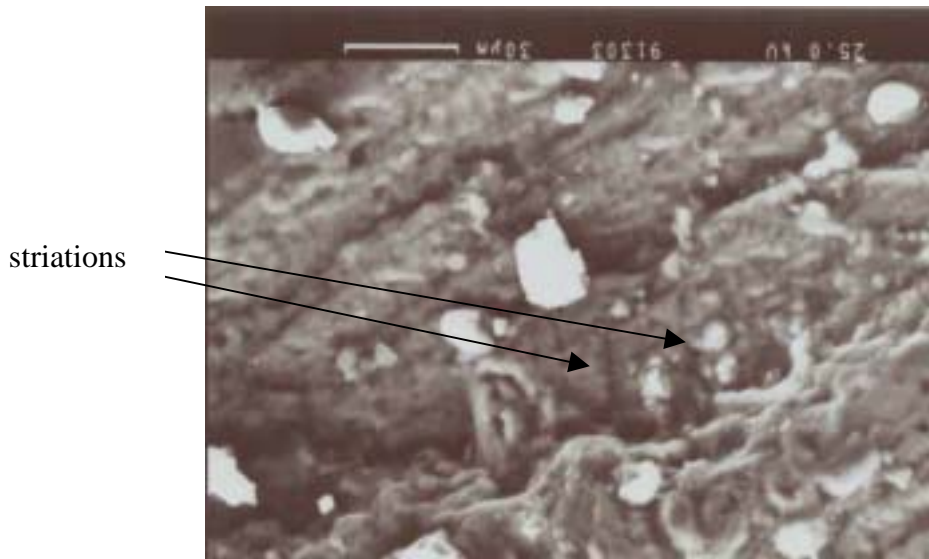
upper door reveal (LH), striations as arrows indicate, which were taken from area D and E as in Figure 1.16-154, respectively. The typical overload fractography of upper door reveal(LH), dimple structure, cannot be observed due to severe corrosion.

Figure 1.16-161 SEM photograph of upper door reveal (LH), which was taken from area D as in figure 6.(360X)

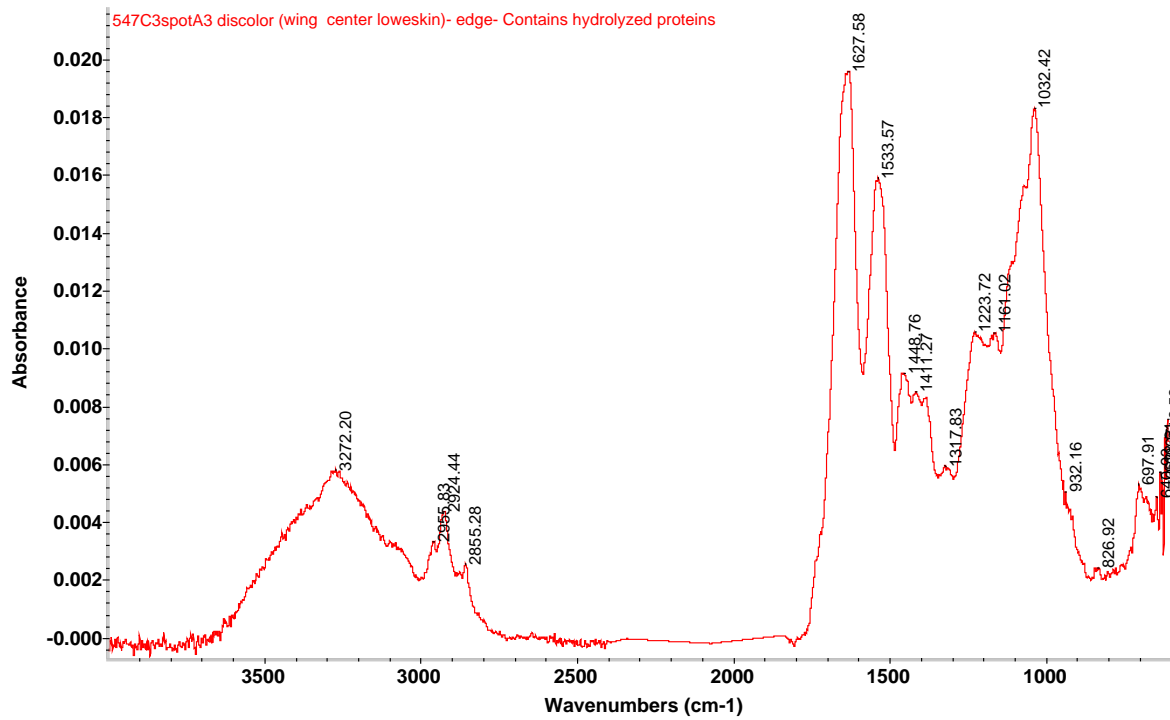
Figure 1.16-178 FT-IR spectrum of discoloration from sample 547C3.

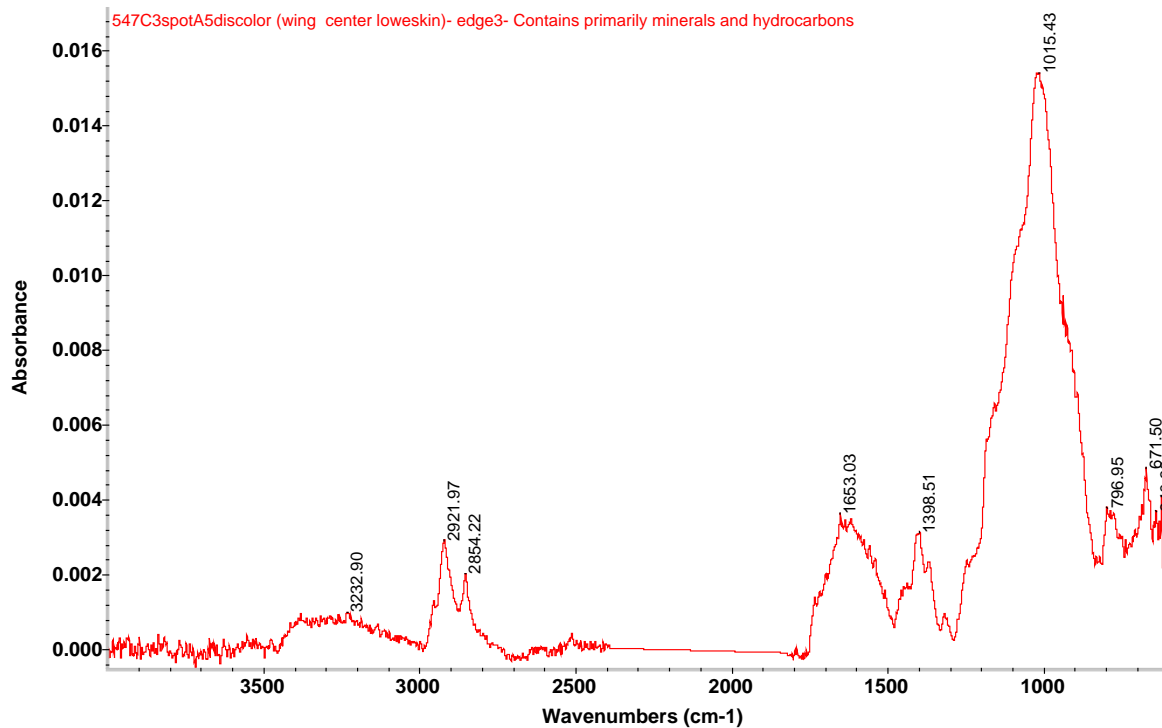
Figure 1.16-179 FT-IR spectrum of discolorations from sample 547C3.

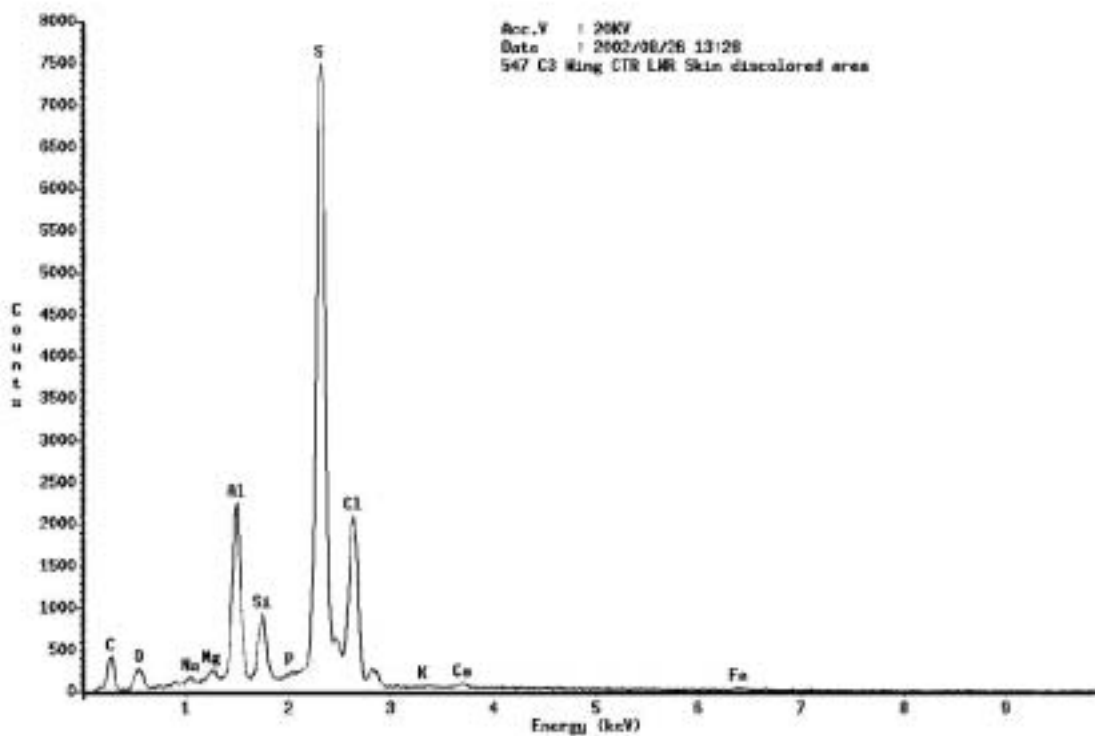
The discolored areas found on the wing center section of C1611 match the discolored areas from the retired 747 and are consistent with environmental contamination. No evidence of unburned fuel was found in the submitted samples. Sample 547C3 had an elevated level of sulfur. The origin of the sulfur was not determined.

Figure 1.16-180 EDX spectrum of discolorations from sample 547C3. This sample is typical of 10-100 but has elevated sulfur.

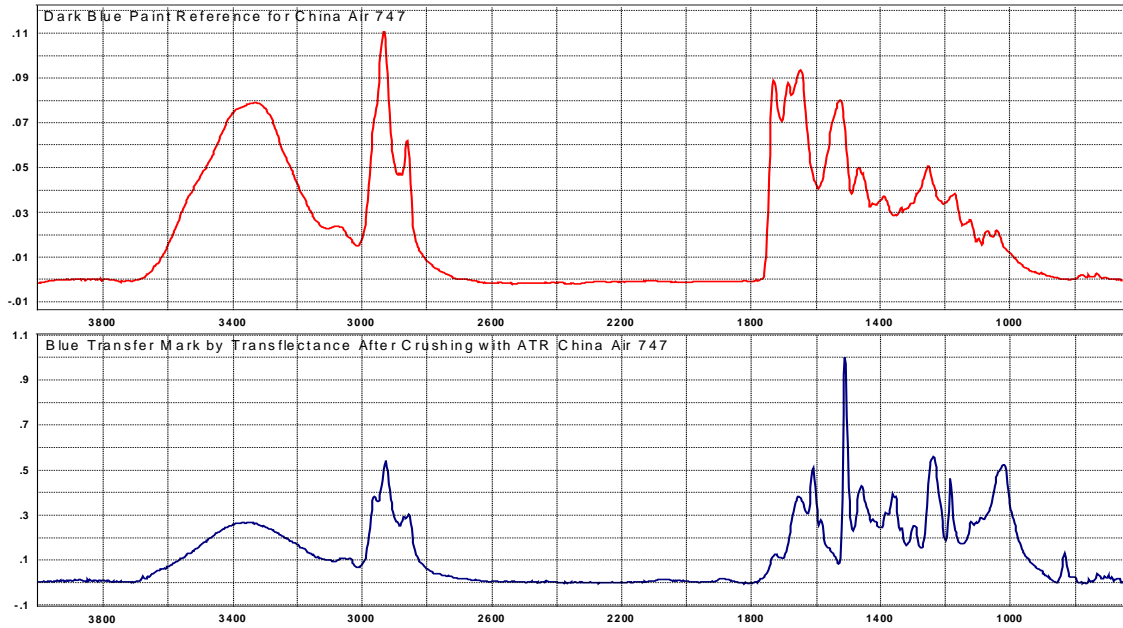
The transfer marks do not match the paint samples provided for comparison. They differ in both in elemental composition and in the polymer base materials from any of the reference samples.

Figure 1.16-196 FT-IR spectrum of dark blue paint sample (656C3, upper spectrum) compared to the spectrum of the dark blue transfer mark (lower spectrum).

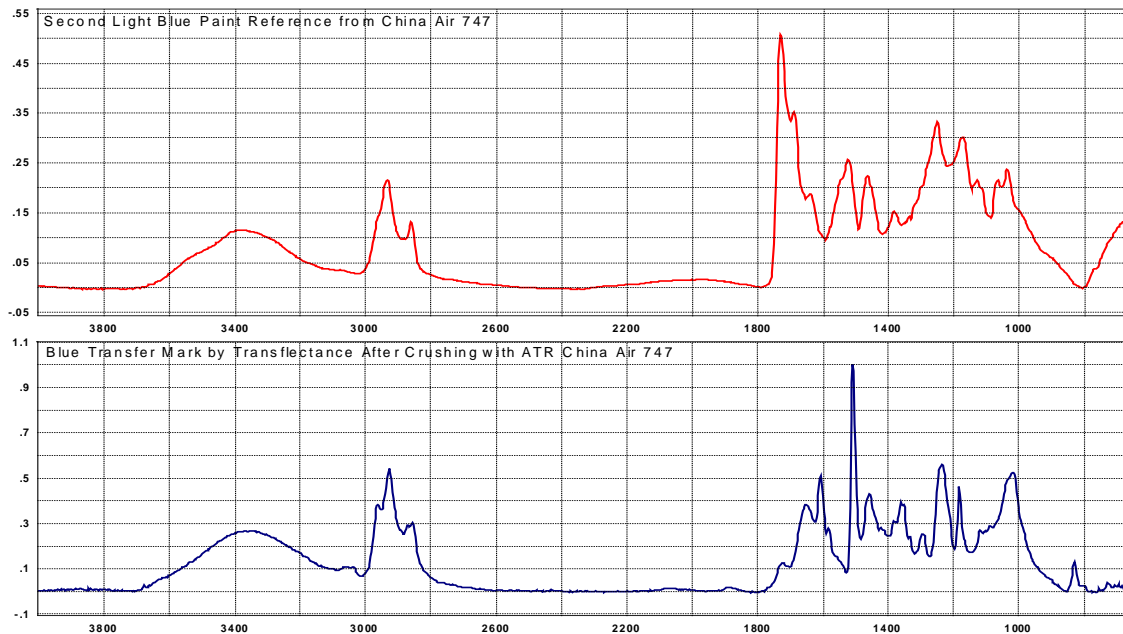
Figure 1.16-197 FT-IR spectrum of light blue paint sample (650C3, upper spectrum) compared to the spectrum of the dark blue transfer mark (lower spectrum).

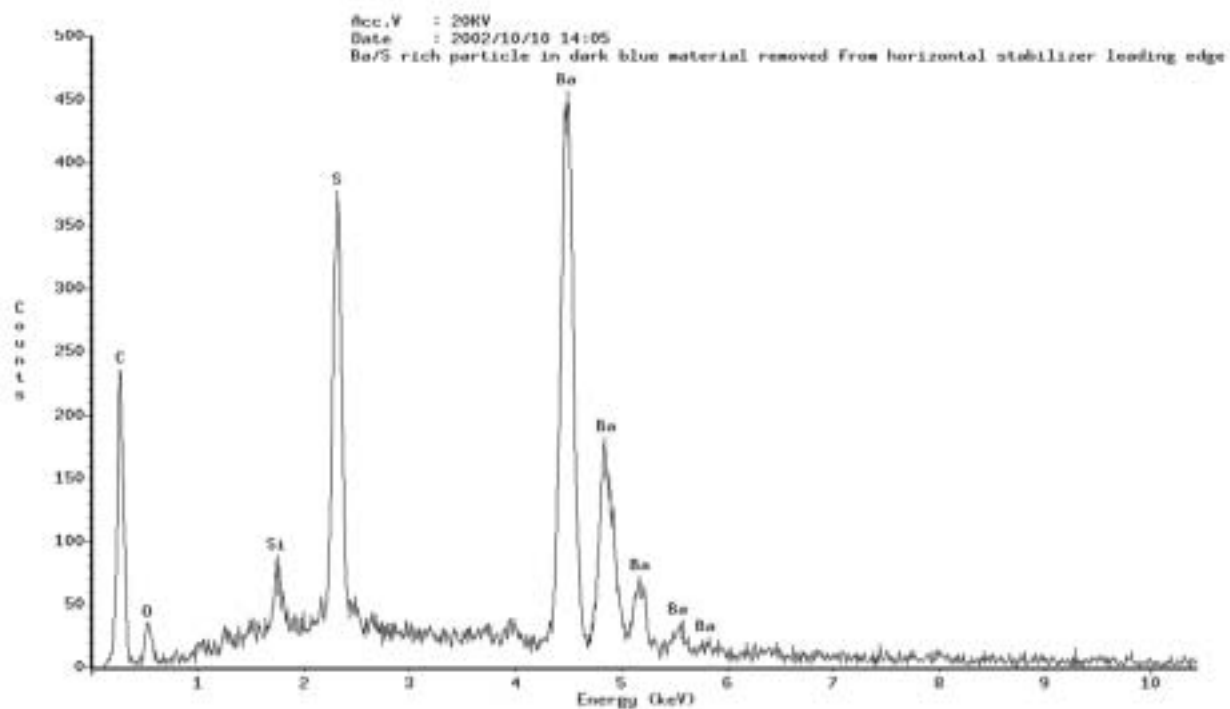
Elemental data was obtained from the transfer marks, the paint samples and the interior samples. These are shown in Figures 1.16-203 through 212. The dark blue transfer mark was found to contain barium and sulfur rich particles that were on the order of 1 micron in diameter (see EDX in Figure 1.16-204). These particles were not found in any of the other samples. Due to the limited amount of material that could be separated, it is possible that these particles could have been missed in the light blue transfer sample. The elemental data is summarized in Table 1.16-15, which indicates the presence or absence of particular elements in the various samples.

Figure 1.16-204 EDX spectrum of barium and sulfur rich particle found in dark blue transfer mark.

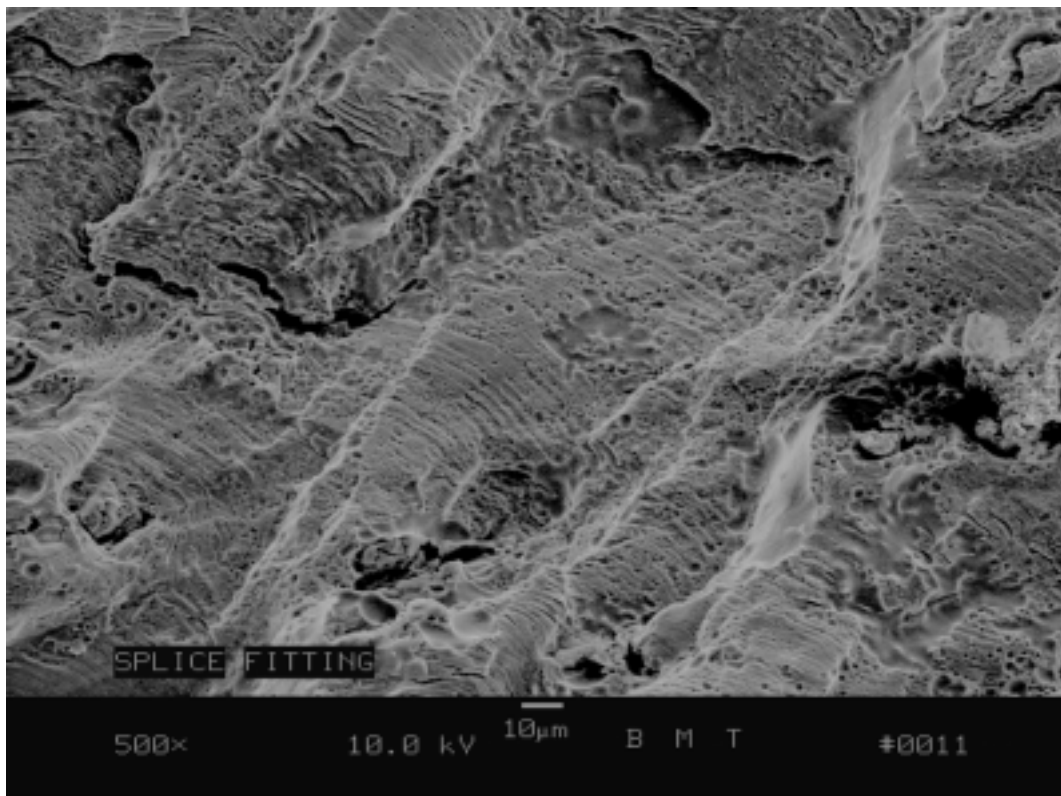
Figure 1.16-220 SEM photograph of the inboard fracture of the tee fitting within the flat profile (thumbnail) region showing fatigue striations.

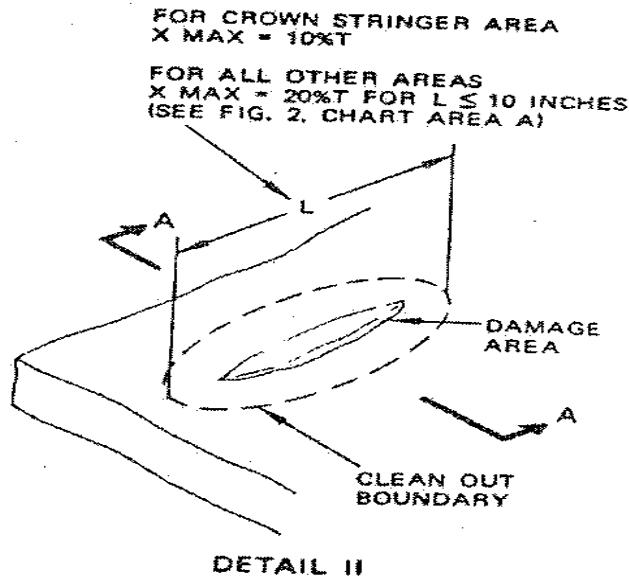
Figure 1.6-1 Fuselage skin allowable damage

The SRM 53-30-01 dated on June 15, 1976(Attachment 9-7) provided the definition of fuselage skin allowable damage. The SRM 53-30-01 states for all areas other than crown, the acceptable length of one damaged area is limit to 10 inches and the depth of clean up is limited to 20 % of the original thickness. The distance of the damage from an existing hole, fasteners, or skin edge must not be less than 20 times of the depth of clean up. The fuselage skin allowable damage is shown in Figure 1.6-1.

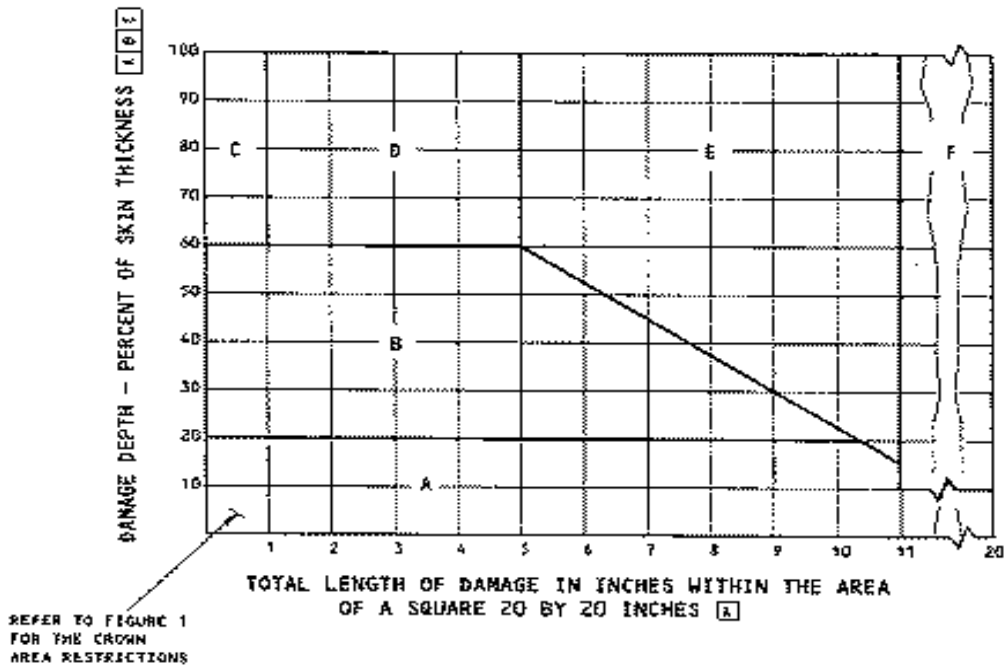
Figure 1.6-2 the operating limits for the damaged skin

The SRM 53-30-01 also states the total length limit of damage area must be within the area of 20 by 20 square inches. If the length is more than 10 inches, then the depth of clean up is limited to 10 % of the original thickness. The operating limit for the damaged skin is shown in Figure 1.6-2. The remaining skin thickness must be 90 % or above of the original thickness and the sum of the total length of damage are limited to 20 inches.

Boeing SRM 53-30-01 states if the damaged skin is classified within “F” area, operation is not permitted before applicable authority gives the approval.
