In-flight structural breakup, Boeing 747-200 B18255, May 25, 2002 in the Taiwan Straits approximately 23 nm northwest of Makung

CI611 Accident Investigation

Factual Data Report

ASC-AFR-03-06-001

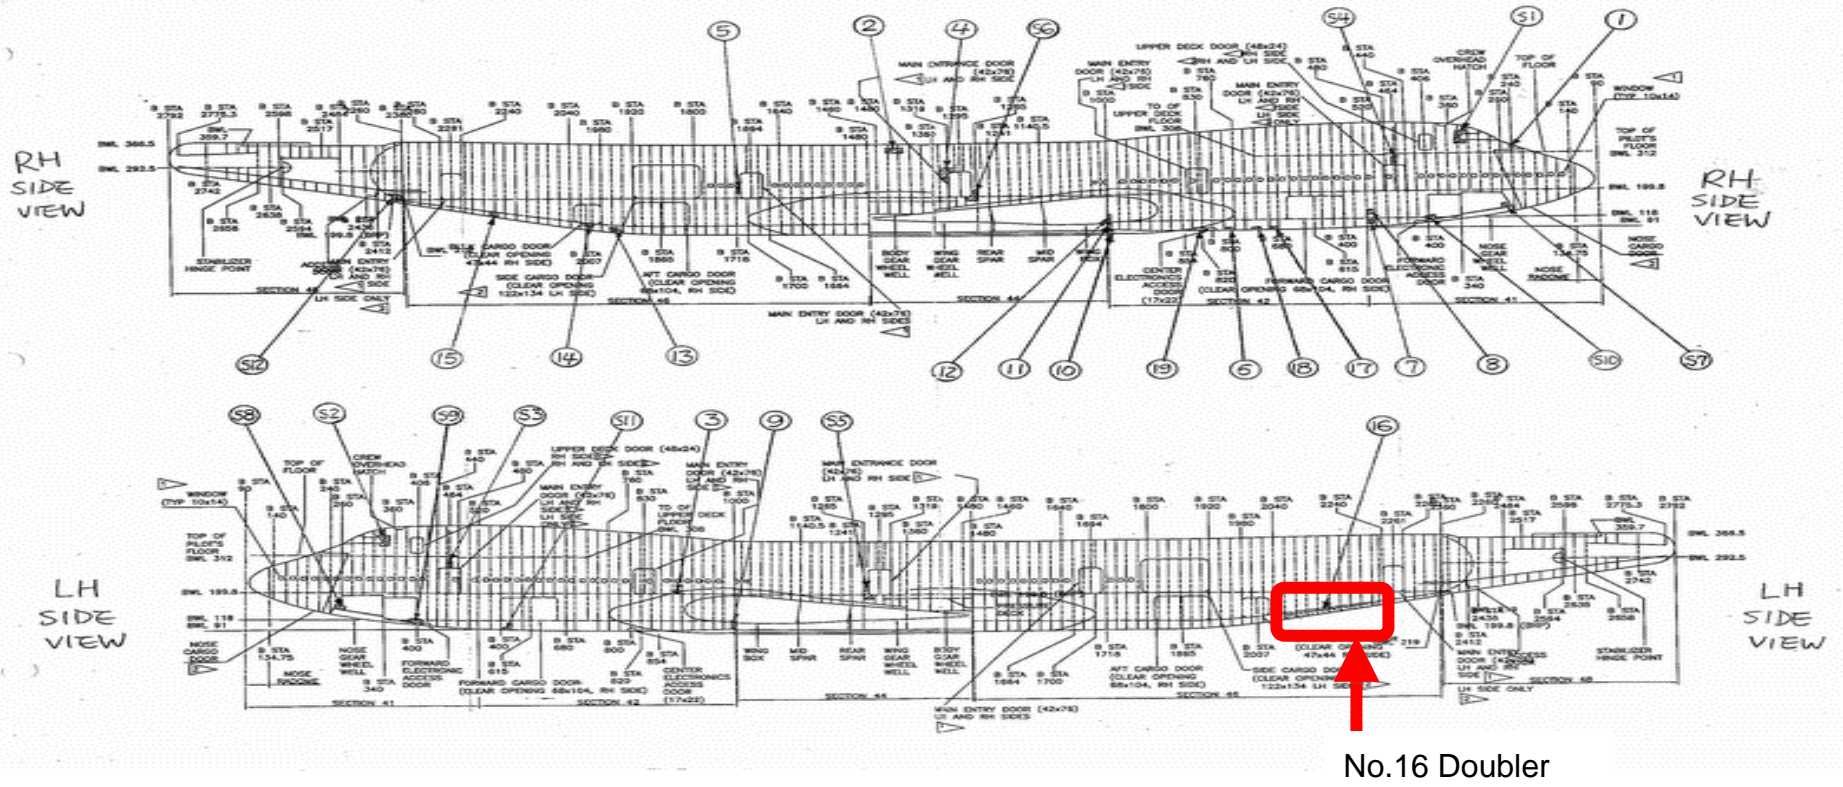
Figure 1.6-3 The Doublers Mapping

The B18255 repaired doubler mapping chart is shown in Figure 1.6-3. Photos of number-16 doubler are shown in Figure, 1.6-4 and 1.6-5.

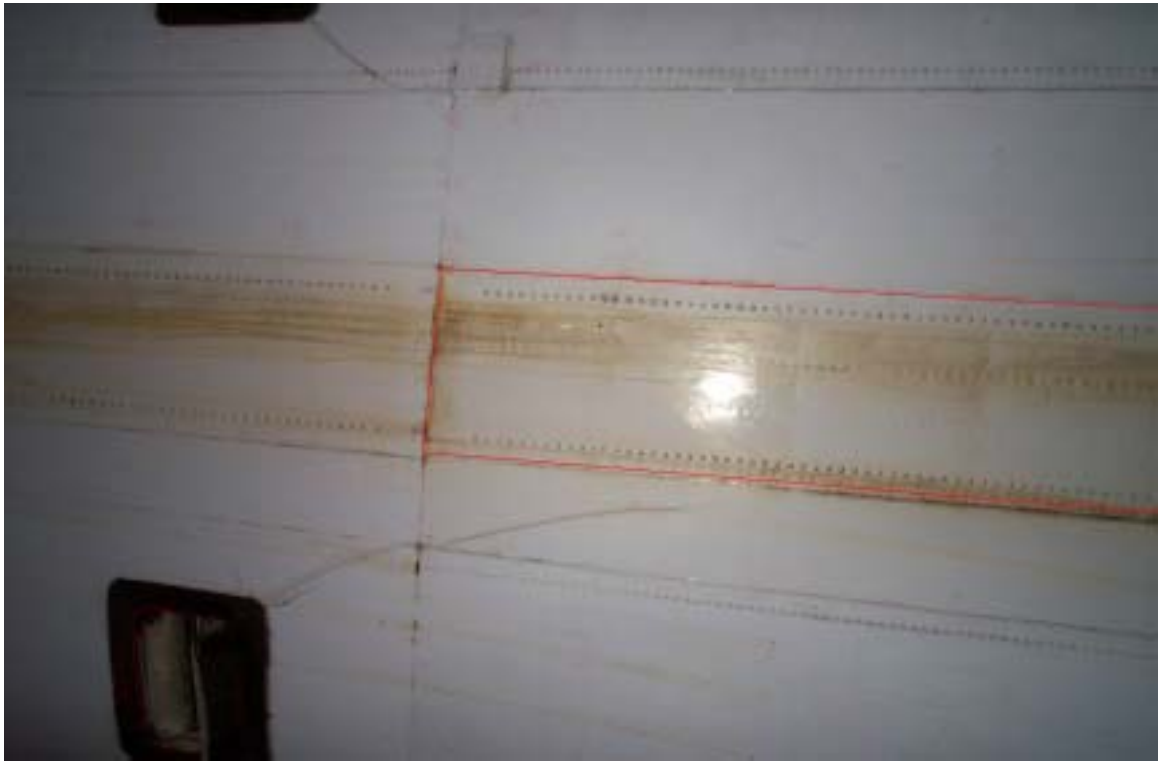
Figure 1.6-4 No.16 doubler (Picture taken at 6C on Nov 26,2001)

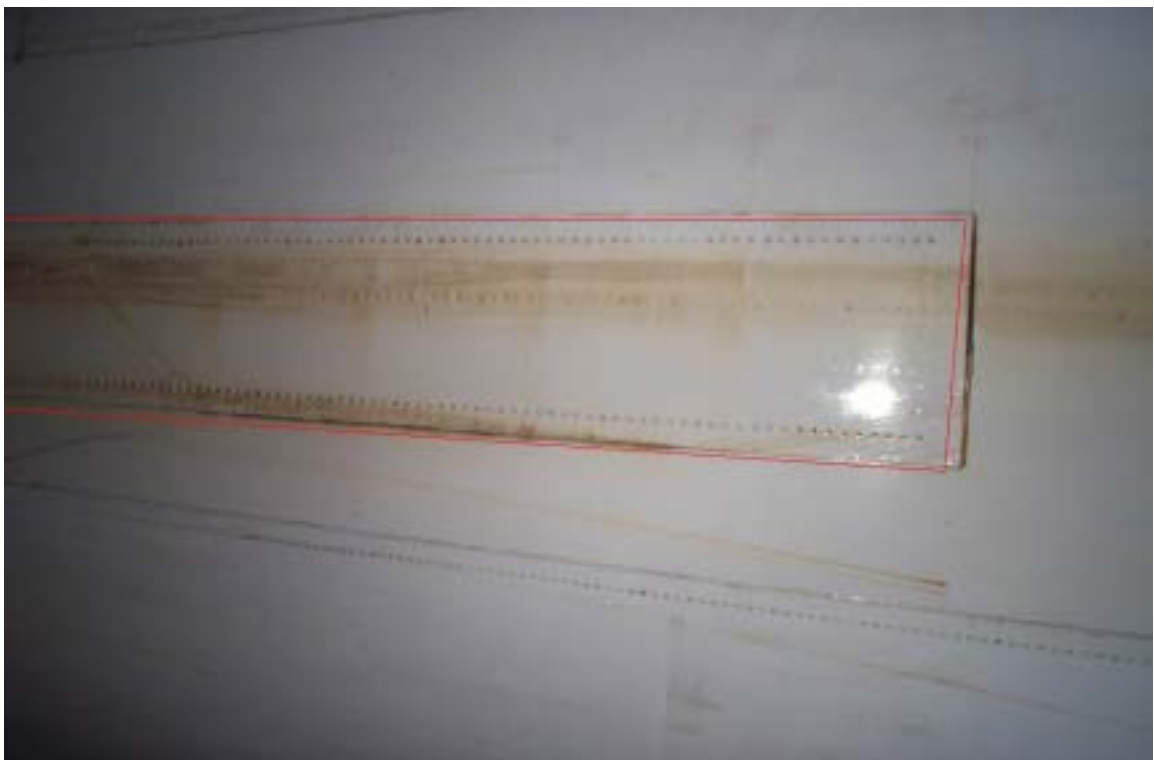
Figure 1.6-5 Number 16 doubler and surroundings (Picture taken at 6C on Nov 26,2001

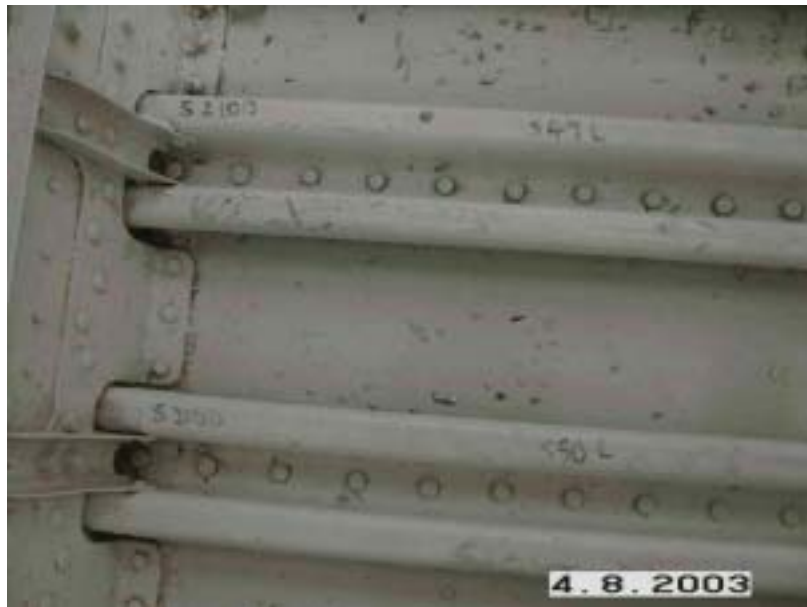
Figure 1.6-6 shows a B-747-200 freighter bilge after corrosive protection compound removed. One can see that the paint of the bilge and the general condition of skin, stringers, frames and the rivets can be distinctly determined via visual inspection.

Figure 1.6-6 A bilge with the corrosion preventative compound removed

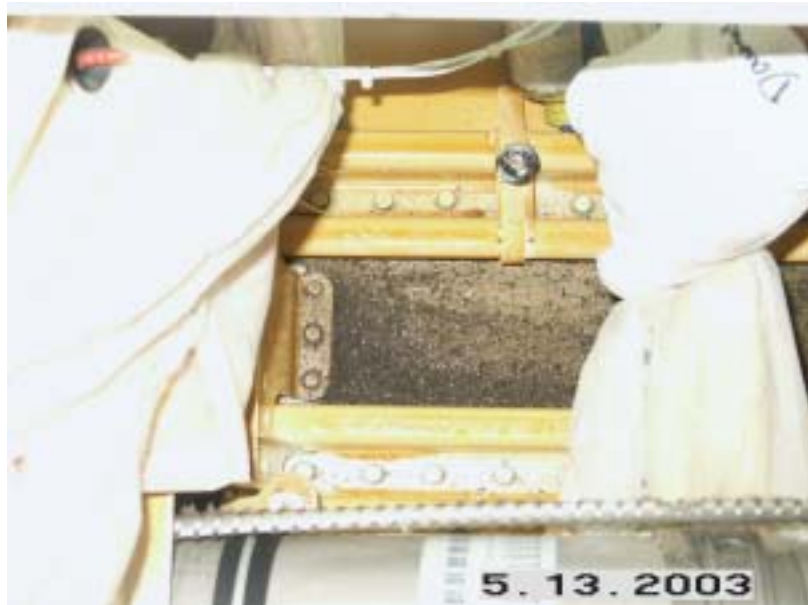
Figure 1.6-7 shows the bilge before corrosion preventative compound was removed. The stain on the lower lobe skin covers part of the paint. The bilge was covered with dirt and residual that smothered two adjacent isolative blankets of the bulk cargo lower lobe.

Figure 1.6-7 A bilge without removing the corrosion preventative compound

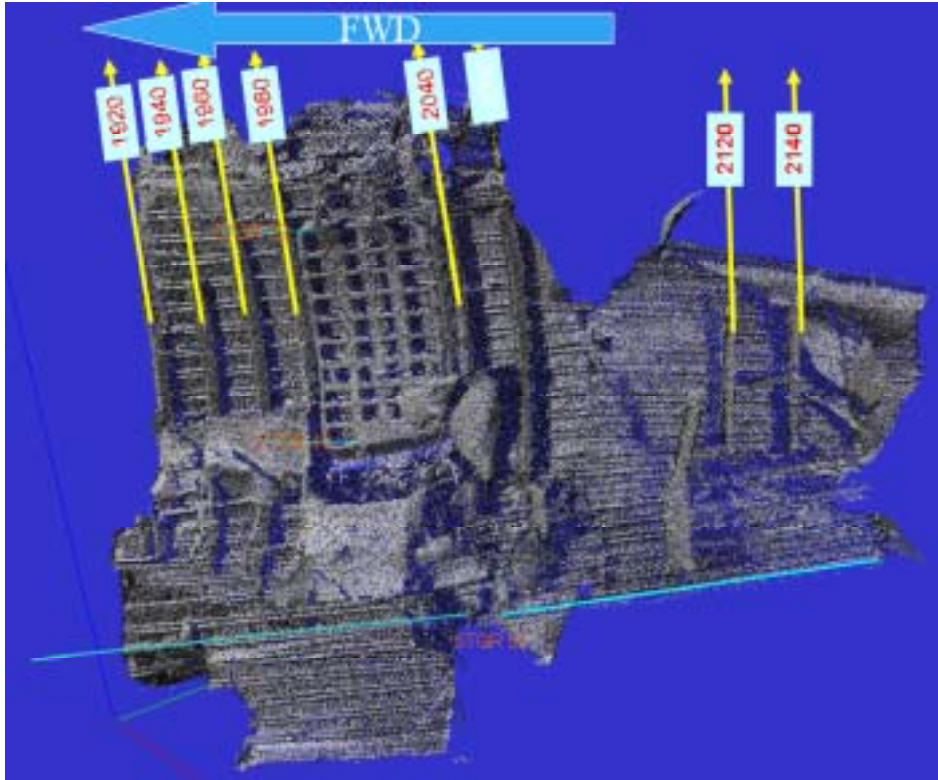
Figure 1.19-11 Item #640

The 3D scanning photos of Item #640, Item #741, Item #631 and Item #726 are shown in Figure 1.19-11~14.

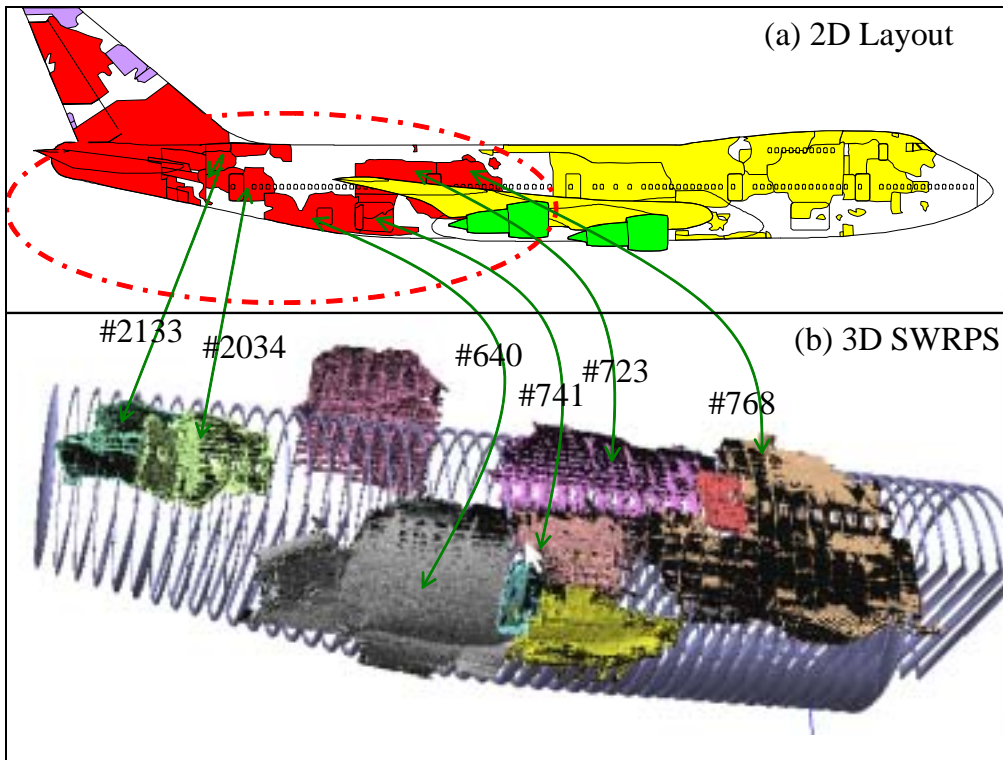
Figure 1.19-15 Comparison of 2D layout and 3D software reconstruction on right-hand side of section 46.

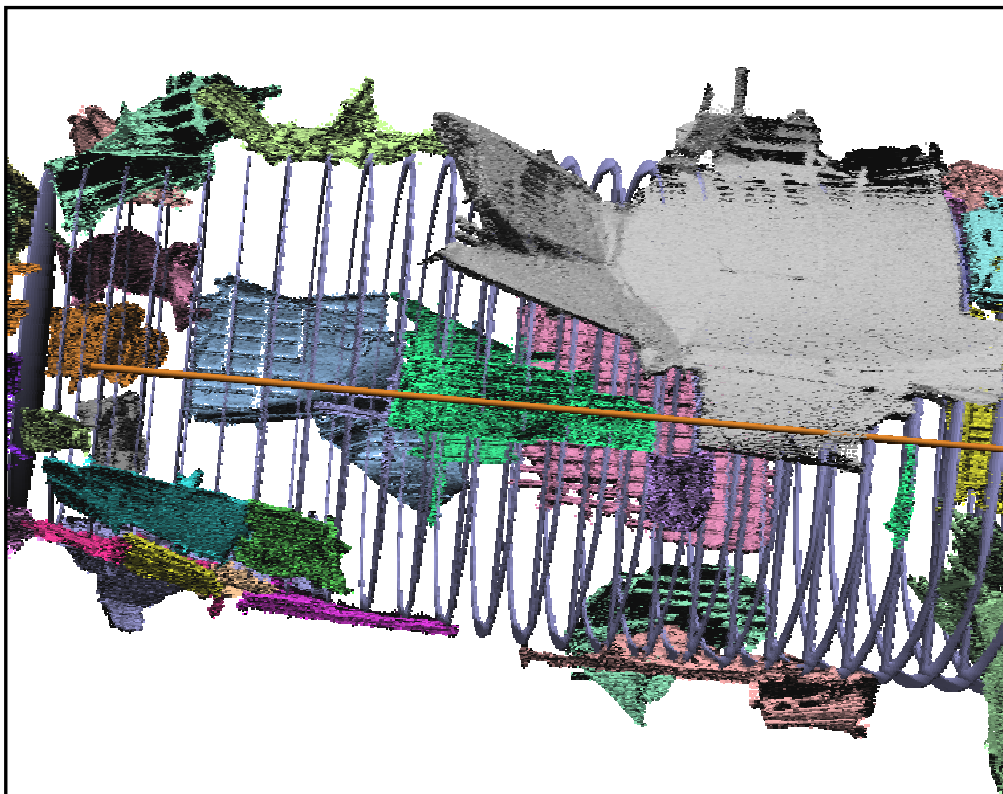
Figure 1.19-16 Detail side view the result of 3D software reconstruction at section 46.

Figure 1.19-16 shows the detail side view the result of 3D software reconstruction at section 46. Includes the item 640 (gray color) and repair doublers (green color).

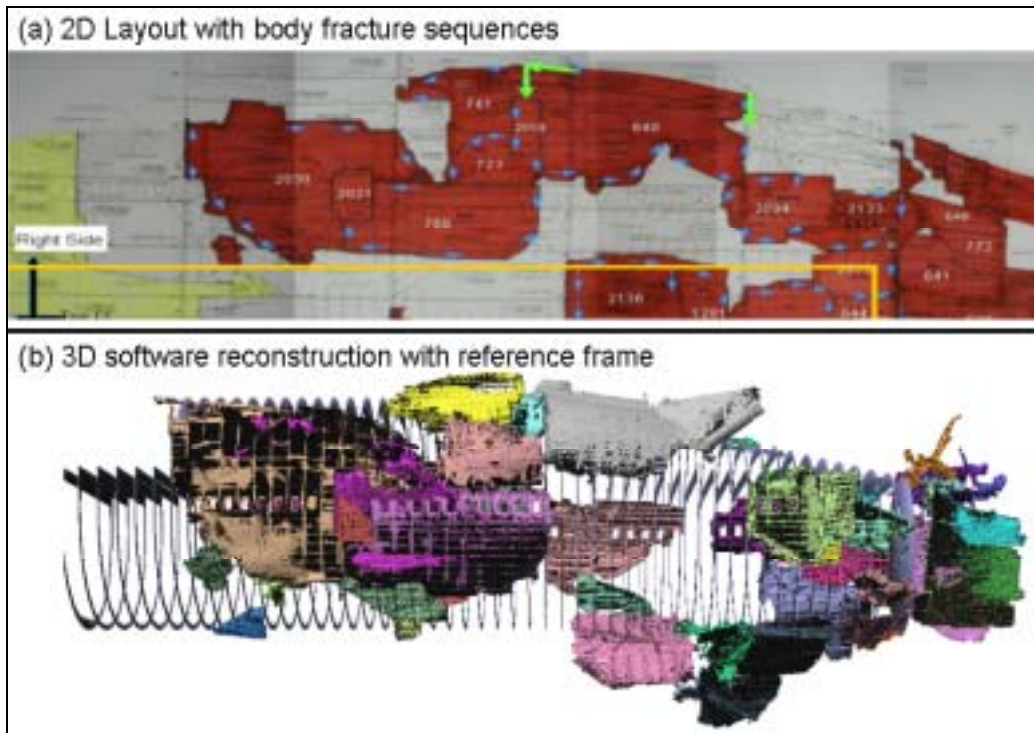
Figure 1.19-17 Comparison of 2D layout and 3D software reconstruction on right-hand side of section 46 and pressure bulkhead.

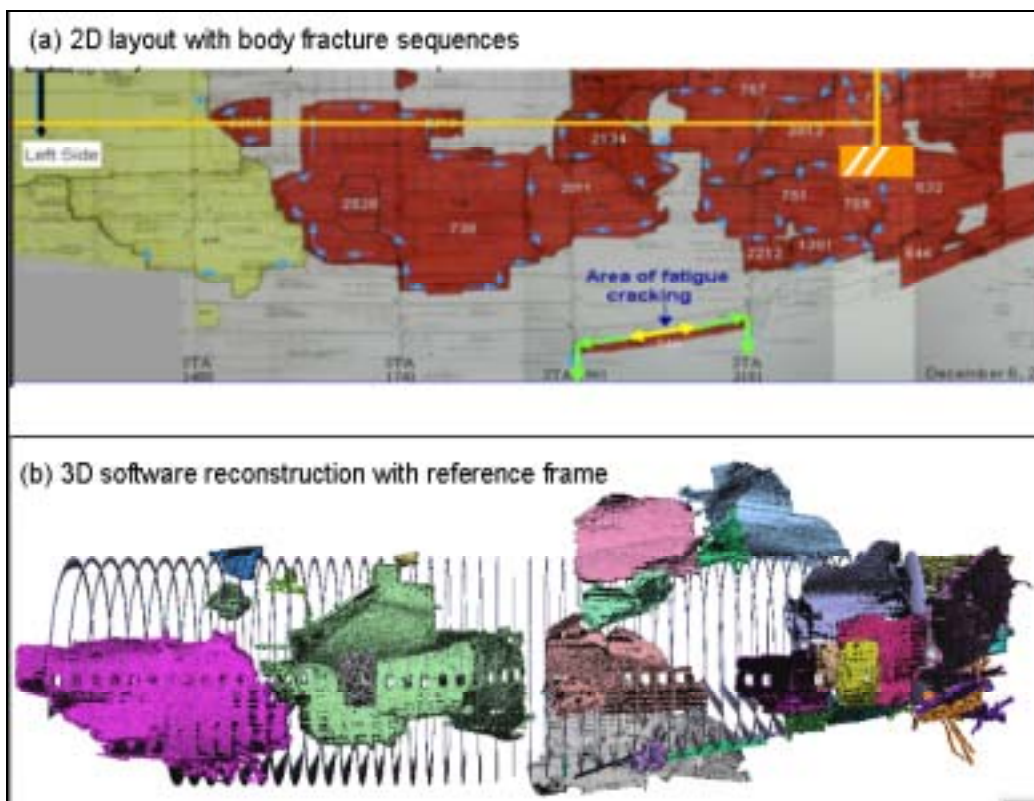
Figure 1.19-18 Comparison of 2D layout and 3D software reconstruction on left-hand side of section 46 and pressure bulkhead.
