Loss of engine and stall on takeoff, American Airlines, Inc., DC-10-10, N110AA, Chicago-O'hare International Airport, Chicago, Illinois, May 25, 1979

Micro-summary: This McDonnell Douglas DC-10-10 stalled and crashed after the loss of the #1 engine caused a catastrophic flight control failure.

AIRCRAFT ACCIDENT REPORT

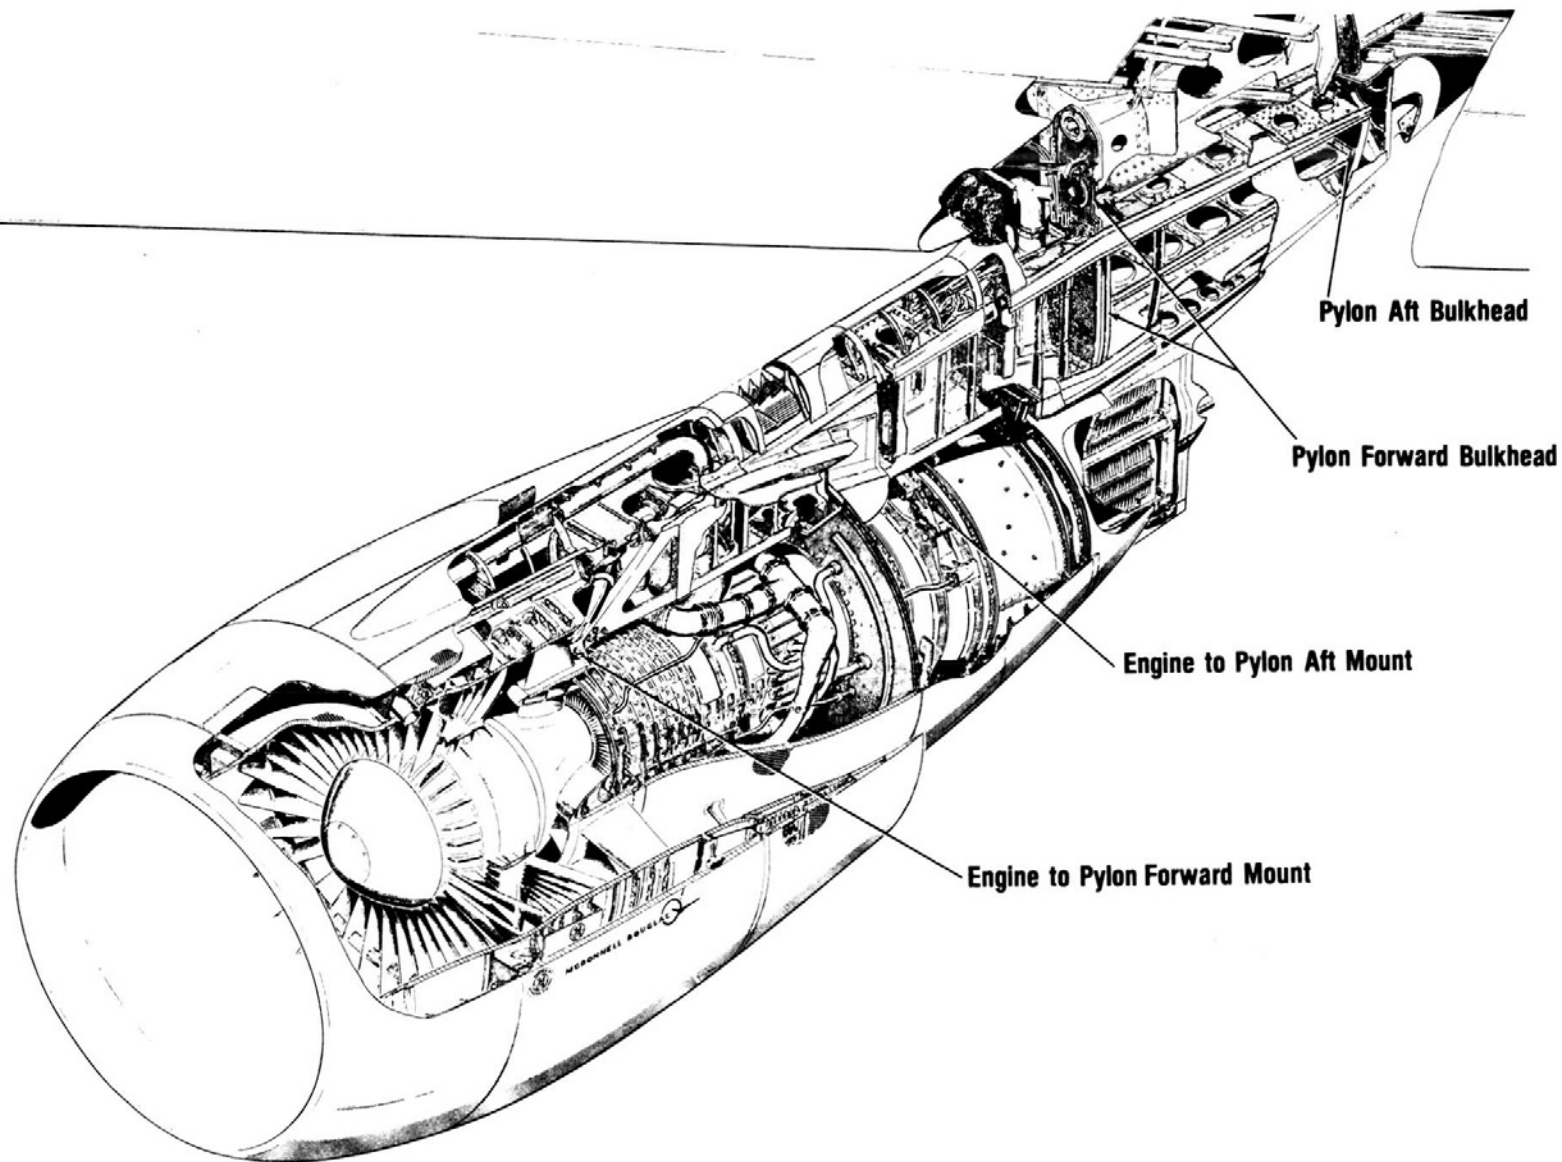
Figure 2. Engine and pylon assembly.

The pylon is attached to the wing using spherical ball joints in three different structural elements. Two of the spherical joints are aligned vertically in a forward bulkhead which is attached to structure in the wing forward of the front spar. Another spherical joint behind the forward bulkhead transmits thrust loads from pylon structure into a thrust link which in turn is connected through another spherical joint to structure on the lower surface of the wing. The third attachment point is a spherical joint in the pylon aft bulkhead which attaches to a clevis mounted on the underside of the wing. The pylon forward bulkhead and portions of the flange from the pylon aft bulkhead either remained with the separated No. 1 pylon or were scattered along the runway. (See figures 2 and 3.) The No. 1 pylon's aft clevis attach assembly and portions of the pylon aft bulkhead, wing thrust angle assembly and thrust link, and pylon forward bulkhead attach assembly remained with the wing.

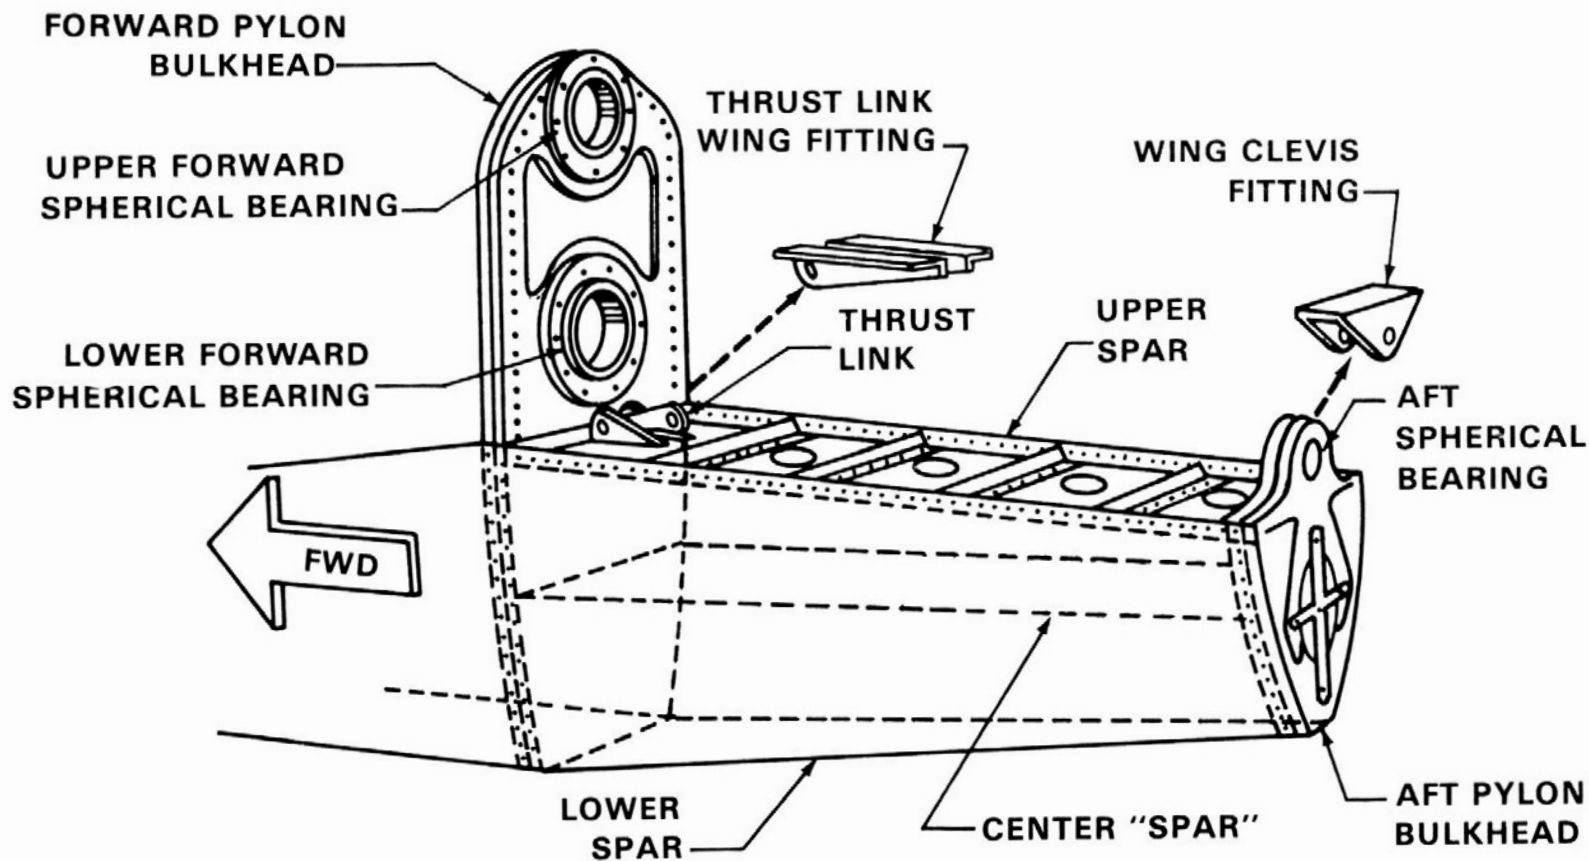
Figure 3. Pylon assembly.

The wing's forward support fitting, which attached the pylon forward bulkhead to the wing at the upper and lower plugs and spherical bearings, was found at the main wreckage site. The upper and lower plugs and their attaching hardware were intact, and the upper and lower spherical bearings were attached to the fitting.

The pylon thrust fitting remained attached to the forward portion of the pylon's aft upper spar web. The pylon thrust link, which attached the pylon thrust fitting to the wing thrust angles, was found at the main wreckage site attached to a portion of the wing thrust angles. Its forward spherical bearing was cocked to the extreme left, and a segment of the bearing which had broken away was found on the runway.

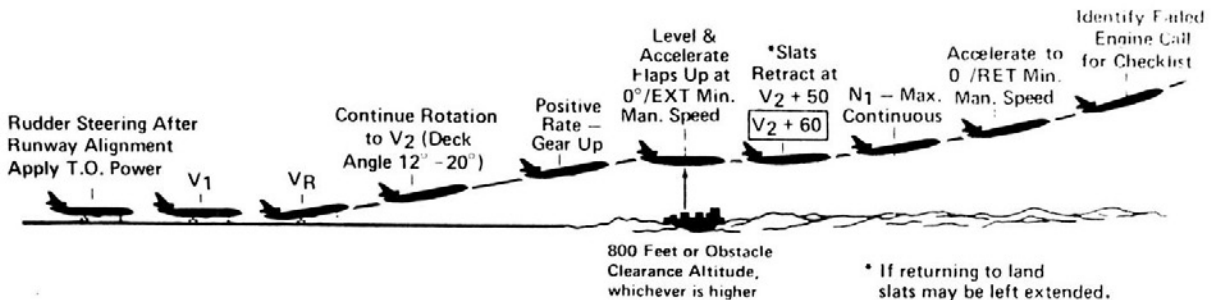
Figure 14. Diagram of AAL emergency procedure.

The Operating Manual's discussion of the procedure contained an annotated profile drawing of the takeoff. (See figure 14.) The annotations accompanying the profile sketch state (after the aircraft is airborne), "Continue rotation to V₂ (Deck angle 12°-20°)." Over the next picture of the aircraft is the note, "Positive rate-Gear up." The next picture shows the aircraft level at 800 ft AGL and contains the accelerate instructions noted above.

On July 23, 1979, American Airlines issued Operations Bulletin No. DC-10-73 which amended the procedure. The bulletin states, in part:

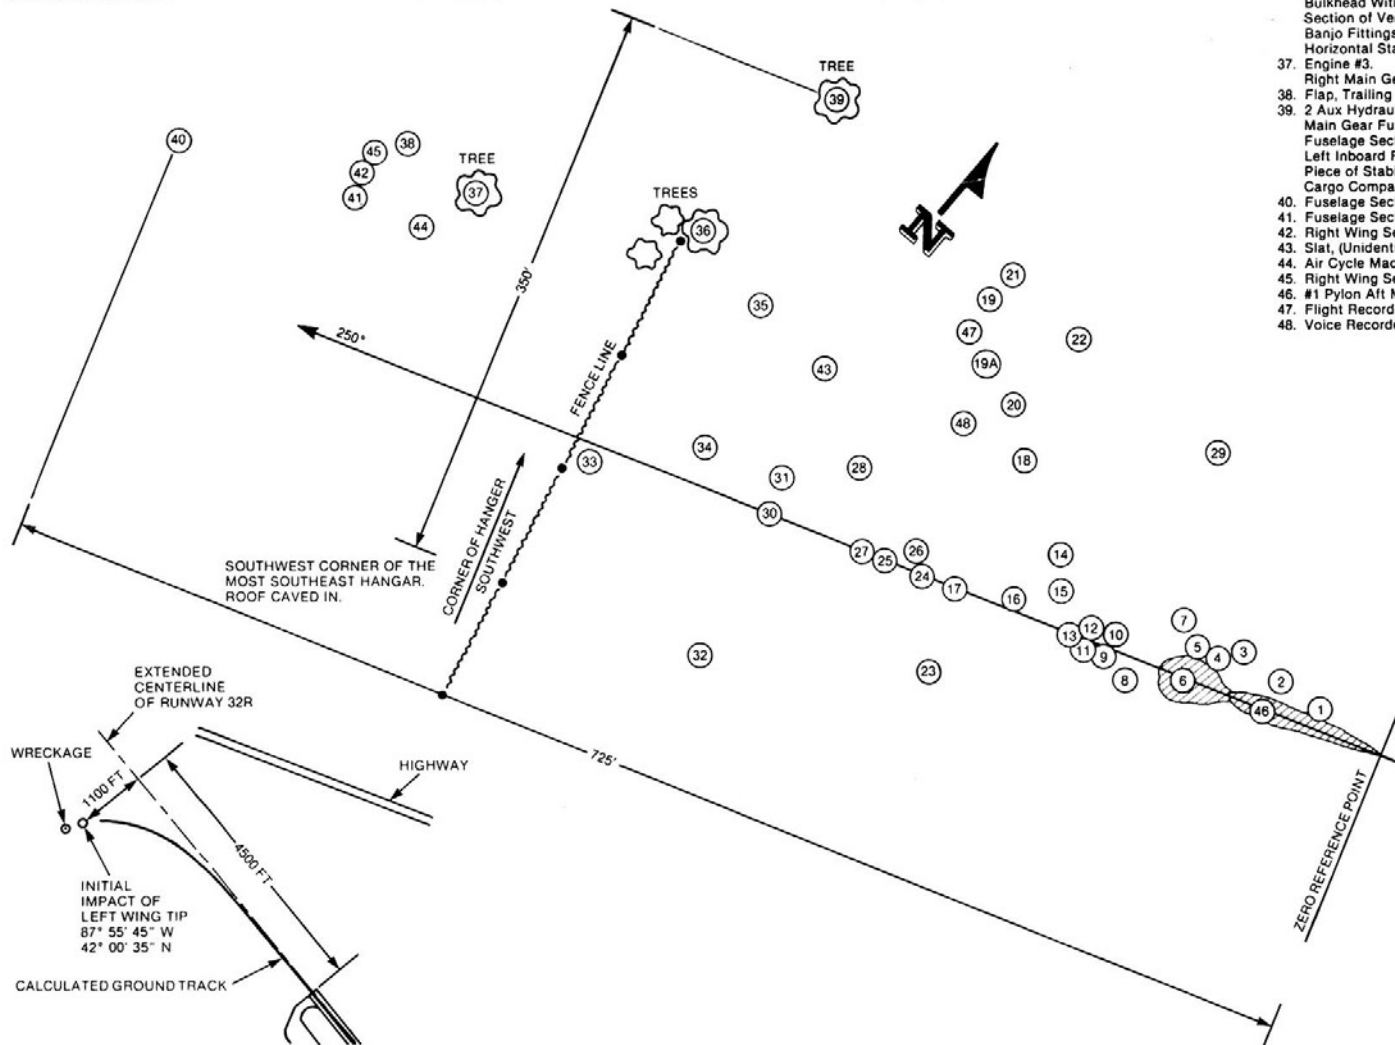
APPENDIX D
WRECKAGE DIAGRAM

Flight 191 struck the ground in a left wing-down and nosedown attitude. The left wingtip hit first, and the aircraft exploded, broke apart, and was scattered into an open field and a trailer park. The disintegration of the aircraft structure was so extensive that little useful data were obtained from postimpact examination of the wreckage with the exception of the No. 1 pylon, which was found off the right side of runway 32R. (See figure 1.)
