**Runway excursion, Scandinavian Airlines System Flight 901, McDonnell Douglas DC-10-30, Norwegian Registry LN-RKB, John F. Kennedy International Airport Jamaica, New York, February 28, 1984**

## **AIRCRAFT ACCIDENT REPORT**

**SCANDINAVIAN AIRLINES SYSTEM  
FLIGHT 901  
McDONNELL DOUGLAS DC-10-30  
JOHN F. KENNEDY  
INTERNATIONAL AIRPORT  
JAMAICA, NEW YORK  
FEBRUARY 28, 1984**

**NTSB/AAR-84/15**

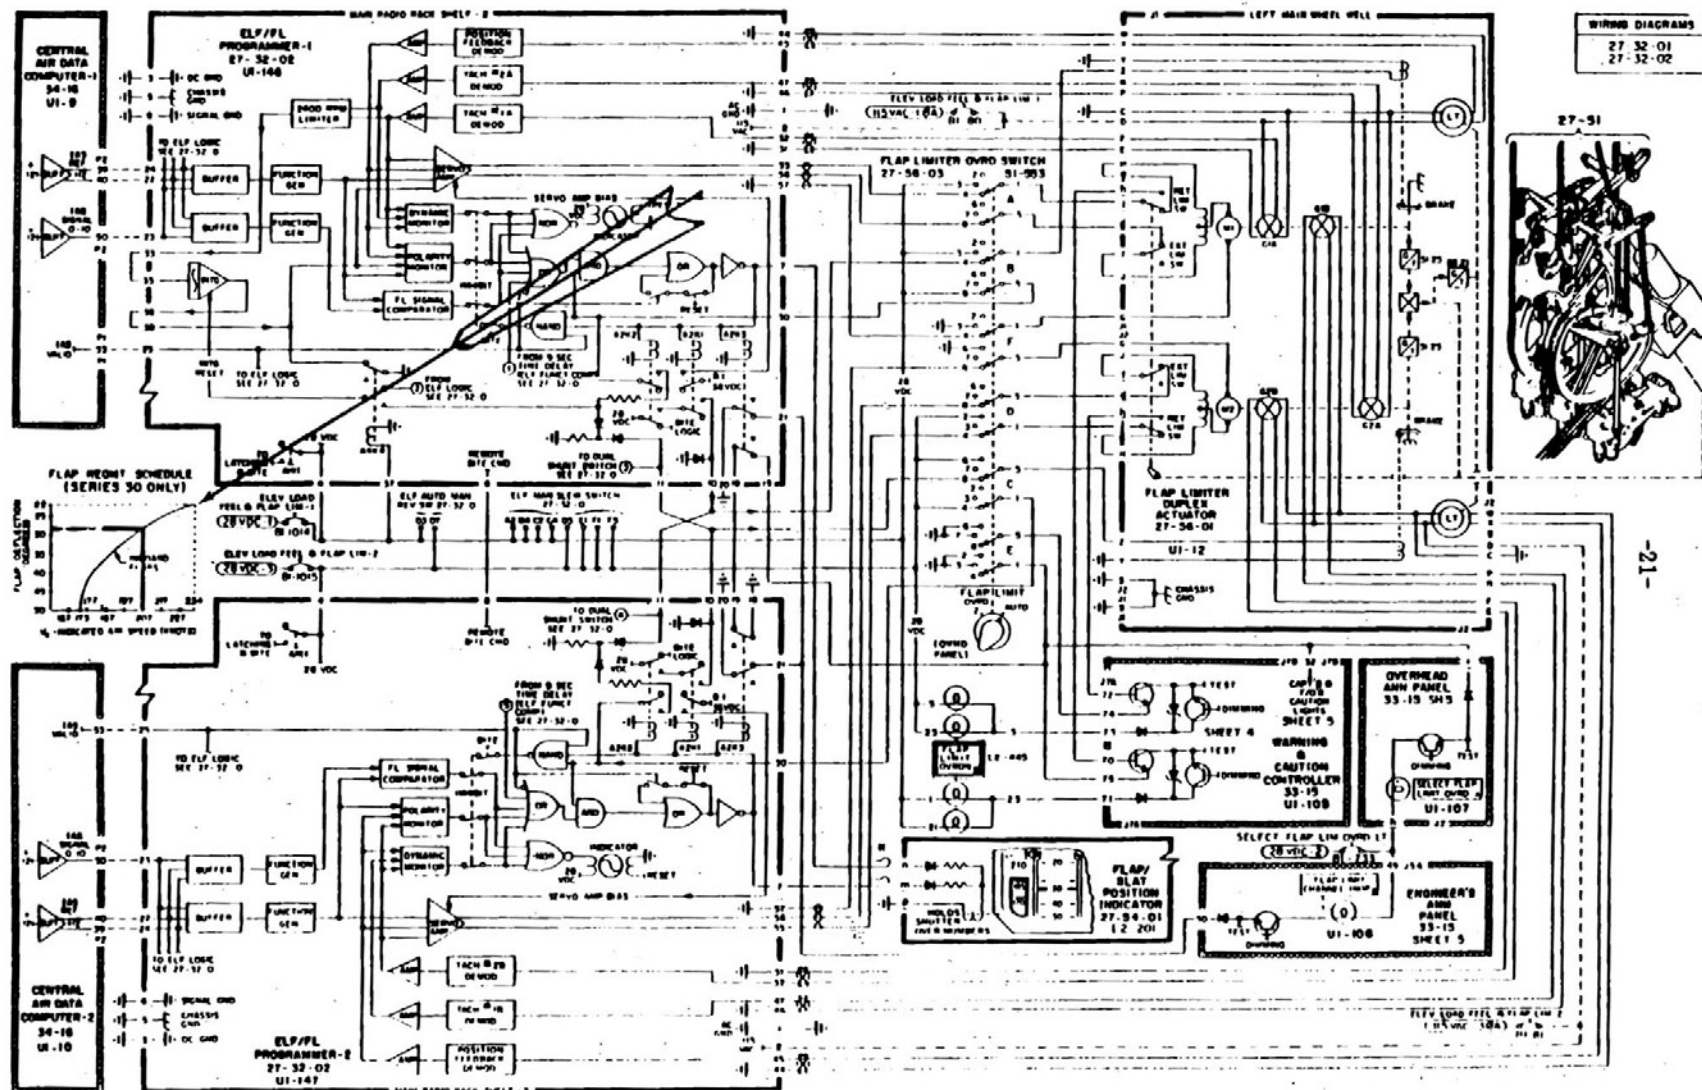
Figure 3.--Flap Limiter System.

During the first 30 seconds of descent (from 1,500 ft to about 870 ft AGL), the throttle position and engine  $N_1$  went to flight idle, indicated airspeed increased to 190 knots and then began to decrease, and the flaps started down to the  $35^\circ$  position. During the next 10 seconds (from 870 ft to 700 ft), the throttles and engine  $N_1$  came up to about 84 percent, the indicated airspeed began climbing from 180 knots, and the flaps reached the  $35^\circ$  position. For the next 32 seconds, until about 18 seconds from touchdown (from 700 ft to 70 ft), the throttle position and  $N_1$  stayed about 84 percent while indicated airspeed continued to climb to a peak of 209 knots. As the airspeed increased past about 193 knots, the flap limiting system on the aircraft began to retract the flaps. (See figure 3.) The flaps continued up to about  $27^\circ$  at an indicated airspeed of 209 knots about 15 seconds before touchdown. About 20 seconds before touchdown, the autopilot was switched from the command to the control wheel steering mode. Three seconds later, the throttle position was reduced to flight idle at a faster rate (about  $9.5^\circ$  per second) than the autothrottle programming allows ( $2^\circ$  to  $3^\circ$  per second). About this time, the captain stated, "It didn't take power off." (See figure 4.) At 15 seconds before touchdown, the aircraft was about 50 ft radio altitude, pitch began increasing, the airspeed began decreasing, the flaps began to extend back to the  $35^\circ$  setting, and the autothrottles went from the speed mode to the retard mode.

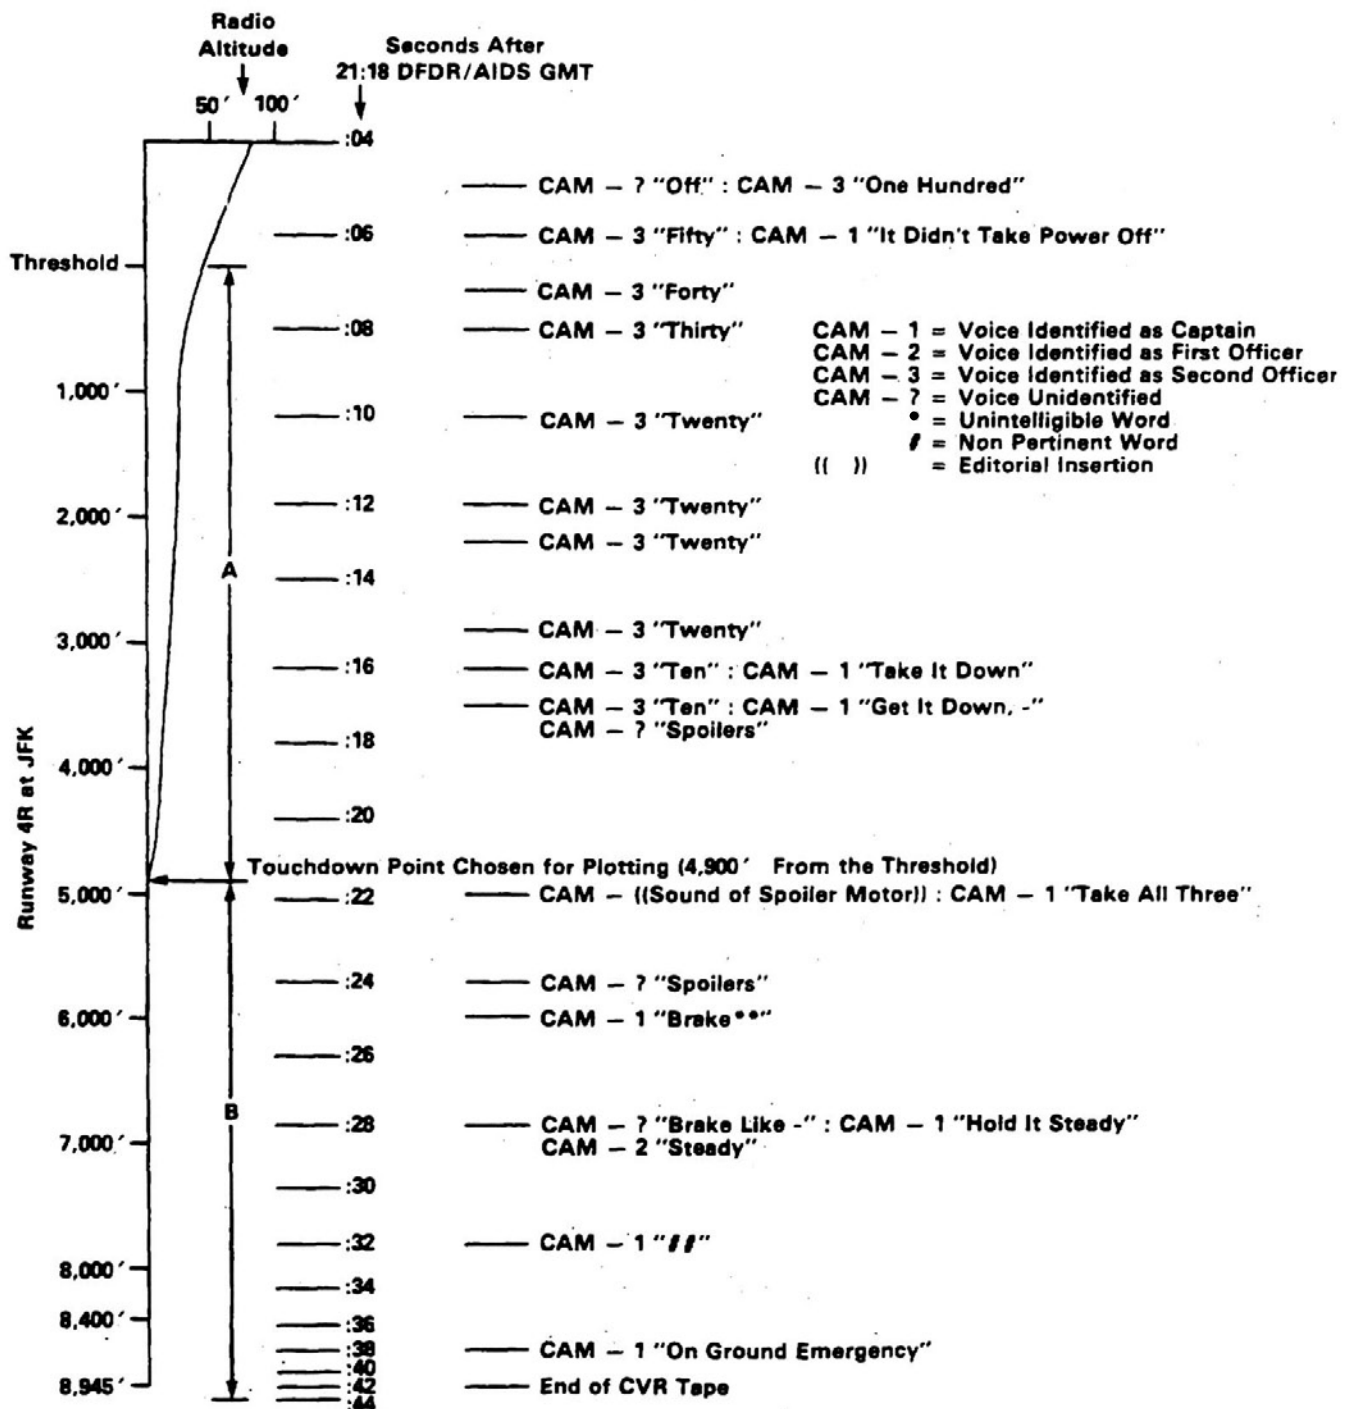
Figure 4.—CVR/AIDS Integration/Runway/Altitude Correlation.

A correlation was made between the CVR cockpit conversation, radio altitude, and position over and on the runway. (See figure 4.) Because CVR times are listed to the nearest second, this correlation is only approximate.

Within 0.7 second after what was determined to be touchdown (21:18:21.6), the spoiler handle came out of the retract position, the spoiler panels that were measured by the AIDS system (5 left and 3 right) came out of the zero degree position, the vertical acceleration peaked, the nose gear strut switch remained in the "air" position, the longitudinal acceleration began a decreasing trend, and the Nos. 1 and 3 thrust reversers were recorded in the stowed position. At 2.0 seconds after touchdown, the nose gear strut switch was recorded in the ground position, the wheel brakes were still in the off position, the spoiler handle was recorded in the extend position, and the spoiler panel reading was about  $60^\circ$ . About 2.8 seconds after touchdown, recorded data showed both wheel brakes on and the No. 1 thrust reverser in the stowed position.  $N_1$  on all three engines during this time (from 14 seconds before touchdown) was about 40 percent (equal to flight idle). Five seconds after touchdown, the  $N_1$  began to decrease from flight idle to ground idle. About 6.4 seconds after touchdown, the No. 1 thrust reverser registered in the deployed position (these data are sampled once every 4 seconds). The No. 3  $N_1$  began increasing from 35 percent at 8 seconds after touchdown, and passed 90 percent at 12 seconds after touchdown. The No. 1  $N_1$  began increasing from 30 percent about 12 seconds after touchdown and attained 88 percent at 15.4 seconds after touchdown where the data ended. The No. 2 engine thrust reverser was in transit for 3.4 seconds and was fully deployed

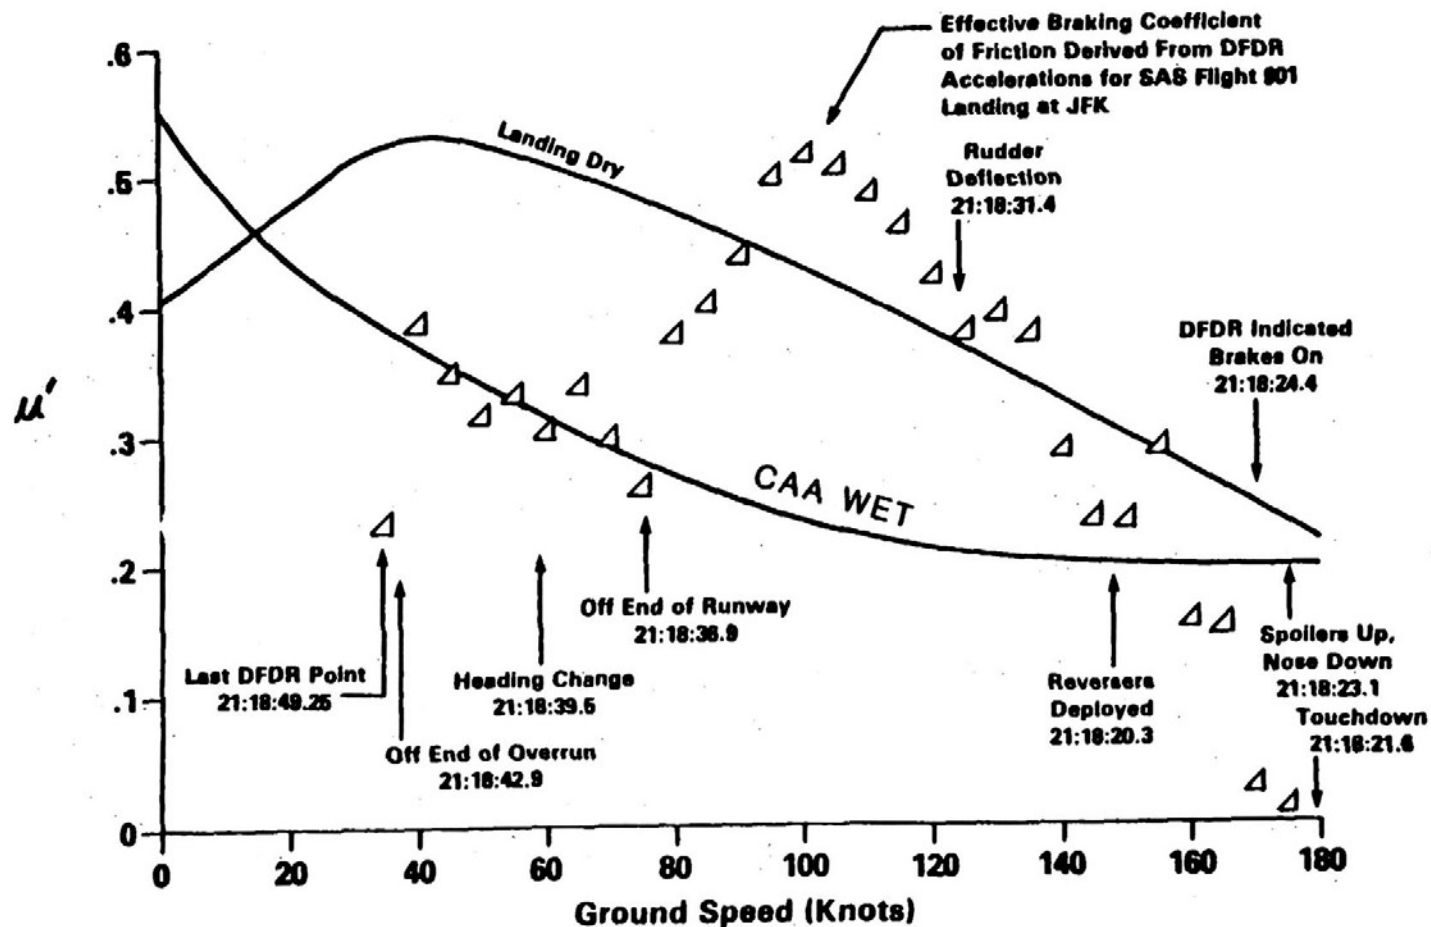
Figure 5.—Effective Braking Coefficient Derived from DFDR.

Calculations made by the Douglas Aircraft Company show calculated effective braking coefficient of friction (Mu prime) as a function of groundspeed for the landing ground roll. (See figure 5.) The force attributed to braking was derived using deceleration data from the DFDR and calculating the drag, lift, and thrust forces on the aircraft. (The effective braking coefficient cannot be directly equated to friction values as measured with the Saab equipment.)
