Runway excursion, Piedmont Airlines Flight 467, Boeing 737-222, N752N, Charlotte Douglas International Airport, October 25, 1986

AIRCRAFT ACCIDENT REPORT

**PIEDMONT AIRLINES FLIGHT 467
BOEING 737-222, N752N
CHARLOTTE DOUGLAS INTERNATIONAL AIRPORT
CHARLOTTE, NORTH CAROLINA
OCTOBER 26, 1986**

NTSB/AAR-87/08

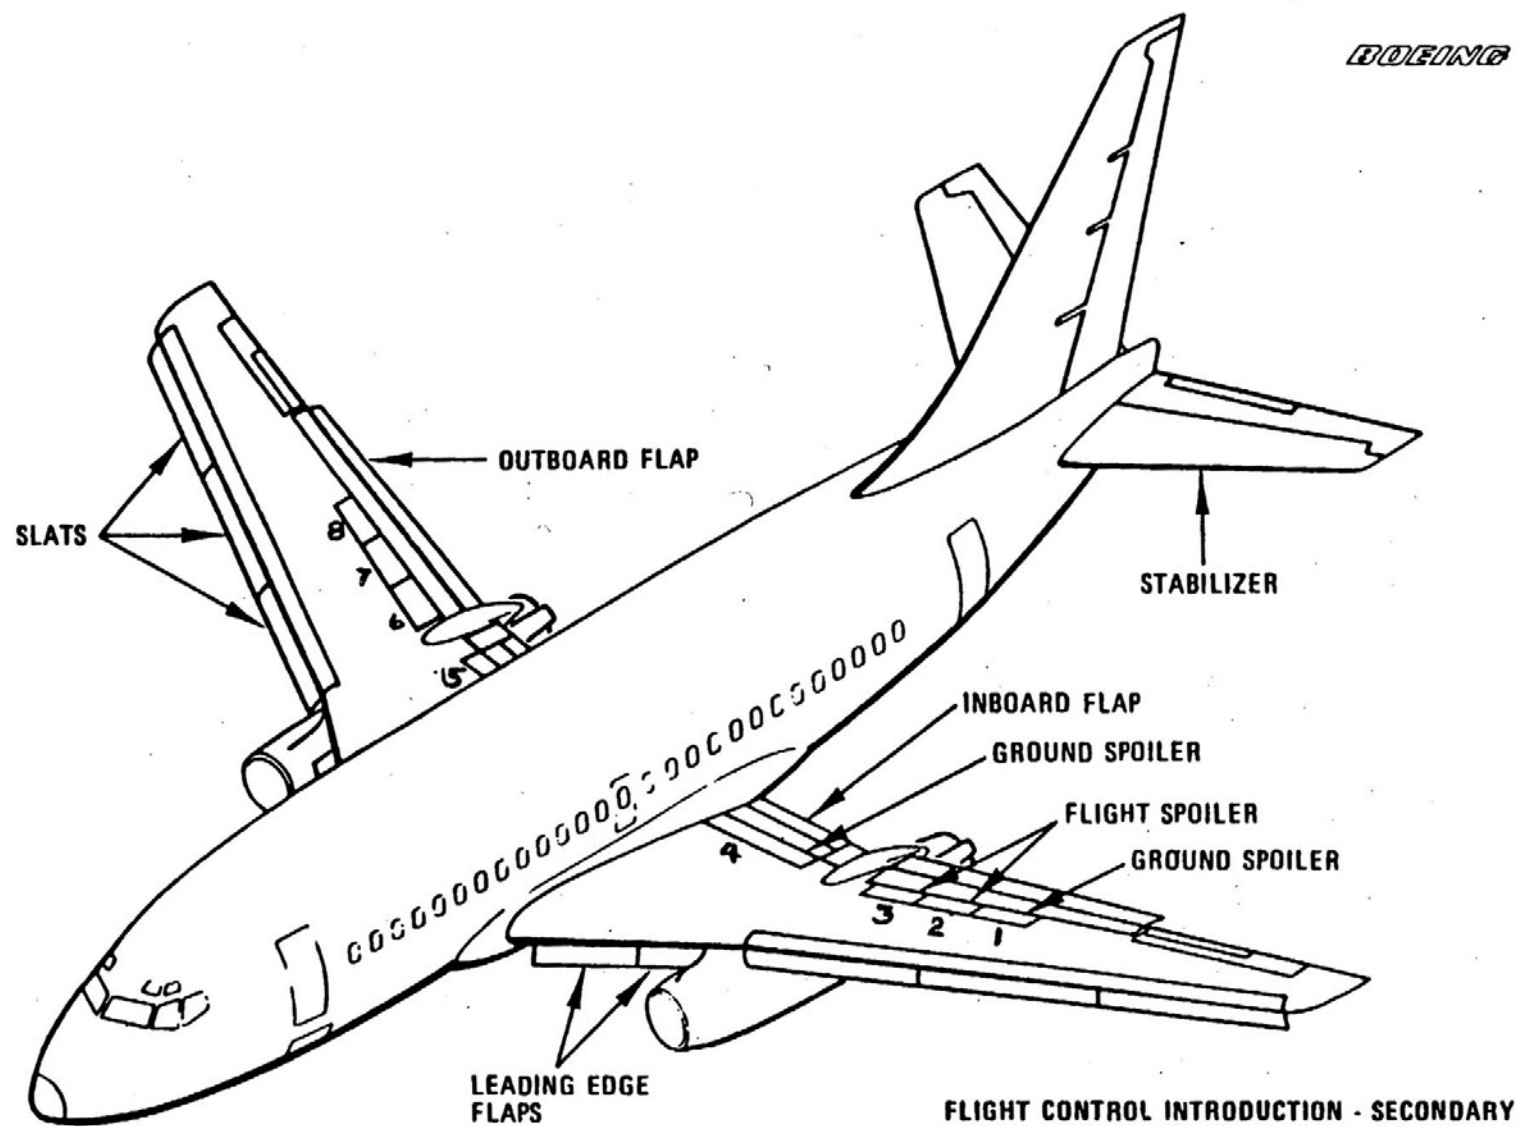
Figure 4.—Boeing 737-222.

On the Boeing 737, the spoilers are composed of eight spoiler panels, four on each wing. (See figure 4.) The outboard and inboard panels on each wing can only be activated on the ground to a maximum deflection of 40° and 60° up, respectively. The

two center panels of each wing also can be used in flight as speed brakes where the panels can be deflected to a maximum of 40°. These panels are used also in conjunction with the ailerons, when the airplane is airborne, for lateral control.
