Aircraft Accident Report, Piper PA-23-150, N2185P and Pan American World Airways Boeing 727-235, N4743, Tampa, Florida, November 6, 1986

**PIPER PA-23-150, N2185P
AND PAN AMERICAN WORLD AIRWAYS
BOEING 727-235, N4743
TAMPA, FLORIDA
NOVEMBER 6, 1986**

NTSB/AAR-87/06

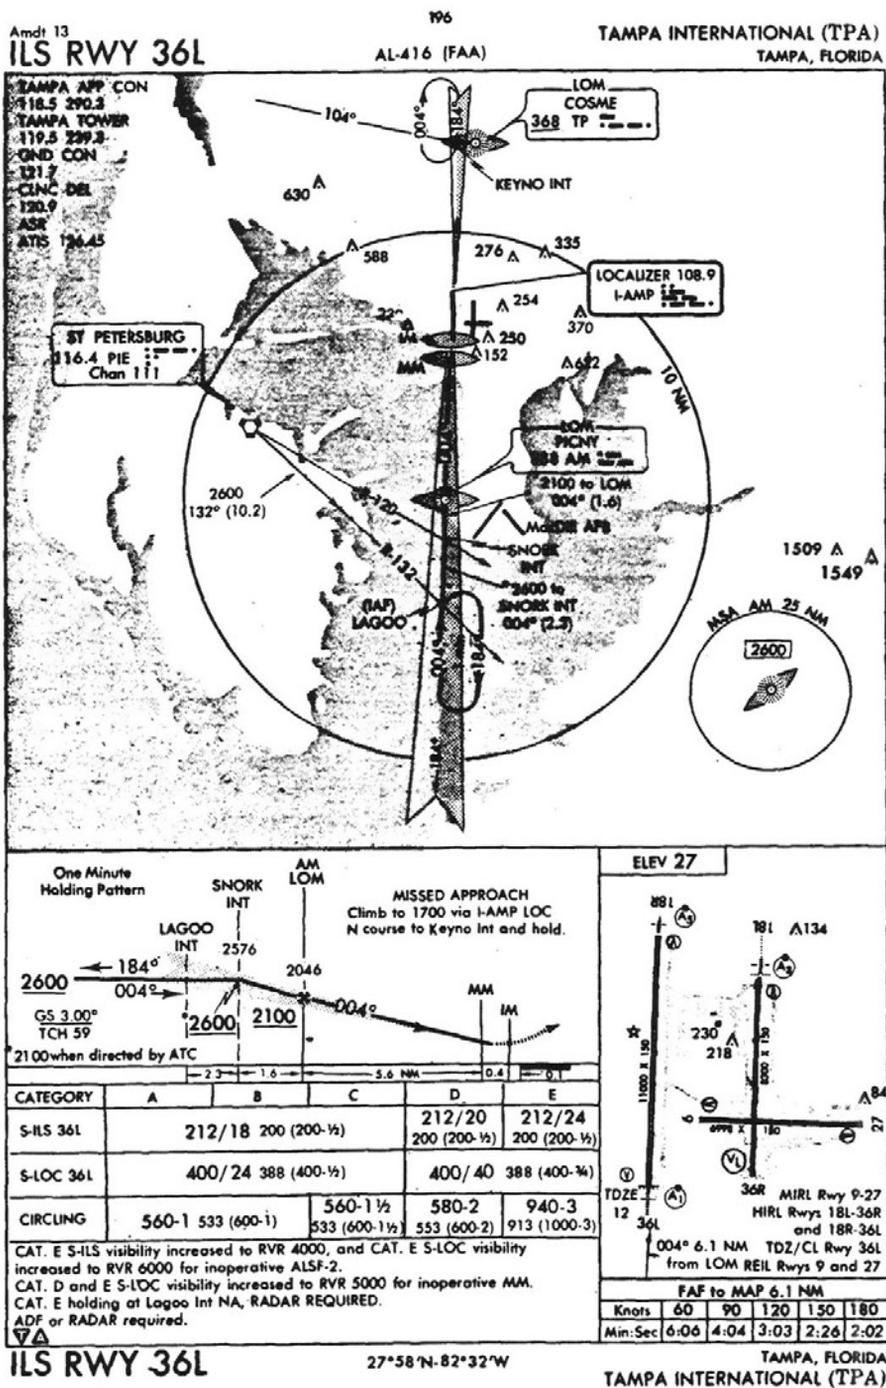
Figure 1.--ILS approach to runway 36L.

At 0633:55, N2185P changed over to the Gibbs sector of Tampa Approach Control. The approach controller told him to expect an ILS approach to runway 36L. (See figure 1.)

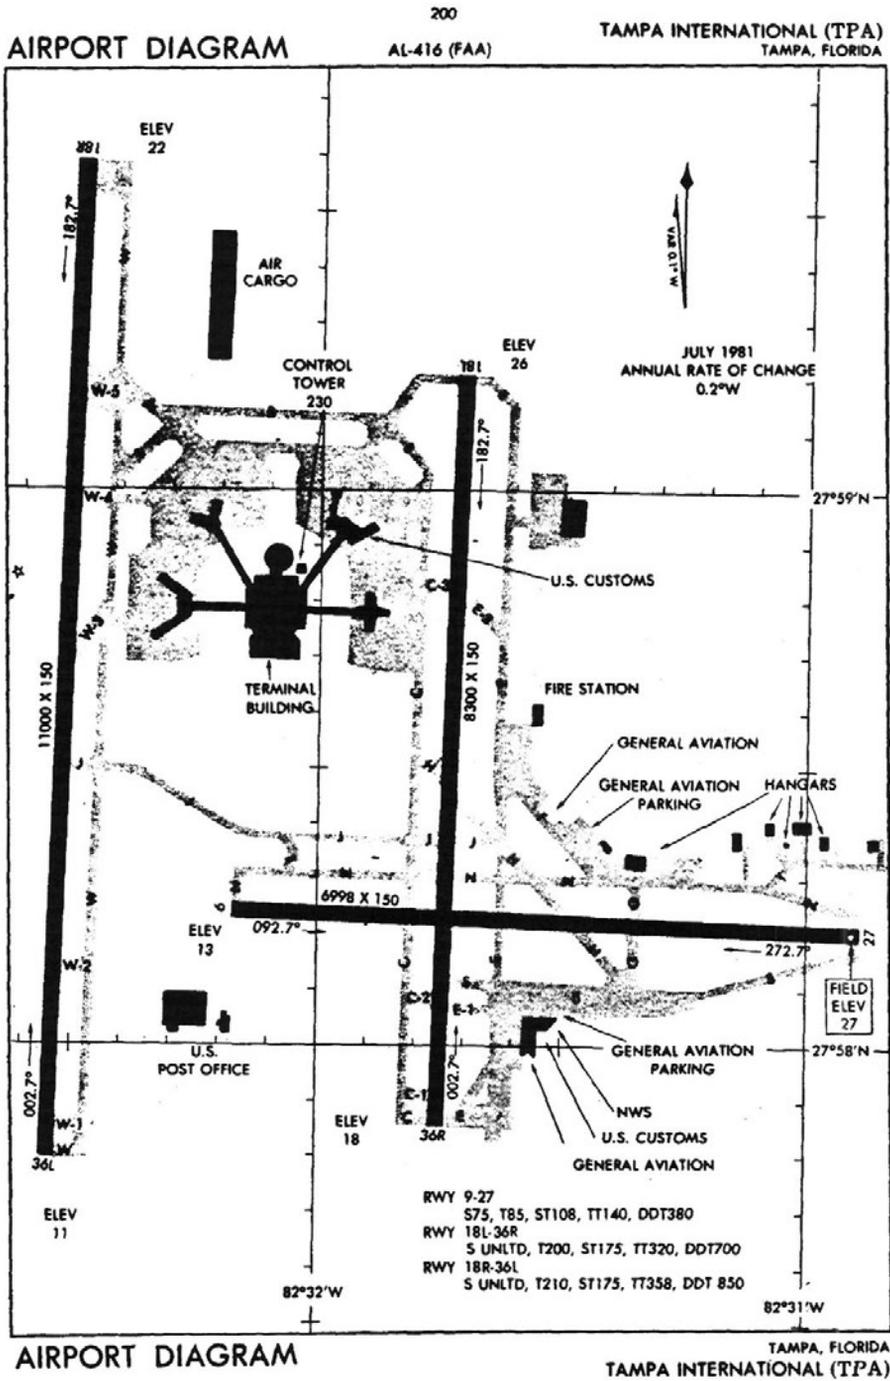
Figure 2.—Diagram of Tampa International Airport.

Meanwhile, N4743, Pan American flight 301, a Boeing 727 with 17 passengers and a crew of 6, had been cleared by the Tampa ground controller to taxi to runway 36L via taxiway W at 0701:15. (See figure 2.) (Pan American's Operations Specifications required an RVR of 600 feet for takeoff.) The B-727's rotating beacon and navigation lights were on, and the landing lights were off. The airplane was not equipped with strobe lights. Due to the fog, the taxi speed was slower than normal. When the airplane was southbound on taxiway W, the captain noted "pockets" in the fog where the runway edge lights and centerline lights were visible. (The distance between the centerlines of the runway and taxiway is 406.25 feet, and the distance between the taxiway centerline and the far side runway lights is about 500 feet.) As he was passing taxiway W-2, the B-727 captain looked up and saw the Apache coming out of the fog on a head-on collision course. The captain said that the approaching airplane did not appear to have touched down yet, but that it looked like it was in a "flaring" attitude; that is, its nose had been raised slightly in anticipation of touchdown. The captain immediately turned his airplane to the right. The first officer said that the Apache pitched up and banked slightly to the left and may have been attempting a go-around. Tire marks on the taxiway indicated that the Apache touched down near the centerline and about 200 feet from the B-727.

About 2 seconds later, the left engine of the Apache struck the B-727 in the lower nose area, separated from the Apache, and remained embedded just behind the radome. Fuel from the Apache's ruptured tanks ignited as it passed under the wing of the

B-727. The B-727 captain attempted to stop; however, his hydraulic brakes were ineffective. As he applied the emergency air brakes, the first officer applied his hydraulic brakes, and the B-727 rolled onto the grass between the taxiway and runway. The Apache came to rest and continued to burn on the taxiway about 100 feet behind the 727. The pilot of the Apache sustained fatal injuries.
