Crash after takeoff due to icing, Continental Airlines, Inc., Flight 1713, McDonnell Douglas DC-9-14, N626TX, Stapleton International Airport, Denver, Colorado, November 15, 1987

AIRCRAFT ACCIDENT REPORT

**CONTINENTAL AIRLINES, INC., FLIGHT 1713
McDONNELL DOUGLAS DC-9-14, N626TX
STAPLETON INTERNATIONAL AIRPORT
DENVER, COLORADO
NOVEMBER 15, 1987**

NTSB/AAR-88/09

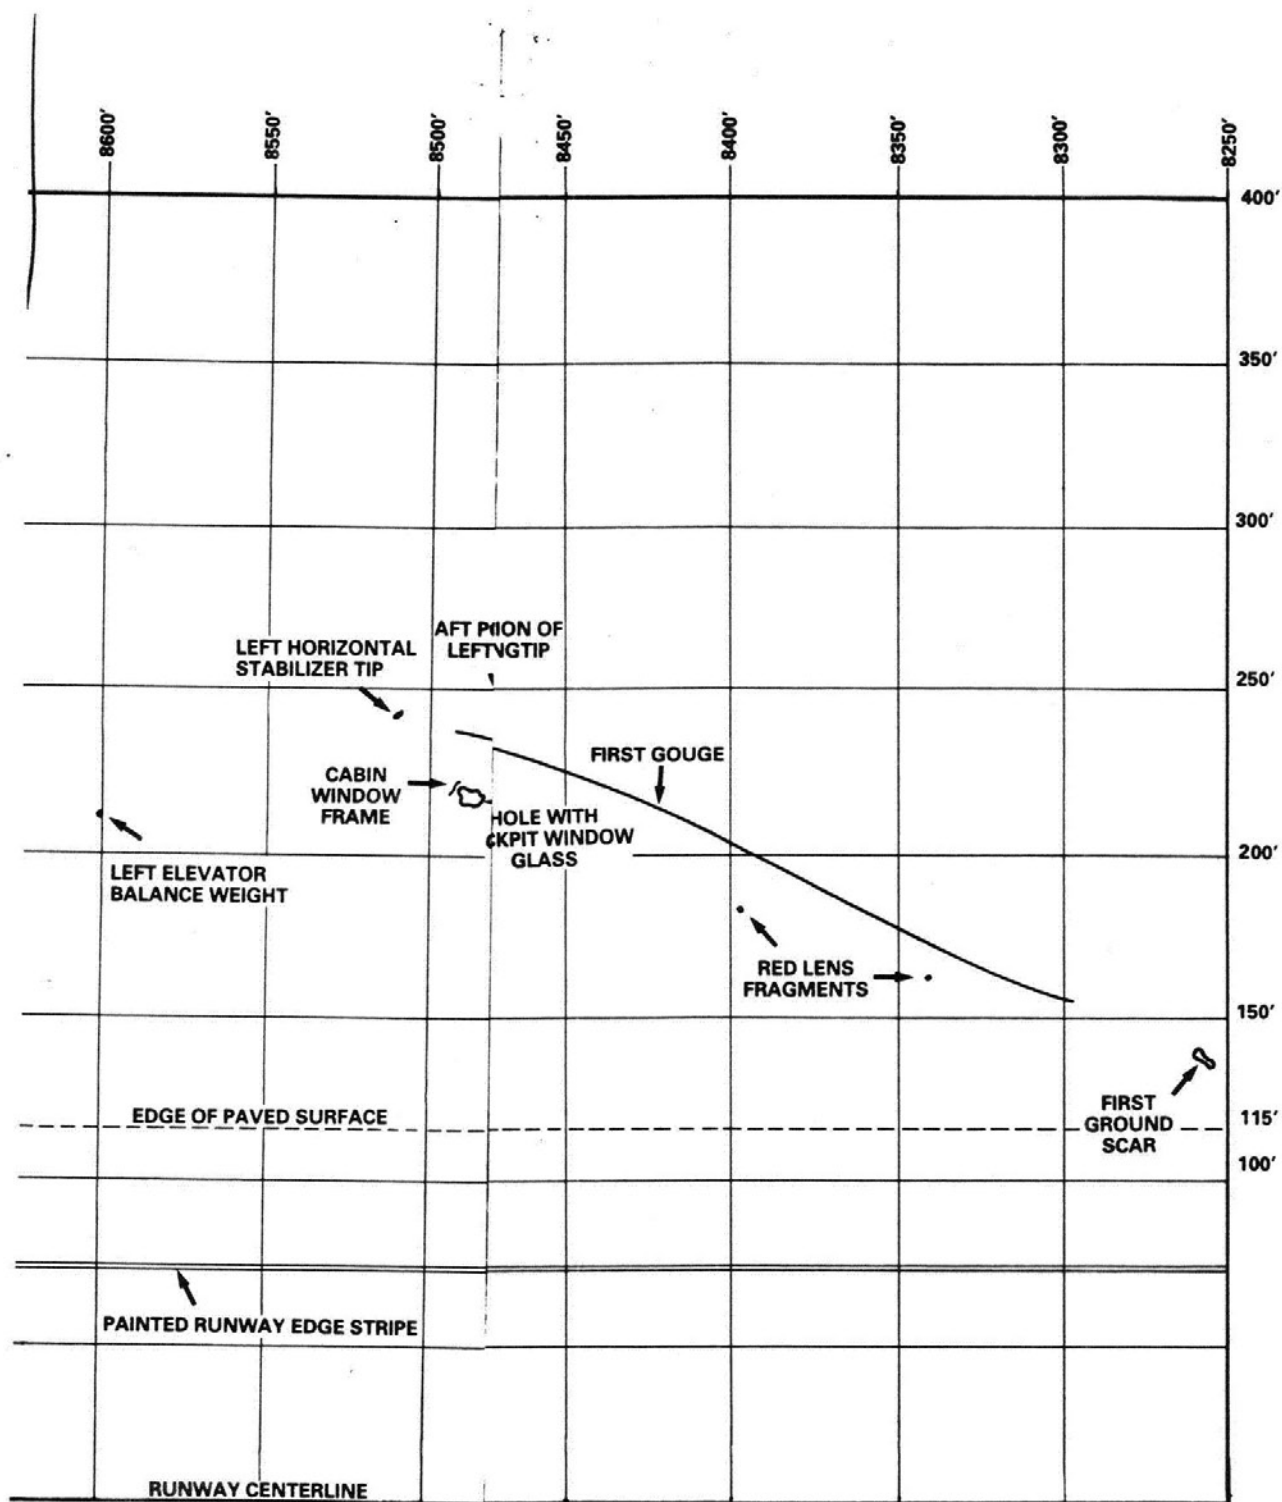
Figure 4. -- Wreckage diagram at accident site.

Three major ground scars were found at the accident site. The first ground scar began 8,244 feet down and 114 feet to the right of the runway 35L centerline. The 214-foot scar angled away from the runway approximately 20° and then turned slightly back toward the runway. The left wingtip landing light lens retaining ring was located 8,257 feet down and 130 feet to the right of the runway centerline. The red glass left navigation light lens also was found in this area. Left wing debris was found in a line between this area and the second ground scar, a crater 11 feet by 11 feet by 9 inches. Examination of the dirt in the crater revealed pieces of glass identified as the outer glass panel of the left cockpit "eyebrow" window. A third major ground scar contained green glass lens material. Other debris in the area of the third crater consisted of various airplane components, including pieces of cabin interior, overhead compartment fragments, and passenger luggage.

The nearly intact empennage/tail cone section of the airplane was located approximately 250 feet down from the third scar. It was inverted and aligned on a magnetic heading of 234°. The empennage was coated with soot but showed no signs of thermal damage. The left horizontal stabilizer tip and left elevator tip were missing. Fragments from these components were located earlier along the wreckage path, south of the empennage.

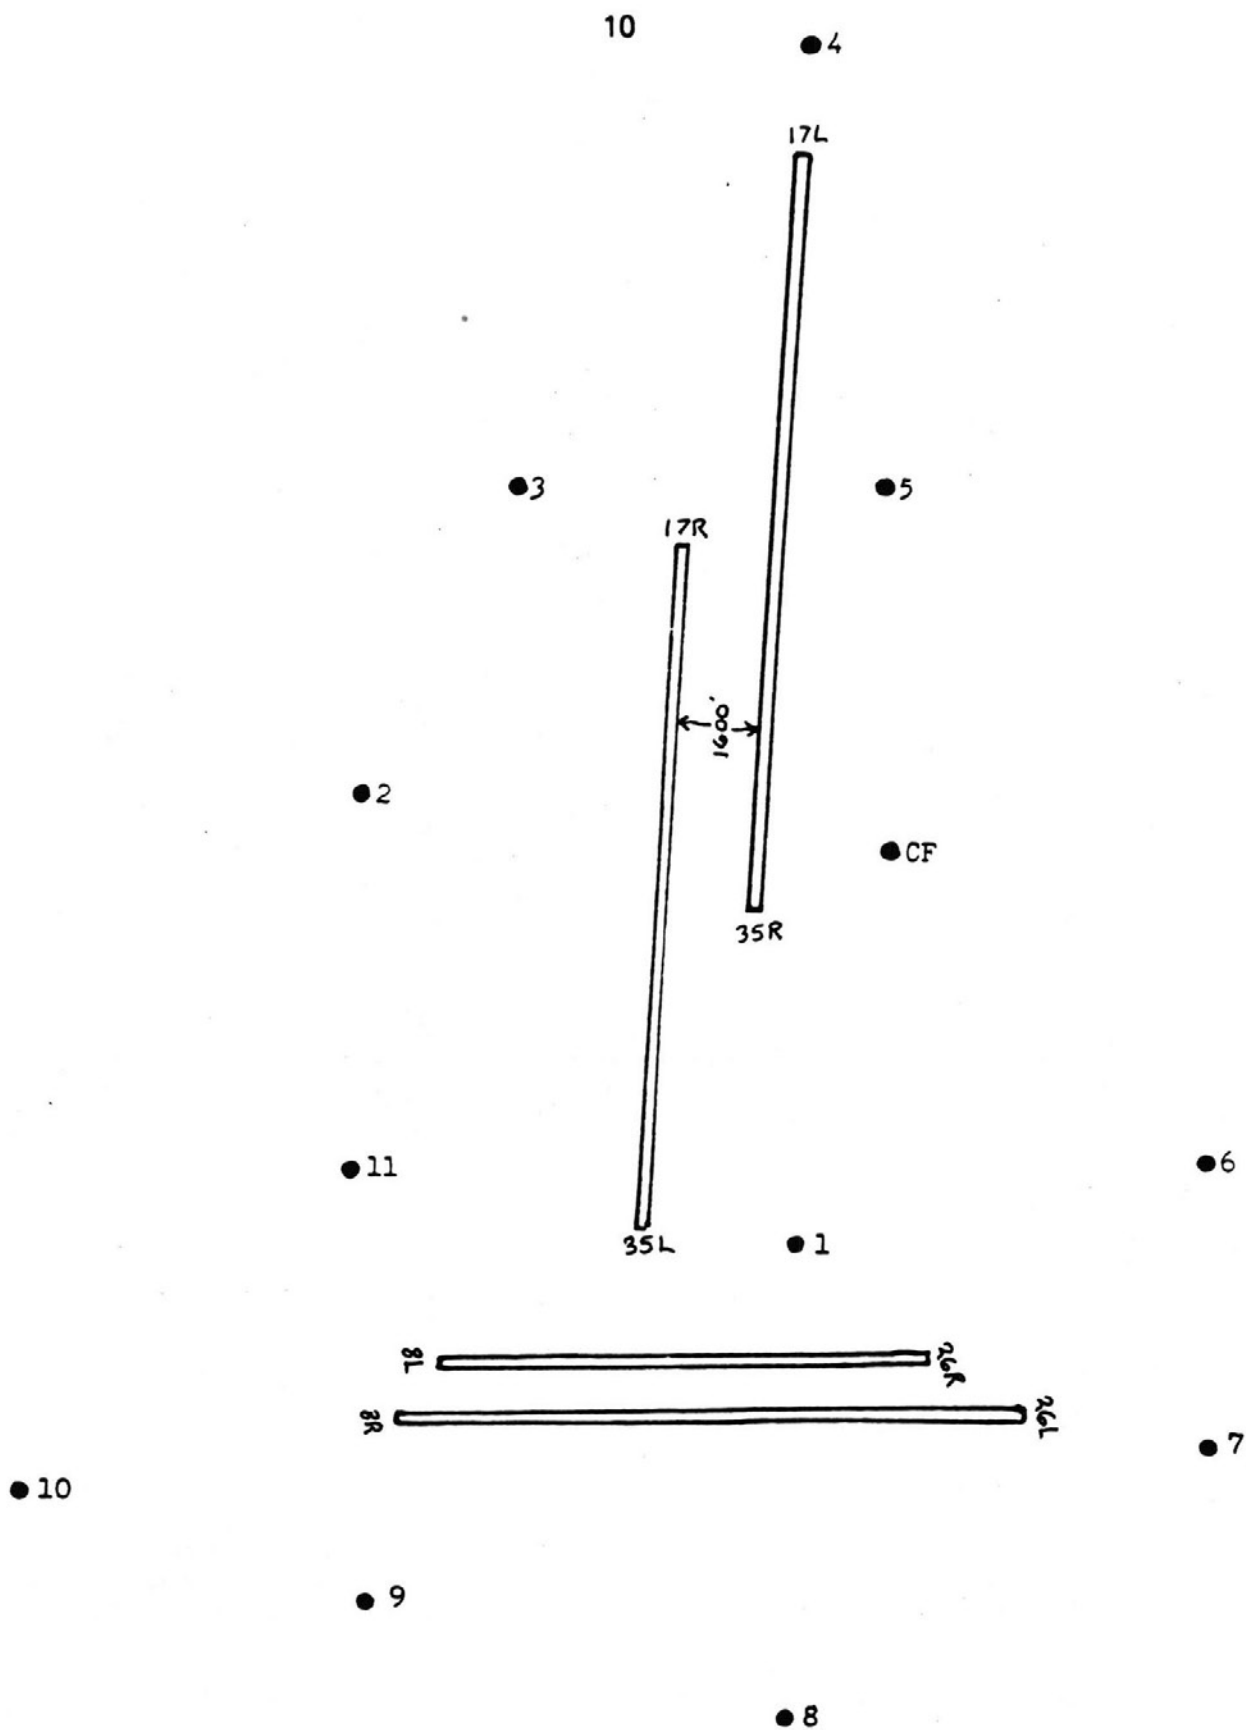
Figure 1.--Wind sensor locations.

The winds recorded from the low level wind shear alert system (LLWAS) were provided by the FAA for 1410:04 to 1419:44. Observations were taken from each sensor at approximately 7-second intervals. (See figures 1 and 2.)

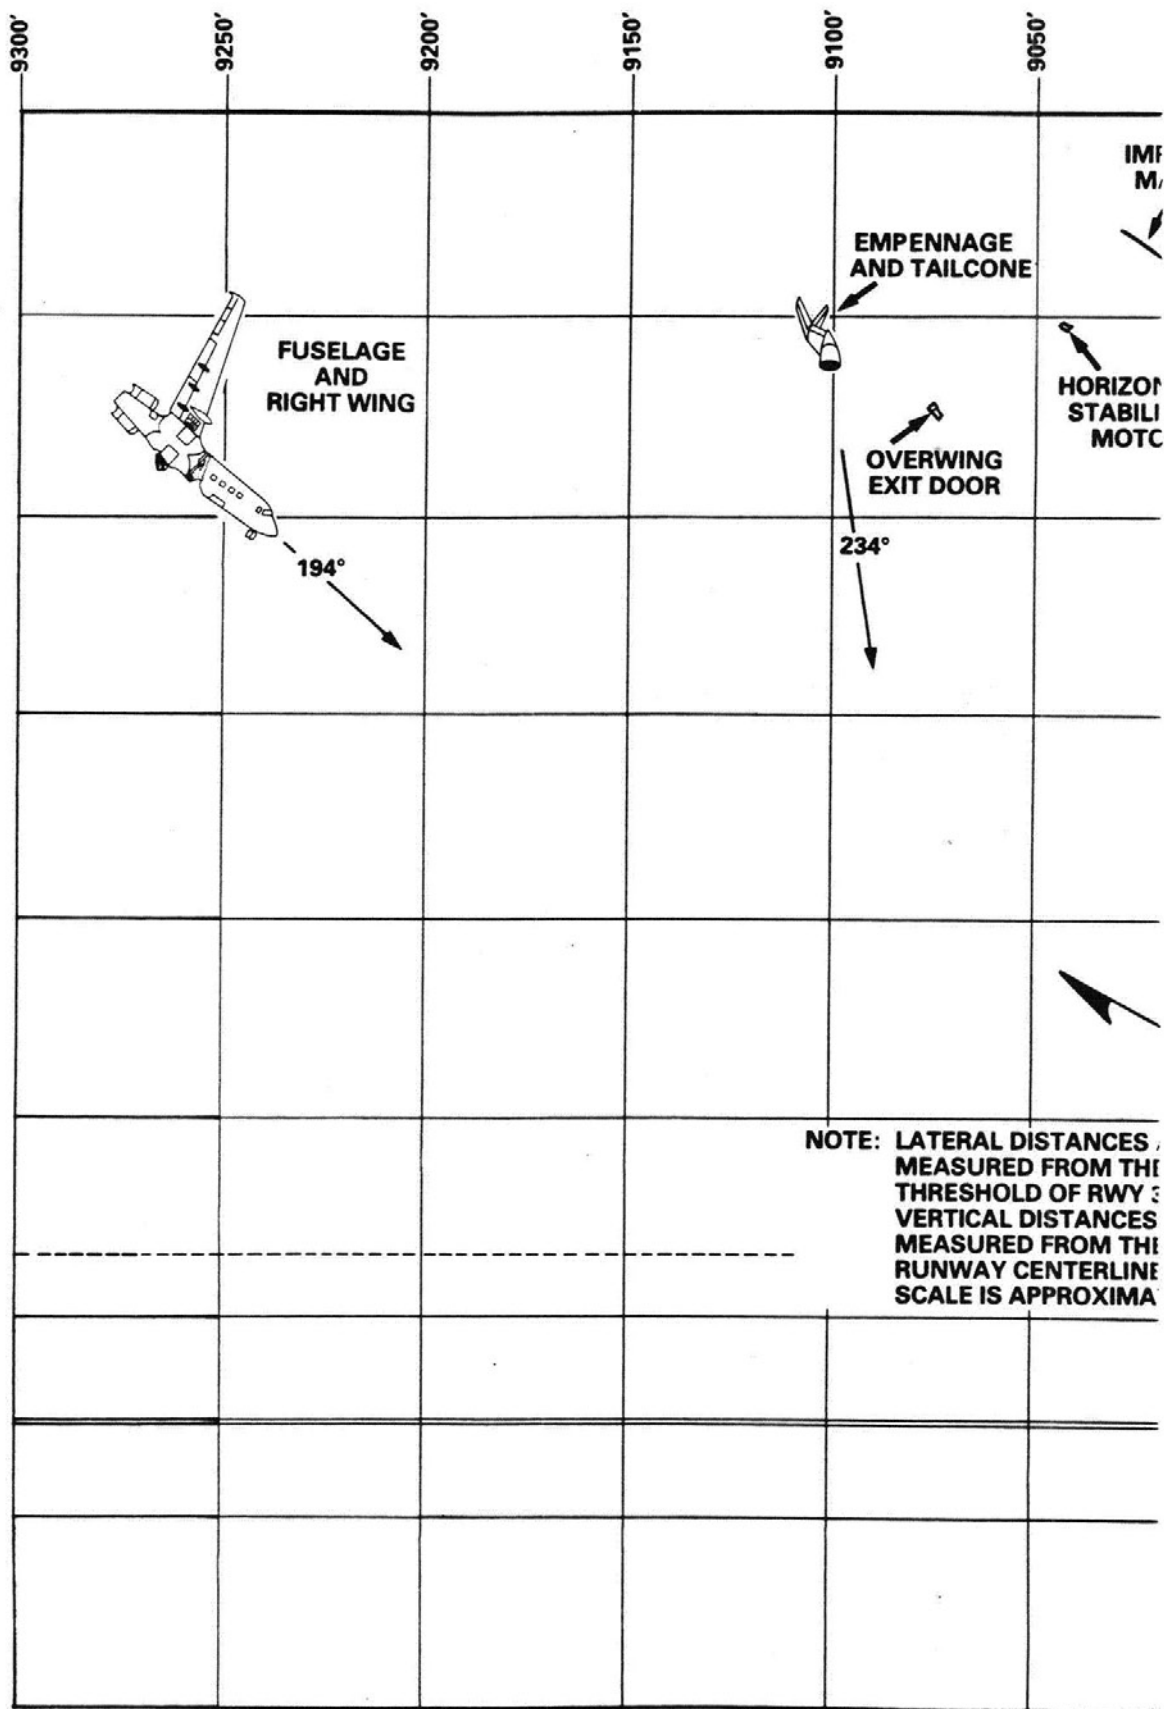
The fuselage and right wing were located approximately 200 feet down from the empennage. The forward portion of the fuselage, which had split at fuselage station 446, was resting on its left side. Longerons 1R through 15R were intact but severely bent and distorted. This was the only structure connecting the forward fuselage to the rear fuselage. The left side of the forward fuselage was badly damaged. Much of the exterior skin and underlying structure was torn away and found along the wreckage path. The right side of the fuselage was distorted and dented in several areas near the forward baggage door. The aft portion of the fuselage was aligned with the forward half of the fuselage and resting inverted. The section of fuselage just aft of the break was collapsed to within inches of the cabin floor. The portion of the fuselage adjacent to the engines was collapsed to the level where the forward part of the engine was resting on the ground. The right wing remained attached in its proximate correct position. (See figures 4 and 5.)
