**In-Flight Fire, McDonnell Douglas DC-9-83, N569AA, Nashville
Metropolitan Airport, Nashville, Tennessee, February 3, 1988**

HAZARDOUS MATERIALS INCIDENT REPORT

**IN-FLIGHT FIRE,
McDONNELL DOUGLAS DC-9-83, N569AA,
NASHVILLE METROPOLITAN AIRPORT
NASHVILLE, TENNESSEE,
FEBRUARY 3, 1988**

NTSB/HZM-88/02

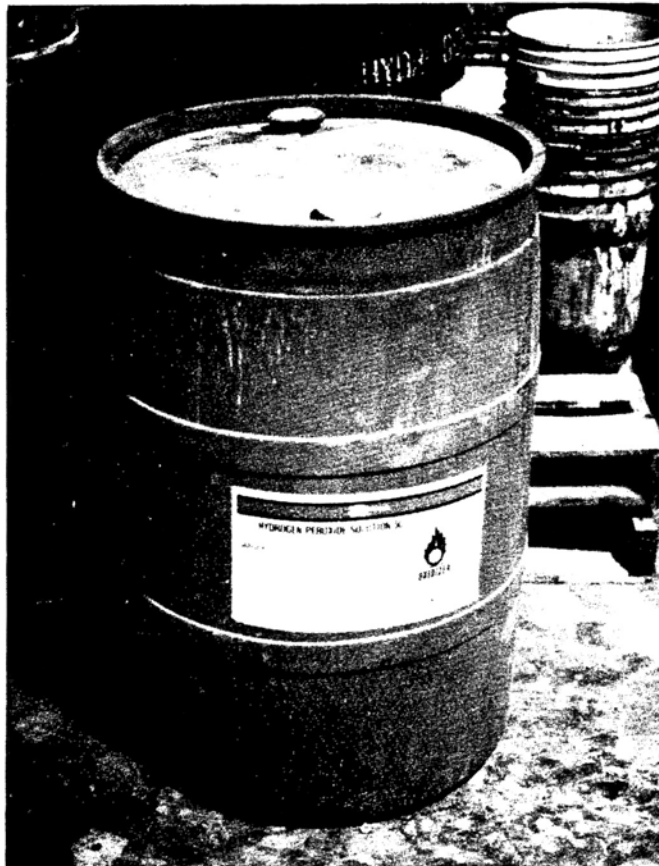
Figure 6.--A 55-gallon drum of hydrogen peroxide at the shipper's facility.

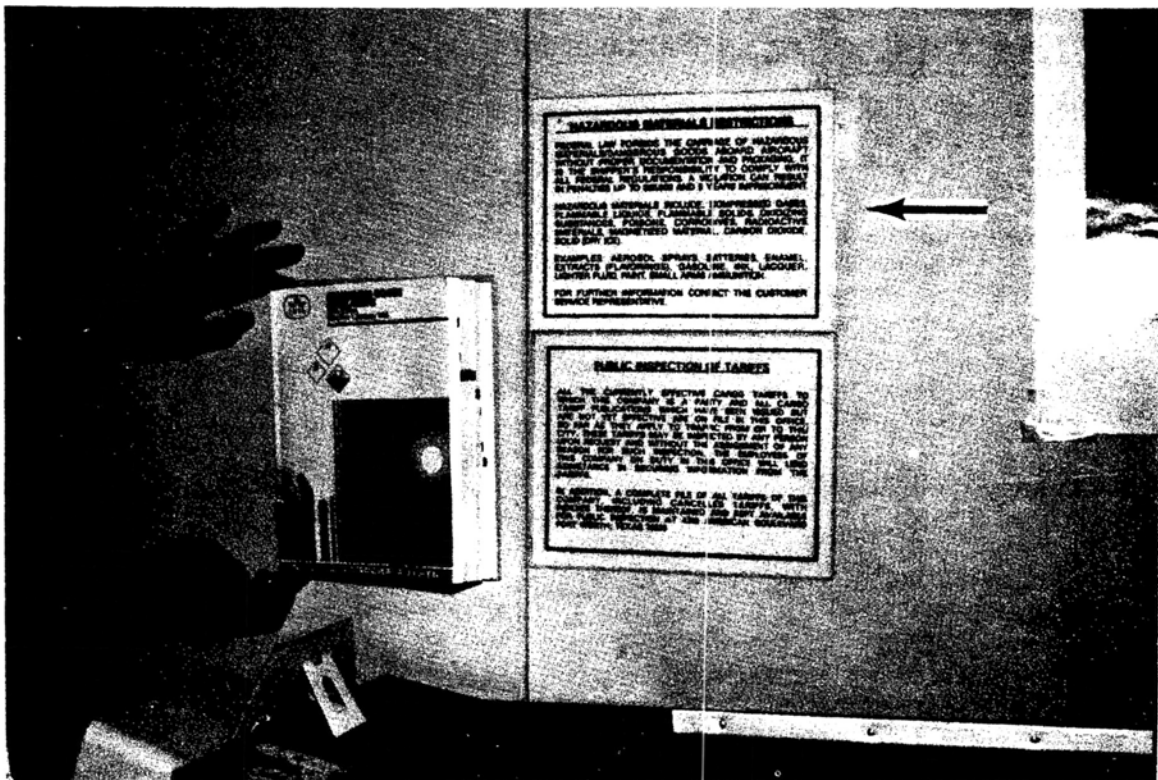
Although not required by the FAA, American Airlines posts a notice in cargo freight offices to warn shippers about hazardous materials restrictions. The notice in the Austin office is approximately 9 inches high by 11 inches wide, the lettering meets minimum size requirements for passenger check-in areas, and it is typical of notices posted throughout the carrier's cargo system. (See figure 7.) The notice is attached to a wall at the end of the customer service counter about eye level, about an arms length away, and on the customer's immediate right (approximately 90°) when the customer faces the freight service clerk behind the counter.

Figure 7.--Hazardous materials restriction notice posted on the wall in the American Airlines air freight office in Austin, Texas.
