Runway collision of Eastern Airlines Boeing 727, Flight 111 and Epps Air Service Beechcraft King Air A100, Atlanta Hartsfield International Airport, Atlanta, Georgia, January 18, 1990

AIRCRAFT ACCIDENT REPORT

RUNWAY COLLISION
OF EASTERN AIRLINES BOEING 727, FLIGHT 111
AND EPPS AIR SERVICE BEECHCRAFT KING AIR A100
ATLANTA HARTSFIELD INTERNATIONAL AIRPORT
ATLANTA, GEORGIA
JANUARY 18, 1990

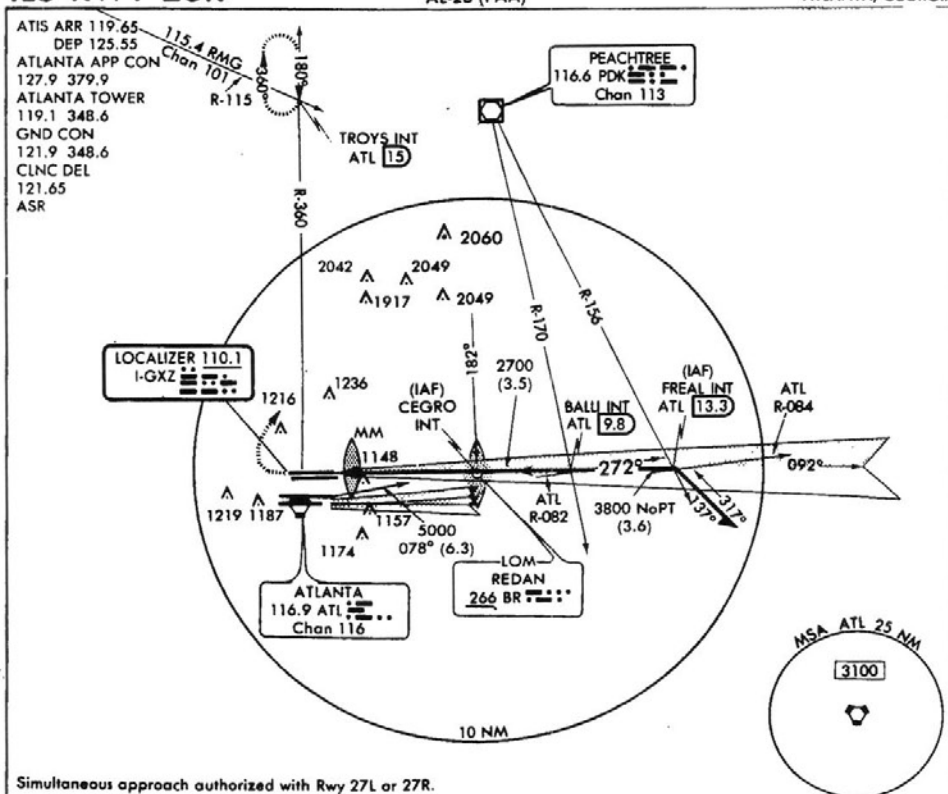
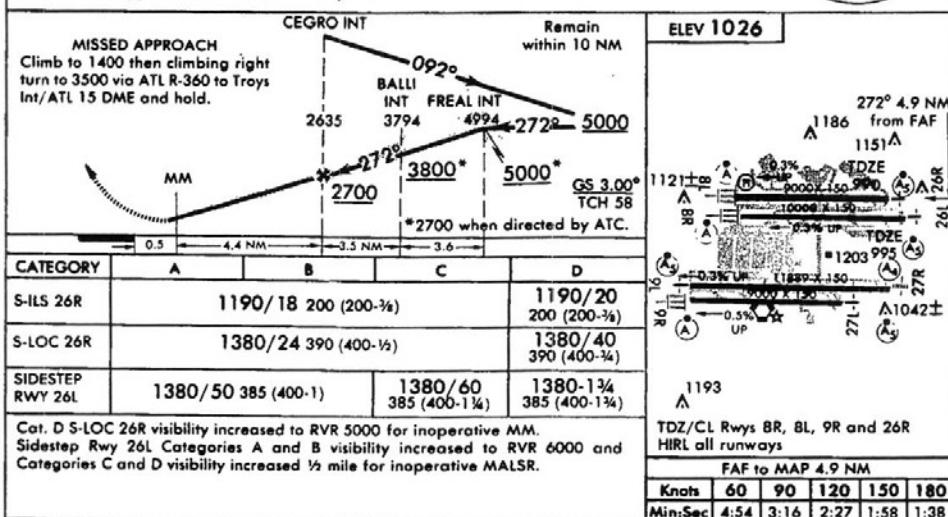
Figure 1.--Approach chart for ILS runway 26 right.

Upon arrival in the Atlanta area, EA 111 was vectored for a final approach and cleared for the Instrument Landing System (ILS) runway 26 right approach at Hartsfield Airport (See figure 1). The captain performed the pilot flying duties.

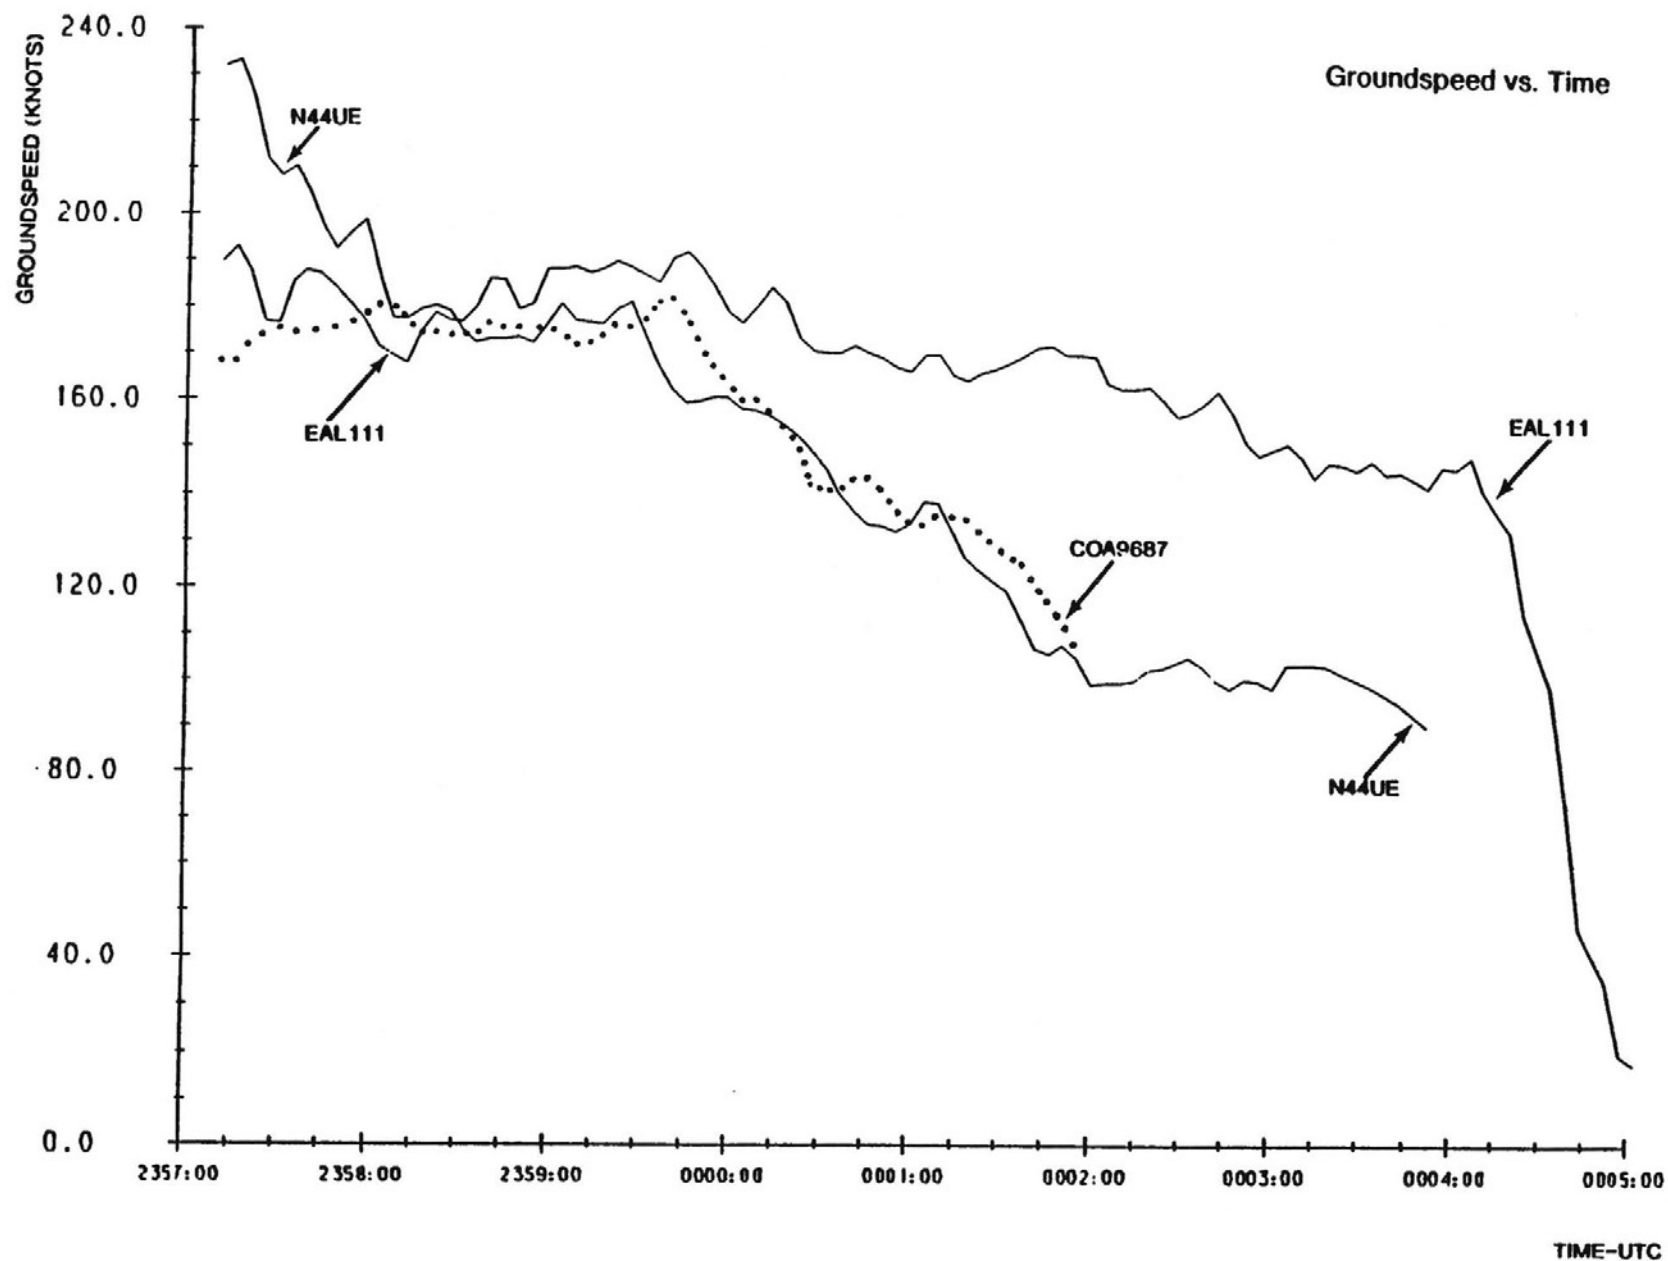
Plots of Calculated Groundspeed as a Function of Time
for EA 111, N44UE and CO 9687.
