Runway Incursion and Collision, Northwest Airlines, Inc. Flights 1482 and 299, Detroit Metropolitan/Wayne County Airport, Romulus, Michigan, December 3, 1990

Investigative Body: National Transportation Safety Board (NTSB), USA

AIRCRAFT ACCIDENT REPORT

**NORTHWEST AIRLINES, INC.
FLIGHTS 1482 AND 299
RUNWAY INCURSION AND COLLISION
DETROIT METROPOLITAN/WAYNE COUNTY AIRPORT
ROMULUS, MICHIGAN
DECEMBER 3, 1990**

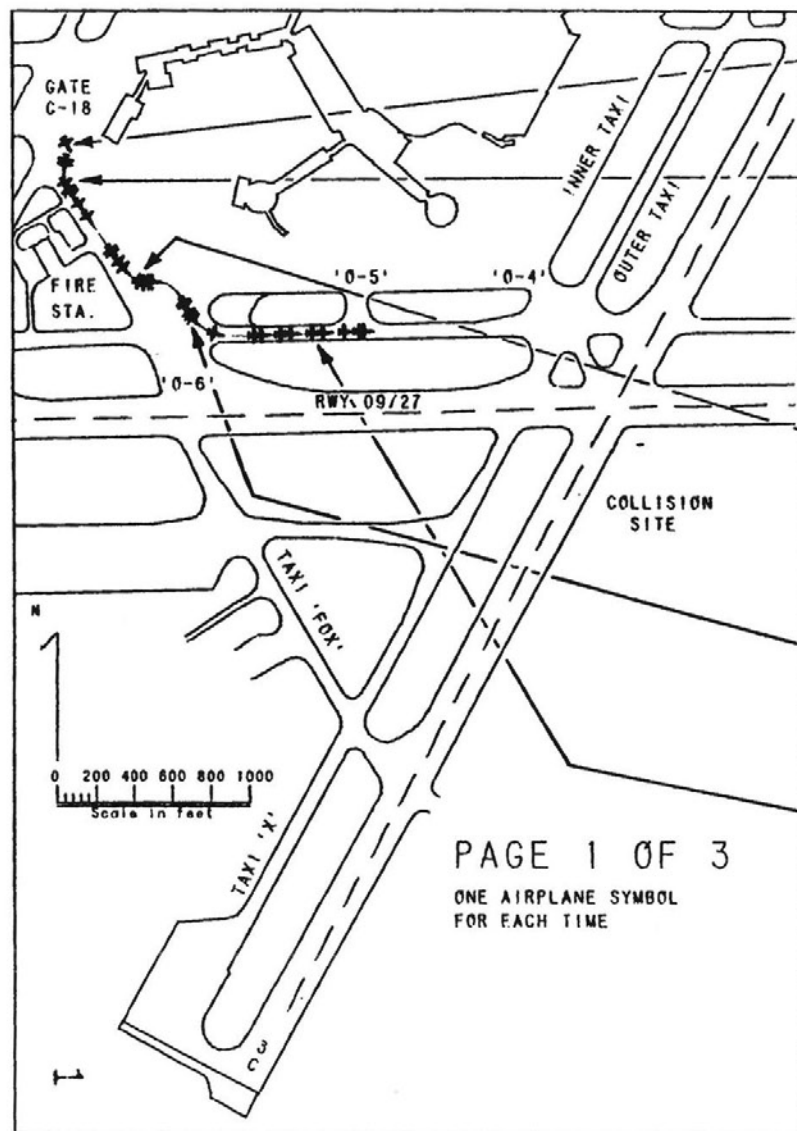
Dialogue from Cockpit Voice Recorder

SELECTED DIALOGUE FROM COCKPIT VOICE RECORDING:

1335:31 GND FOURTEEN EIGHTY TWO RIGHT TURN OUT OF PARKING TAXI
RUNWAY THREE CENTER EXIT RAMP AT OSCAR SIX CONTACT
GROUND NOW ONE ONE NINER POINT FOUR FIVE
1336:33 CAM-1 THAT FOG IS PRETTY BAD HERE.
39 NW299 GROUND NORTHWEST TWO NINETY NINE IS ABEAM OSCAR NINE
1337:02 CAM-2 HEY IT LOOKS LIKE IT'S GOIN' ZERO ZERO OUT THERE.
08 GND WHAT'S YOUR POSITION
09 RDO-2 RIGHT BY THE FIRE STATION.
11 GND ROGER NORTHWEST FOURTEEN EIGHTY TWO TAXI INNER OSCAR
SIX FOX REPORT MAKING THE AH RIGHT TURN ON X-RAY
17 RDO-2 INNER OSCAR SIX TO FOXTROT, REPORT XRAY.
25 CAM-2 * OSCAR SIX, OH THAT PROBABLY THIS ACROSS THAT RUNWAY-
46 CAM-1 SO A LEFT TURN.
48 CAM-2 NEAR AS I CAN TELL. MAN I CAN'T SEE * OUT HERE.
53 CAM-2 THAT'S STILL THE INNER THOUGH THAT WAY.
57 CAM-2 GO THAT WAY.
1338:09 CAM-2 OKAY THERE'S OSCAR SIX RIGHT HERE.
12 CAM-1 OKAY SO WHAT DO WE DO HERE?
13 CAM-2 GO WE TAKE OSCAR SIX TO FOXTROT.
16 CAM-1 RIGHT TURN RIGHT HERE?

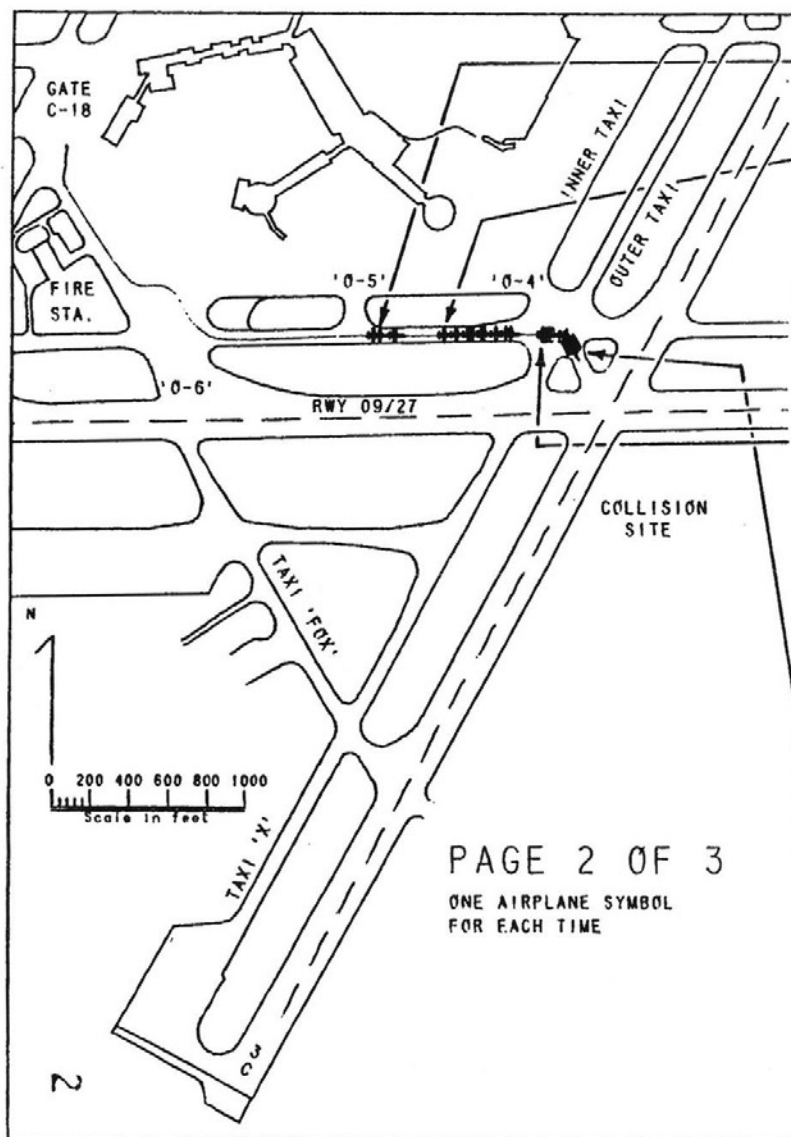
Dialogue from Cockpit Voice Recorder

SELECTED DIALOGUE FROM COCKPIT VOICE RECORDING:

1340:31 RDO-2 OKAY OSCAR FOUR THEN RIGHT ON X-RAY ROGER.
 :34 NW299 NORTHWEST TWO NINETY NINE JUST CLEARED NINE TWO SEVEN ON FOX
 :41 GND NORTHWEST FOURTEEN EIGHTY TWO REPORT AH REPORT
 APPROACHING X-RAY AND FOX
 1341:05 GND NORTHWEST FOURTEEN EIGHTY TWO AT OSCAR FOUR MAKE THE
 RIGHT TURN ON X-RAY AND THEN REPORT CROSSING NINE TWO SEVEN
 :11 RDO-2 ROGER AT AH OSCAR FOUR MAKE THE RIGHT TURN ONTO X-RAY.
 :17 CAM-1 THIS IS NINE TWO SEVEN HUH?
 :19 CAM-2 THAT SAYS X-RAY RIGHT THERE.
 :24 CAM-1 SO WHAT'S HE WANT US TO DO HERE?
 :25 CAM-2 YOU CAN MAKE THE RIGHT TURN HE SAID AND REPORT
 CROSSING TWO SEVEN AND THEN I'LL ASK HIM.
 :31 CAM-2 THERE'S OSCAR FOUR. THIS IS X-RAY.
 :37 RDO-2 AND GROUND AH FOURTEEN EIGHTY TWO DID YOU SAY WE
 WERE CLEARED TO CROSS TWO SEVEN AND NINE.
 :40 GND NORTHWEST FOURTEEN EIGHTY TWO AFFIRMATIVE CROSS NINE TWO SEVEN
 1342:00 CAM-1 THIS THIS A RIGHT TURN HERE JIM?
 :01 CAM-2 THAT'S THE RUNWAY.

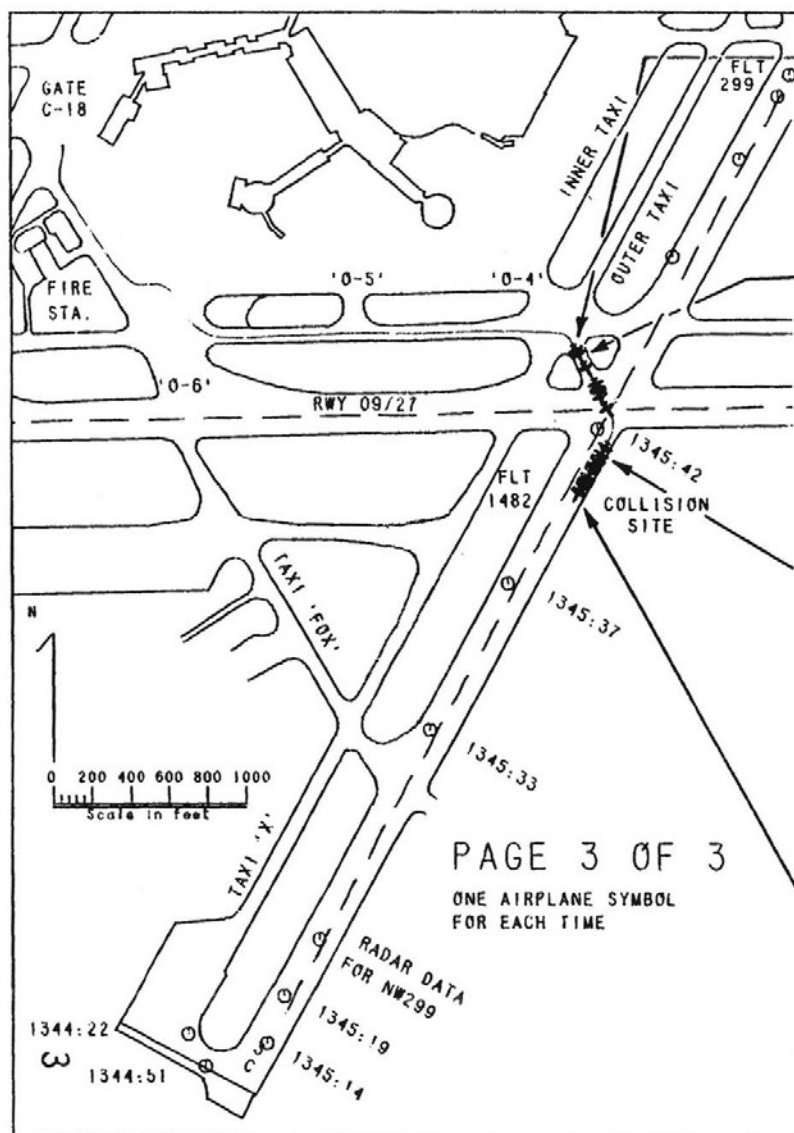
Dialogue from Cockpit Voice Recorder

SELECTED DIALOGUE FROM COCKPIT VOICE RECORDING:

1343:22 CAM-2 IS THERE A TAXIWAY OVER THERE?
 :24 CAM ((SOUND SIMILAR TO PARKING BRAKE BEING SET))
 :24 CAM-1 NAW I DON'T SEE ONE.
 :35 CAM-1 GIVE HIM A CALL AND TELL HIM THAT
 AH WE CAN'T SEE NOTHIN' OUT HERE.
 :45 GND NORTHWEST FOURTEEN EIGHTY TWO GROUND SAY YOUR POSITION
 :48 RDO-2 AH BELIEVE WE'RE AT THE INTERSECTION OF AH
 X-RAY AND AH NINE TWO SEVEN.
 :58 GND X-RAY AND NINE TWO SEVEN OKAY ARE YOU AH SOUTHBOUND
 1344:01 RDO-2 YEAH WE'RE HOLDIN' SHORT OF NINE TWO SEVEN HERE RIGHT NOW.
 :05 GND CROSS NINE TWO SEVEN NORTHWEST FOURTEEN EIGHTY TWO -
 :07 CAM ((SOUND SIMILAR TO PARKING BRAKE RELEASE))
 :15 (ON OTHER FREQUENCY, NW 299 IS CLEARED TO TAKEOFF ON RUNWAY 3C)
 :23 CAM-1 NOW WHAT RUNWAY IS THIS?
 :30 CAM-1 THIS IS A RUNWAY.
 :32 CAM-2 YEAH TURN LEFT OVER THERE.
 :33 CAM-2 NAW THAT'S A RUNWAY TOO.
 :35 CAM-1 WELL TELL HIM WE'RE OUT HERE. WE'RE STUCK.
 :40 CAM-2 THAT'S ZERO NINE.
 :58 GND NORTHWEST FOURTEEN EIGHTY TWO JUST TO VERIFY YOU
