In-Flight Engine Separation, Japan Airlines, Inc., Flight 46E, Boeing 747-121, N473EV, Anchorage, Alaska, March 31, 1993

Investigative Body: National Transportation Safety Board (NTSB), USA

IN-FLIGHT ENGINE SEPARATION
JAPAN AIRLINES, INC., FLIGHT 46E
BOEING 747-121, N473EV
ANCHORAGE, ALASKA
MARCH 31, 1993

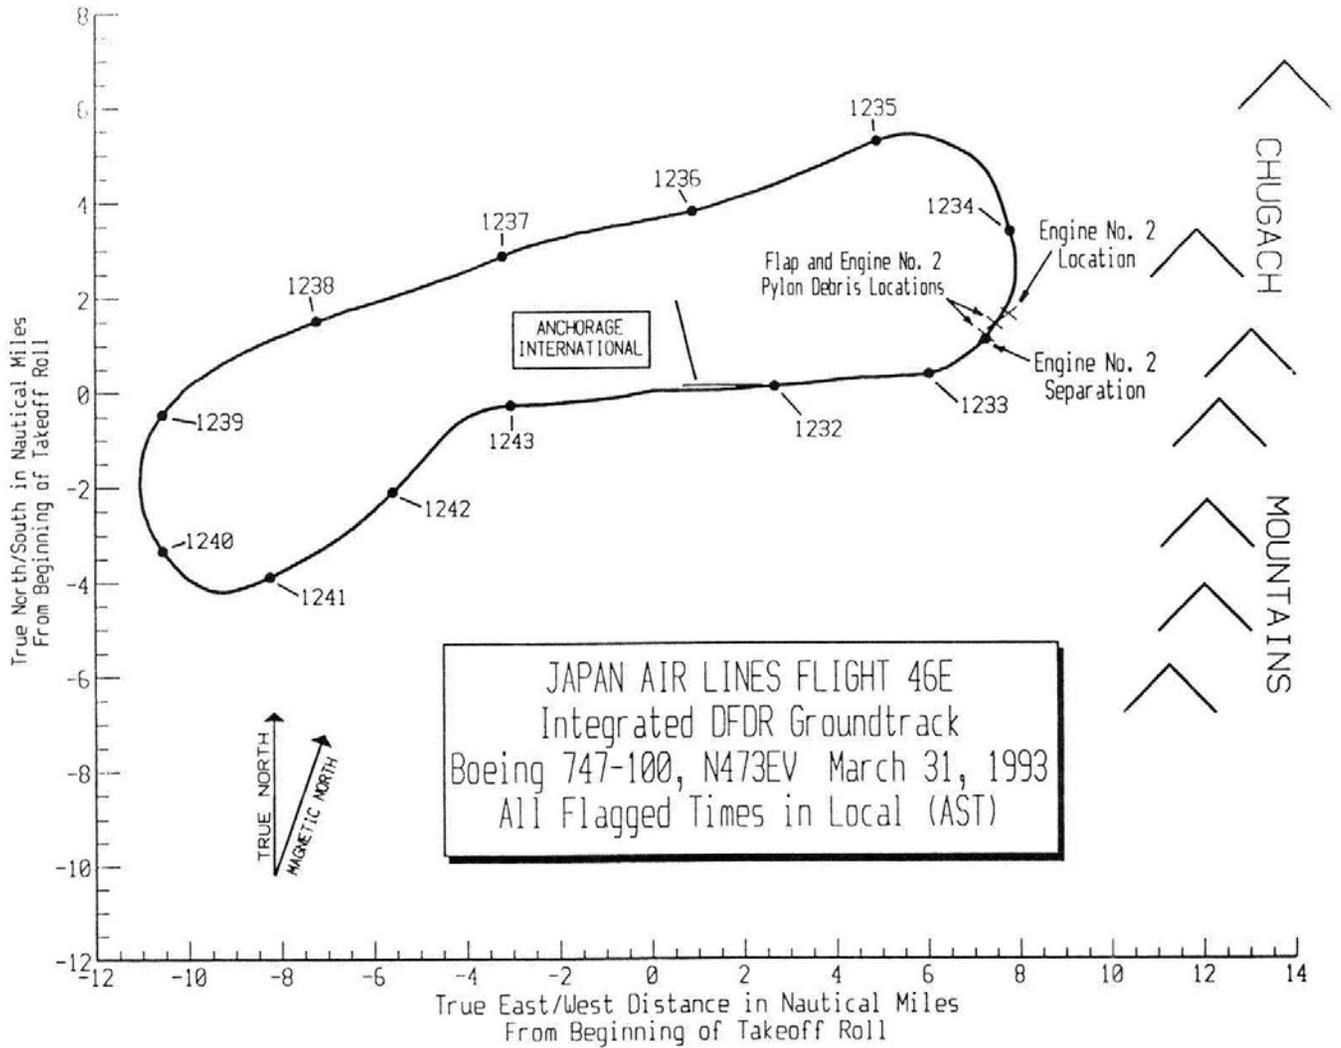
Several private dwellings, automobiles, and landscaping were damaged by the impact of the No. 2 engine and various parts of the engine pylon and wing LEDs. Figure 1 is a diagram of the airplane's flightpath and the wreckage location.

Figure 1.--Flightpath and wreckage location.
