Inadvertent In-Flight Slat Deployment, China Eastern Airlines Flight 583, McDonnell Douglas MD-11, B-2171, 950 Nautical Miles South Of Shemya, Alaska, April 6, 1993

AIRCRAFT ACCIDENT REPORT

INADVERTENT IN-FLIGHT SLAT DEPLOYMENT
CHINA EASTERN AIRLINES FLIGHT 583
McDONNELL DOUGLAS MD-11, B-2171
950 NAUTICAL MILES SOUTH OF SHEMYA, ALASKA
APRIL 6, 1993

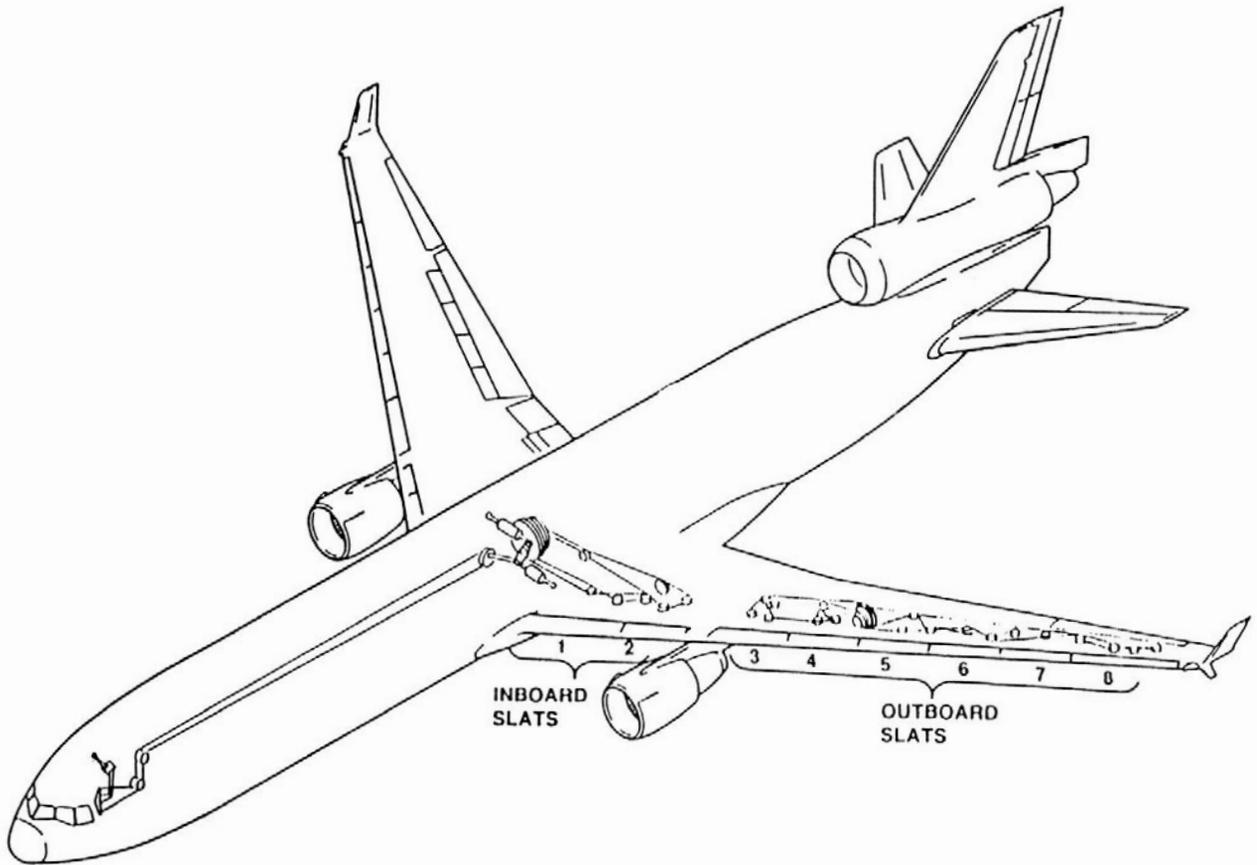
Figure 1.--Slat cable system.

The flap/slat handle moves a closed-loop control cable system (see figure 1) to operate the inboard slat control valve. The inboard slat control valve supplies hydraulic pressure to two inboard slat actuators. These actuators rotate the inboard cable drive drum to extend or retract the inboard slats. As the inboard slats extend or retract, follow-up cables and mechanical linkages move the outboard slat control valve.

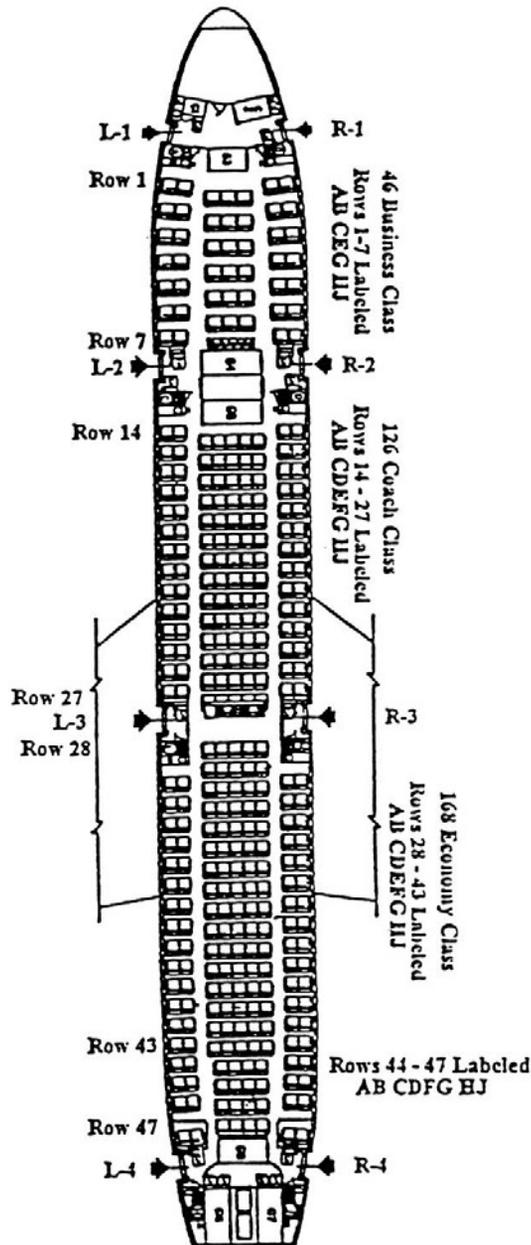
Figure 6.--Passenger cabin configuration.

The passenger cabin was configured for 46 business and 294 coach class seats. (See figure 6).
