## Runway Overrun During Landing, American Airlines Flight 1420, McDonnell Douglas MD-82, N215AA, Little Rock, Arkansas, June 1, 1999

## AIRCRAFT ACCIDENT REPORT

RUNWAY OVERRUN DURING LANDING  
AMERICAN AIRLINES FLIGHT 1420  
MCDONNELL DOUGLAS MD-82, N215AA  
LITTLE ROCK, ARKANSAS  
JUNE 1, 1999

**NTSB/AAR-01/02  
PB2001-910402  
Notation 7195A  
Adopted October 23, 2001**

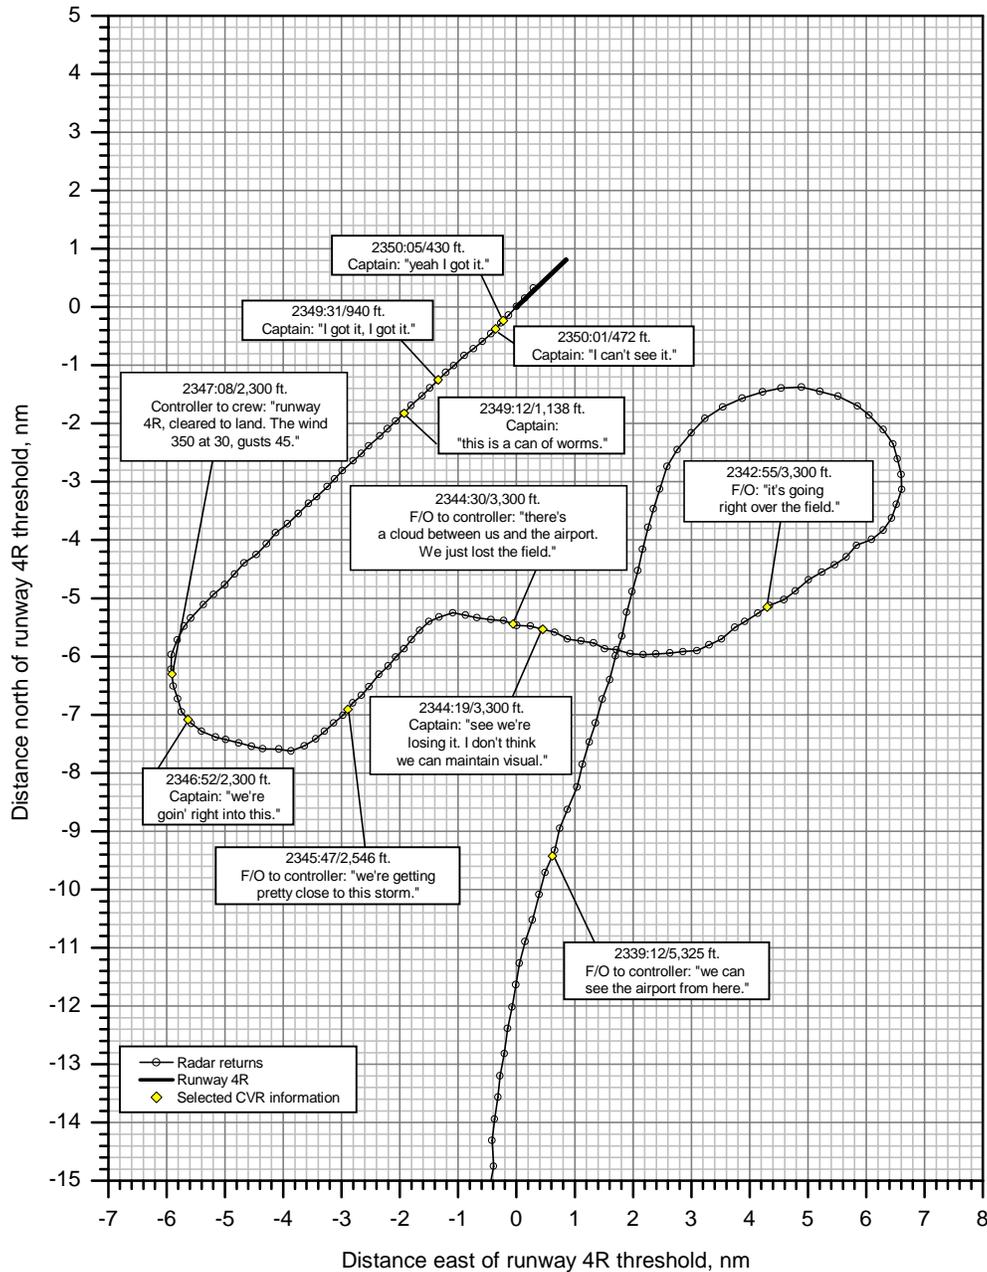
**Figure 1.** Flight 1420's Approach Path to the Airport and Key CVR Comments

The CVR indicated that, at 2350:00, the first officer said, "we're way off." Flight data recorder (FDR) information indicated that the localizer deviation value was about one dot to the right at that point.<sup>18</sup> About 1 second later, the captain stated, "I can't see it." About 3 seconds afterward, the first officer asked, "got it?" to which the captain replied, "yeah I got it." At 2350:13 and :14, the CVR recorded the sound of the ground proximity warning system (GPWS) radio altitude callout "sink rate."<sup>19</sup> Calculations based on FDR data indicated that the airplane was descending through an altitude of about 70 feet afl at the time of the first sink rate warning and about 50 feet afl at the time of the second warning. Figure 1 shows flight 1420's flightpath to Little Rock and runway 4R along with key CVR comments and the airplane's location when the comments were made.

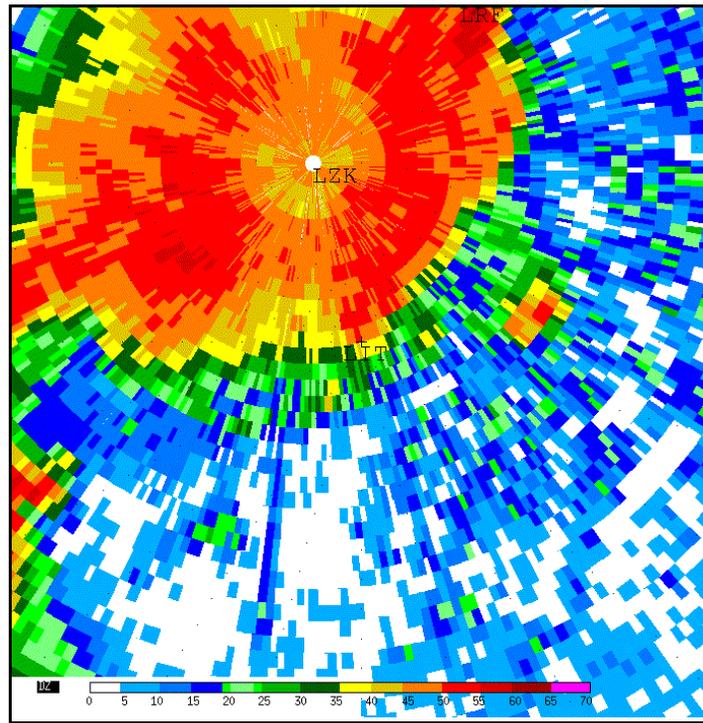
Figure 7. 0.4° Base Reflectivity Scan at 2334:27

The WSR-88D's base reflectivity images provided the radar reflectivities at the individual elevation scans. The images documented the line of thunderstorms moving across the Little Rock airport area during flight 1420's approach. The WSR-88D 0.4° elevation scan of base reflectivity that was completed at 2334:27 depicted reflectivities of 50 dBz, or NWS level 5 (intense) activity over the northwest section of the airport. By 2340:28, the 0.4° base reflectivity image depicted a large area of activity over the airport with reflectivities of 45 dBz, or level 4 (very strong) activity, and greater. The two strongest areas of activity were located approximately 5 miles west-northwest and northeast at this time. Another area of activity located approximately 3 miles southwest of Little Rock was beginning to move toward the east-southeast with reflectivities reaching 54 dBz, or level 6 (extreme) activity. Figures 7 and 8 show the base reflectivity products for 2334:27 and 2340:28, respectively.

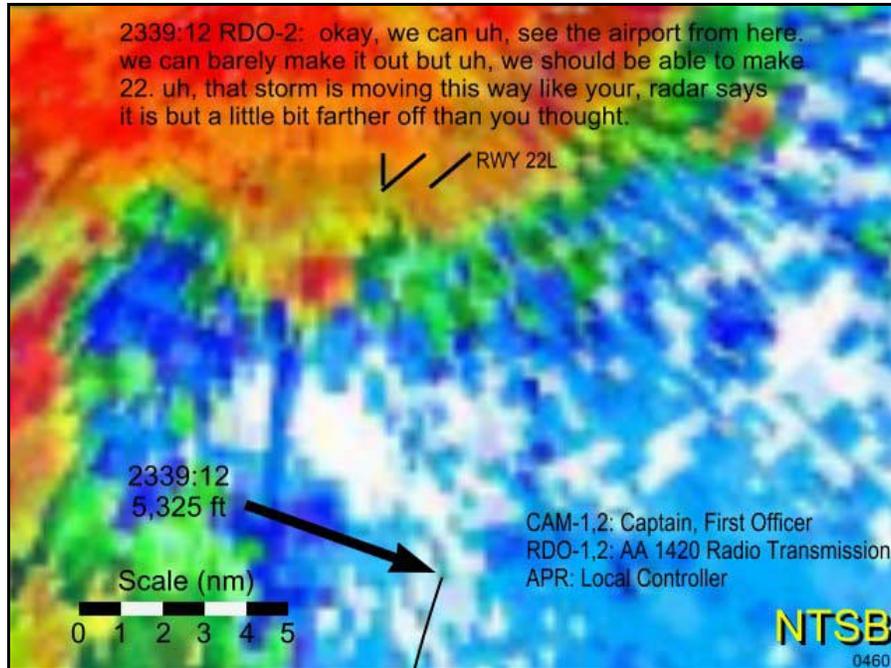
**Figure 18.** Weather and Flight Information for 2339:12

American’s policy did not prohibit flight crews from continuing an approach with thunderstorms in the terminal area as long as the crews ensured that their intended route was clear of the thunderstorms. During the descent into the terminal area, there was no evidence to indicate that the route was not clear. In public hearing testimony, the first officer stated that, during the descent, the weather was to the left and moving off to the right and that the airport looked clear. Thus, the Safety Board concludes that, during the

descent into the terminal area, the flight crewmembers could have reasonably believed that they could reach the airport before the thunderstorm.

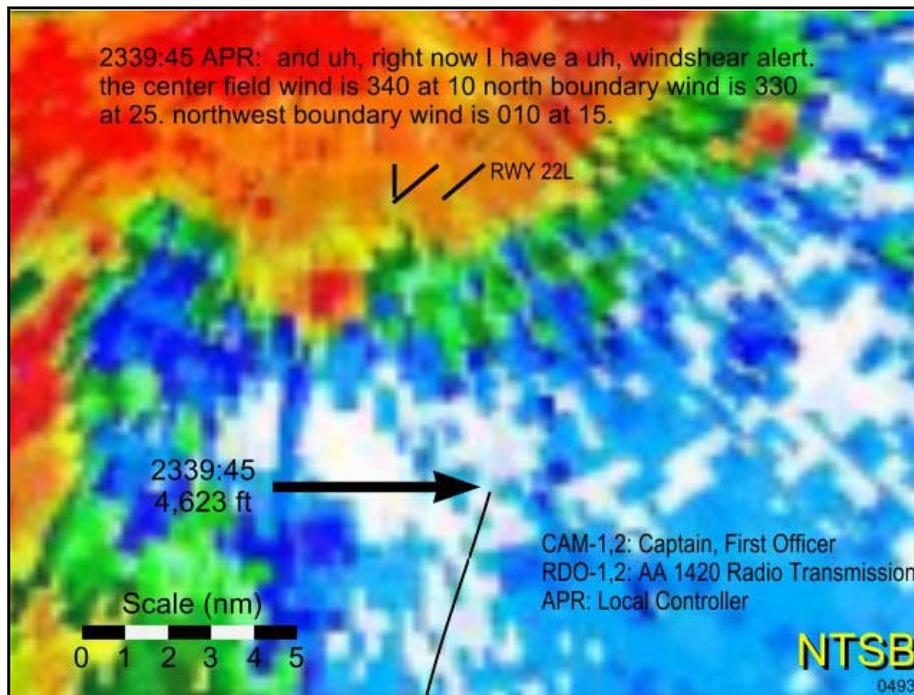
**Figure 19.** Weather and Flight Information for 2339:45

The flight crewmembers had been previously told by the controller to expect an instrument landing system (ILS) approach to runway 22L. At 2339:45, the local controller broadcast the first of two windshear alerts, reporting that the centerfield wind was 340° at 10 knots.<sup>178</sup> At this point, the airplane was about 8 miles from the airport. Afterward, the flight crew requested a change in runways from 22L to 4R because the winds had shifted to the northwest. The use of runway 22L could have resulted in a tailwind at the time of landing, so runway 4R was a more appropriate choice because of the expectation of a headwind. (NWS radar data indicated that the leading edge of a line of thunderstorms was over the airport at this time with the heaviest activity located northwest through northeast 5 miles from the runway.)<sup>179</sup> Figure 19 shows a map of the weather conditions at 2339:45 and flight 1420's location.

<sup>178</sup> The windshear alert also indicated that the north boundary wind was 330° at 25 knots and that the northwest boundary wind was 010° at 15 knots.

<sup>179</sup> The leading edge is one of the most hazardous areas in thunderstorms because of the updraft-downdraft interaction.

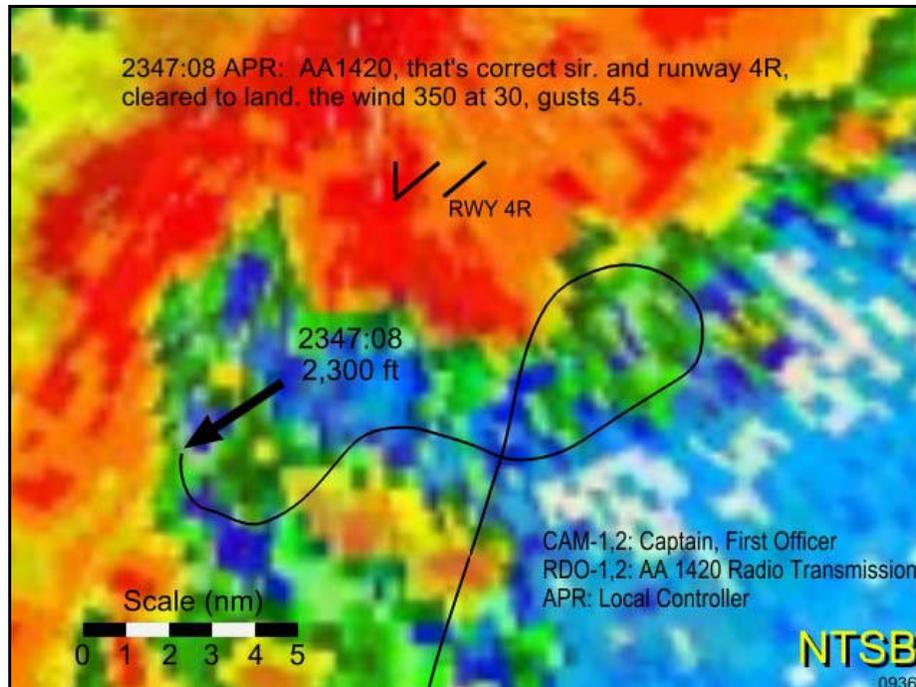
**Figure 24.** Weather and Flight Information for 2347:08

At 2347:08, the controller cleared flight 1420 to land and stated that the wind was 350° at 30 knots gusting to 45 knots. The CVR indicated that flight crew did not discuss the wind information, the heavy rain that was already falling at the airport, or the depiction of the weather on the airborne weather radar. Figure 24 shows a map of the weather conditions at 2347:08 and flight 1420’s location.

Statements from the CVR and the first officer’s postaccident interviews indicated the flight crew’s concern about the location of the thunderstorm in relation to the airport and the airplane. However, the Safety Board concludes that, because the first officer was able to maintain visual contact with the runway as the airplane was vectored for the final approach course, both flight crewmembers might still have believed that flight 1420 could arrive at the airport before the thunderstorm. The Board understands that some other flight crews might continue an approach to a runway under the same circumstances. On the other hand, the Board also recognizes that the approaching storm and the reports of heavy rain, dropping visibility, and increasing crosswinds (from 10 to 30 knots with

gusts to 45 knots) would be sufficient for some flight crews to hold until the storm passed or proceed to an alternate airport.

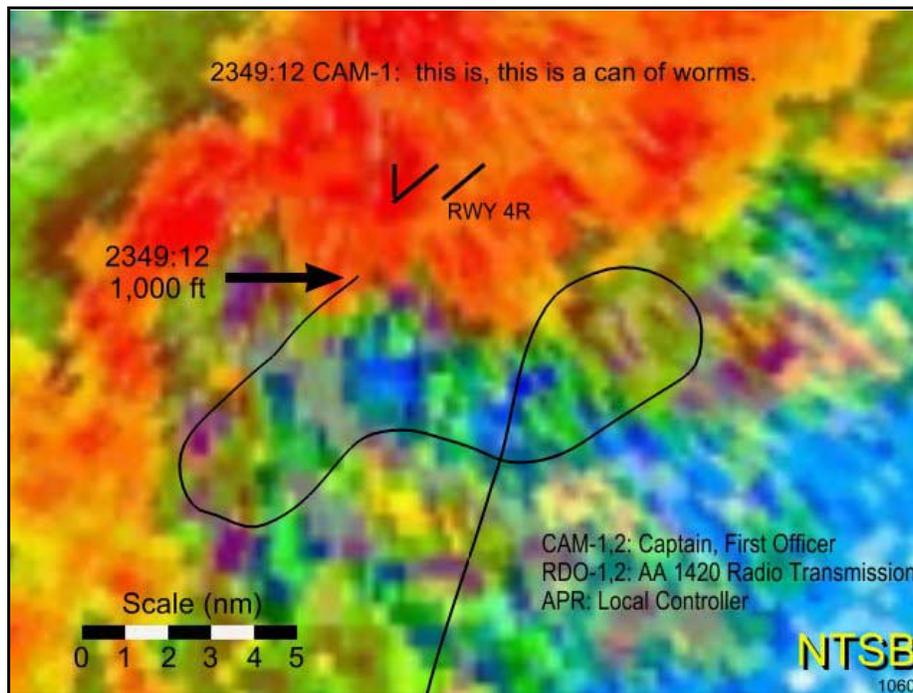
**Figure 25.** Weather and Flight Information for 2349:12

At 2349:10, the controller indicated that the winds were 330° at 28 knots. About 2 seconds later, the captain stated, “...this is a can of worms.” FDR data indicated that the airplane was about 1,140 feet msl (880 feet afl) at this time and that the captain was making active control inputs to keep the airplane on the localizer and glideslope. Also, the FDR data showing fluctuating airspeed ( $\pm 5$  knots, with one excursion to +8 knots and one to -10 knots) and vertical acceleration ( $\pm 0.2$  G with occasional excursions to  $\pm 0.25$  G)<sup>186</sup> were consistent with the presence of gusty and turbulent winds. Figure 25 shows a map of the weather conditions at 2349:12 and flight 1420’s location.

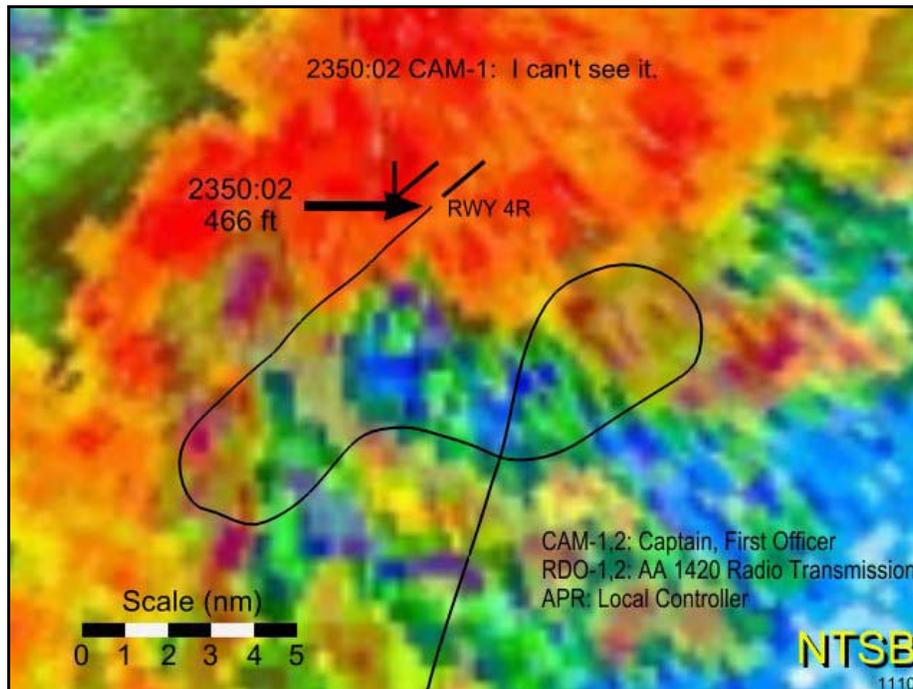
**Figure 26.** Weather and Flight Information for 2350:02

At 2350:02, the captain stated, "I can't see it." Calculations based on FDR data indicated that the airplane was between 5 and 20 feet above the decision height at that time. The Safety Board was not able to determine whether the captain's comment referred to his loss of visual contact with the runway or with its environment. Figure 26 shows a map of the weather conditions at 2350:02 and flight 1420's location.
