## **In-flight upset, EgyptAir Flight 990, Boeing 767-366ER, SU-GAP, 60 Miles South of Nantucket, Massachusetts, October 31, 1999**

PB2002-910401  
NTSB/AAB-02/01  
DCA00MA006

## **Aircraft Accident Brief**

**EgyptAir Flight 990  
Boeing 767-366ER, SU-GAP  
60 Miles South of Nantucket, Massachusetts  
October 31, 1999**

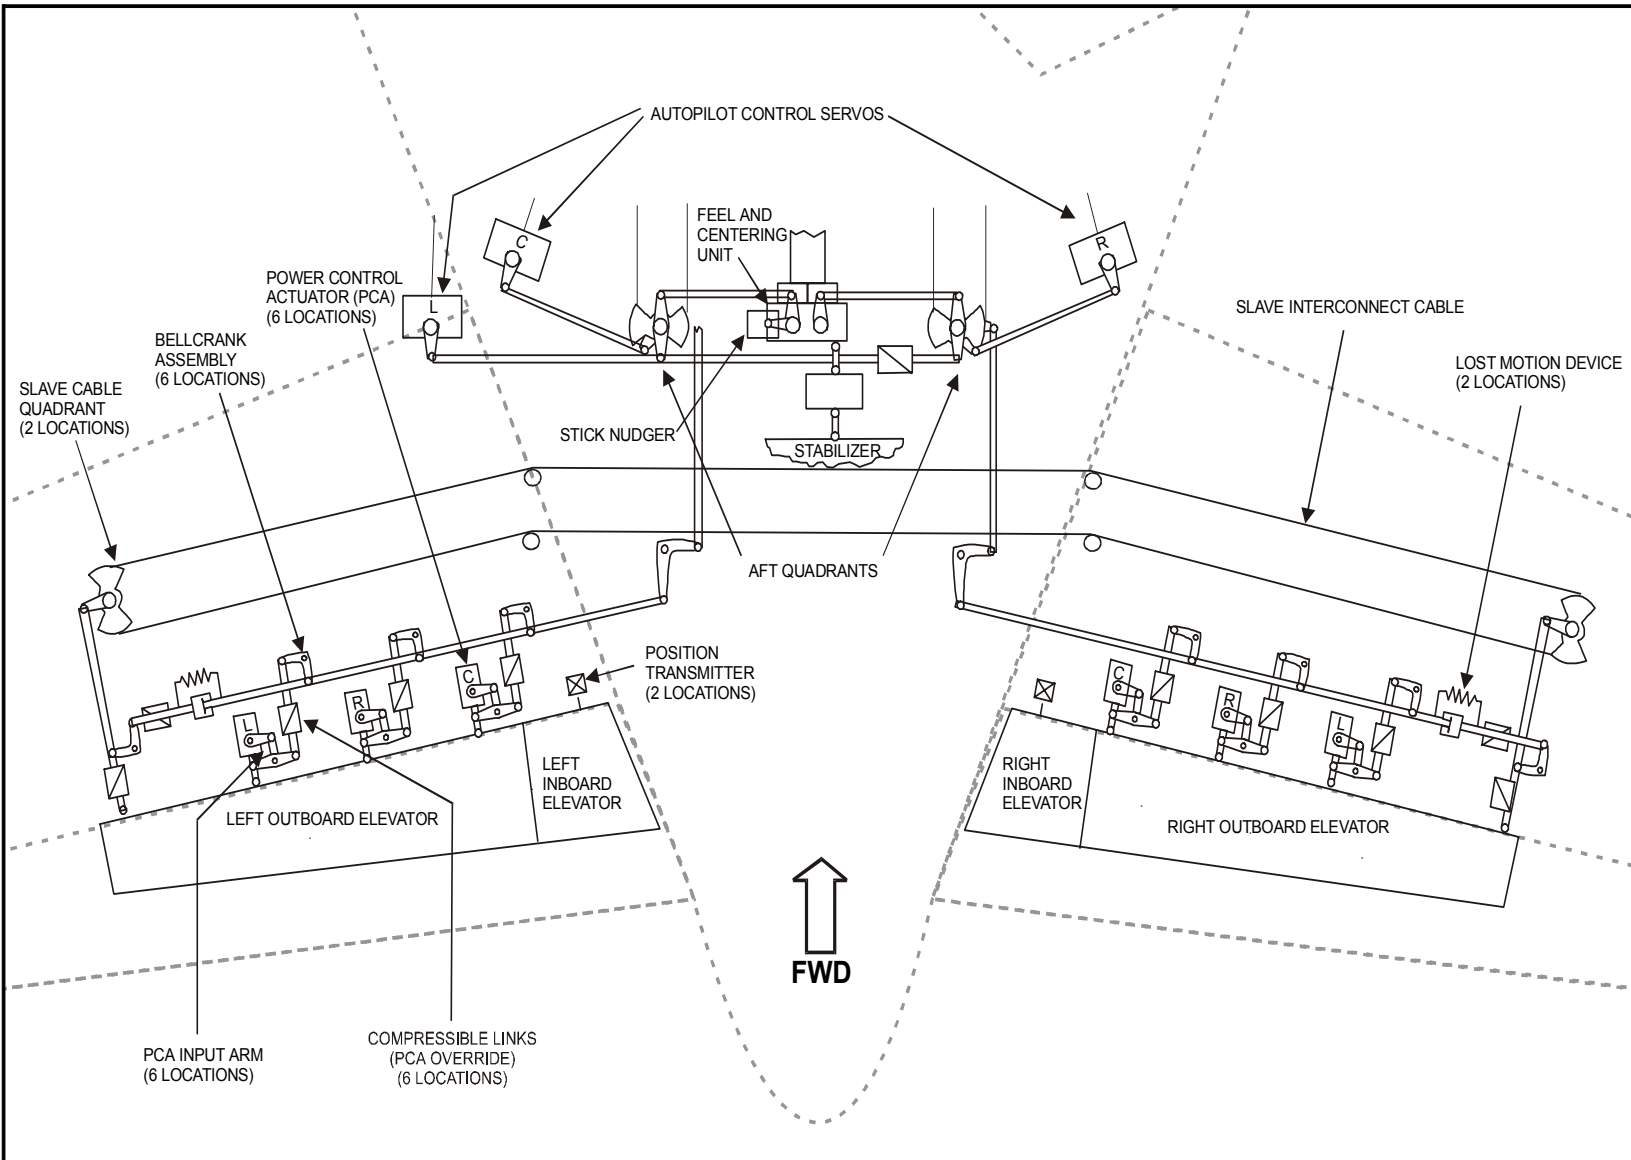
Figure 1b. Diagram of the aft 767 elevator control system components.

Because the accident sequence involved a sustained unusual motion about the airplane's pitch axis, the Safety Board examined the 767's longitudinal flight control system. According to the Boeing 767 Maintenance Manual, the 767's longitudinal flight control system includes two (left and right) sets of linked elevator surfaces (inboard and outboard), which are attached to the rear spar of the movable horizontal stabilizer by hinges. Each outboard elevator surface is driven by three power control actuators (PCA). Because the outboard and inboard surfaces are linked, the inboard elevator surfaces move when the outboard elevator surfaces are driven. Hydraulic power for elevator PCA movement is provided by the 767's three independent hydraulic systems—each hydraulic system powers one of each elevator surface's PCAs, which provides redundancy within the elevator control system. (Components in the elevator control system are shown in figures 1a and 1b.)
