## Loss of Control and Impact with Pacific Ocean, Alaska, Airlines Flight 261, McDonnell Douglas MD-83, N963AS, About 2.7 Miles North of Anacapa Island, California, January 31, 2000

**Investigative Body:** National Transportation Safety Board (NTSB), USA

**NTSB/AAR-02/01  
PB2002-910402  
Notation 7263E  
Adopted December 30, 2002**

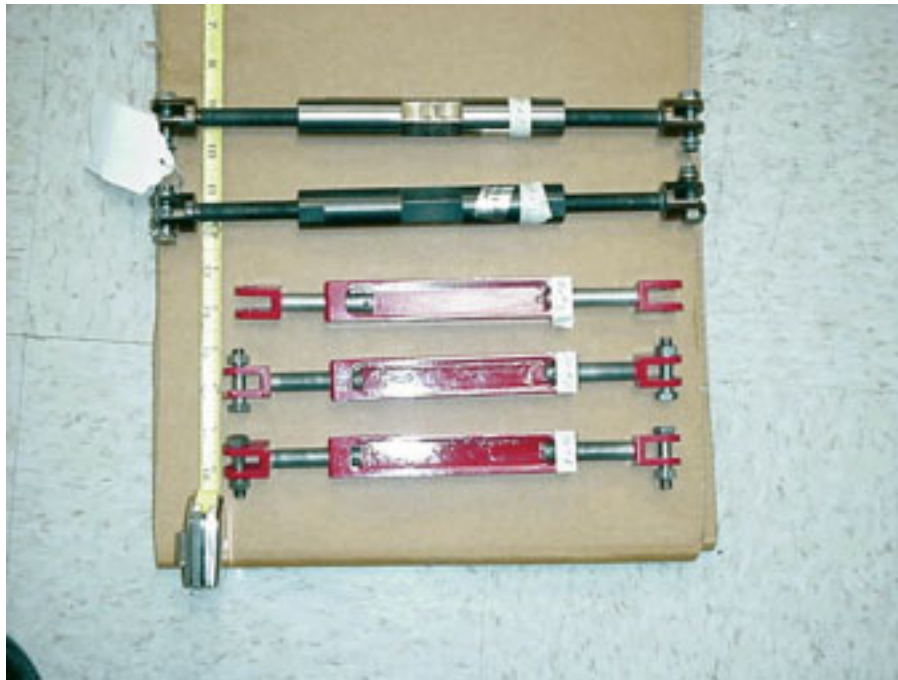
**Figure 10.** Two Alaska Airlines-fabricated restraining fixtures and three Boeing-manufactured fixtures.

During the investigation, Safety Board investigators conducted several on-wing end play checks using both restraining fixtures fabricated by Alaska Airlines<sup>90</sup> and those manufactured by Boeing. Examination of the restraining fixtures indicated that none of the fixtures manufactured by Alaska Airlines met Boeing’s engineering drawing requirements for the fixtures. During several of these tests, the restraining fixtures fabricated by Alaska Airlines yielded lower end play measurements than the measurements obtained using the Boeing-manufactured fixture.<sup>91</sup> Figure 10 shows two of the restraining fixtures fabricated by Alaska Airlines and three of the fixtures manufactured by Boeing.

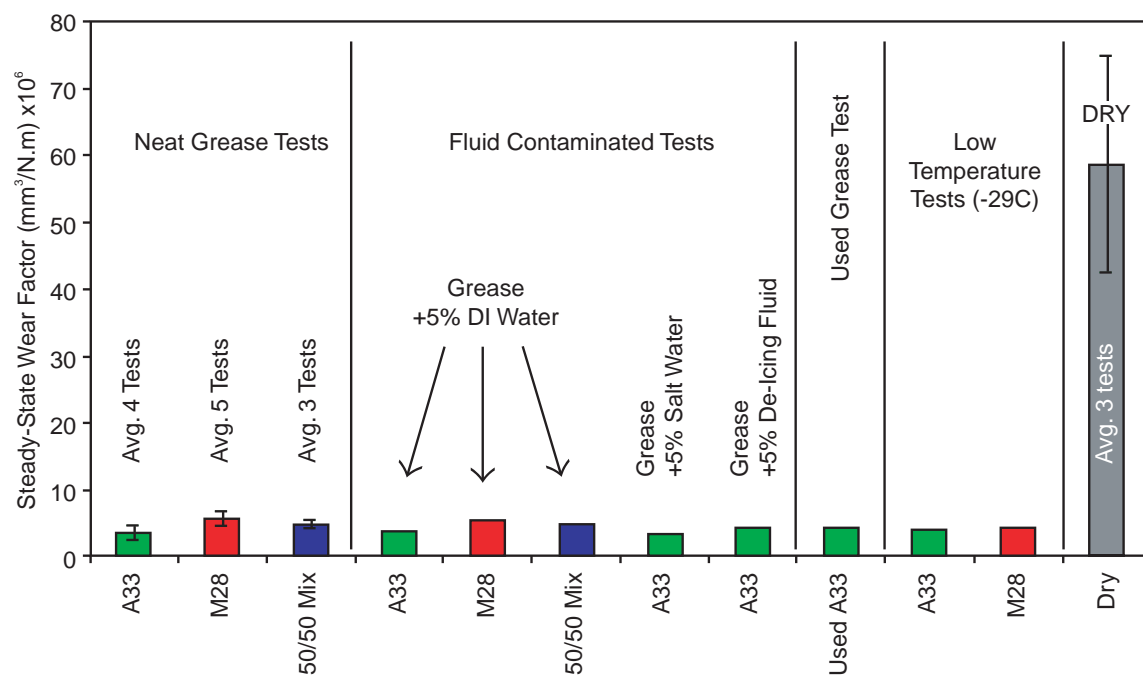
**Figure 19.** A summary of the results of the high-load wear tests, including the contamination and low-temperature tests.

The results of the wear tests showed that, in all ranges of contact pressure, lower wear rates were generated when Aeroshell 33 was used than when Mobilgrease 28 was used. Additionally, the effects of contamination, aging, and subzero temperature exposure were determined to have little effect on the lubricating effectiveness of Aeroshell 33. Only the tests run without any lubrication generated wear rates significantly higher than those generated when Mobilgrease 28 was used. In these cases, wear rates were seen to transition up to 10 times higher than those with equivalent conditions lubricated with Mobilgrease 28. Figure 19 shows a summary of the results of the high-load wear tests, including the contamination and low-temperature tests.
