In-Flight Separation of Vertical Stabilizer, American Airlines Flight 587, Airbus Industrie A300-605R, N14053, Belle Harbor, New York, November 12, 2001

Micro-summary: The vertical stabilizer of this Airbus A300 separated from the airplane shortly after takeoff, resulting in the loss of the airplane.

Investigative Body: National Transportation Safety Board (NTSB), USA

NTSB/AAR-04/04

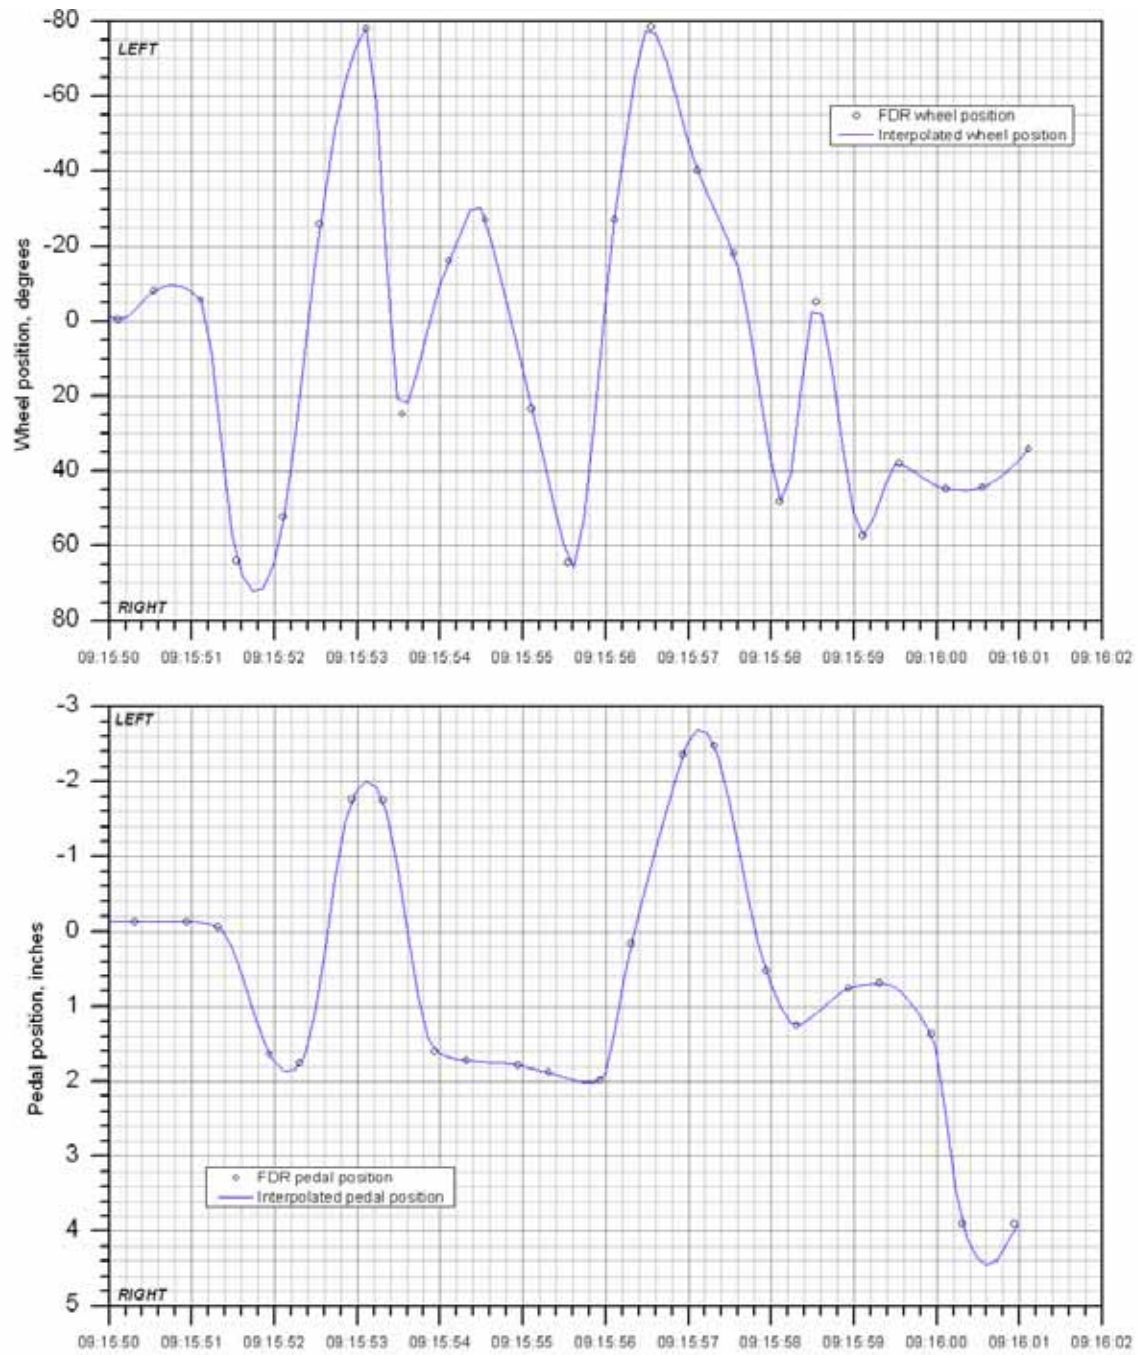
Figure 1. Control Wheel and Rudder Pedal Movements During the Second Wake Encounter

According to the FDR, the rudder pedals moved from 1.7 inches right to 1.7 inches left, 1.7 inches right, 2.0 inches right, 2.4 inches left, and 1.3 inches right between 0915:52 and 0915:58.5.¹⁸ Also, the FDR showed that the control wheel moved 64° to the right at 0915:51.5, 78° (full) to the left at 0915:53.5, 64° to the right at 0915:55.5, and 78° to the left at 0915:56.5.¹⁹ Figure 1 shows these cockpit control movements.

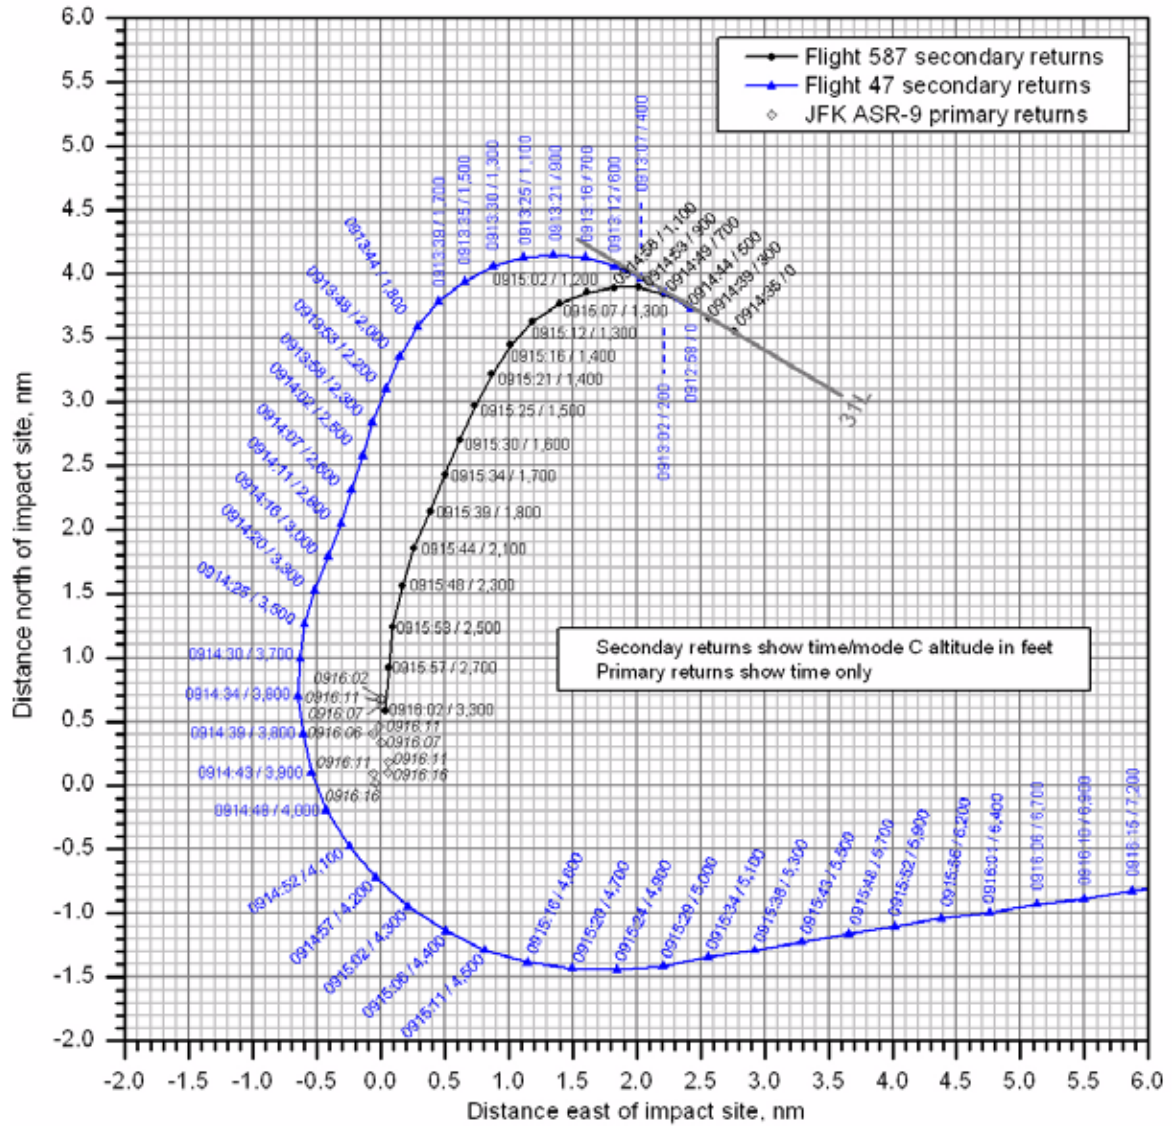
Figure 2. American Airlines Flight 587 and Japan Air Lines Flight 47 Flightpaths

Figures 2 and 3 show flight 587's radar track based on JFK Airport Surveillance Radar-9 (ASR-9) information. Figure 2 shows flight 587's flightpath, from takeoff to impact, in relation to the flightpath for Japan Air Lines flight 47, and figure 3 shows flight 587's flightpath overlaid on a topographical map, along with key events.

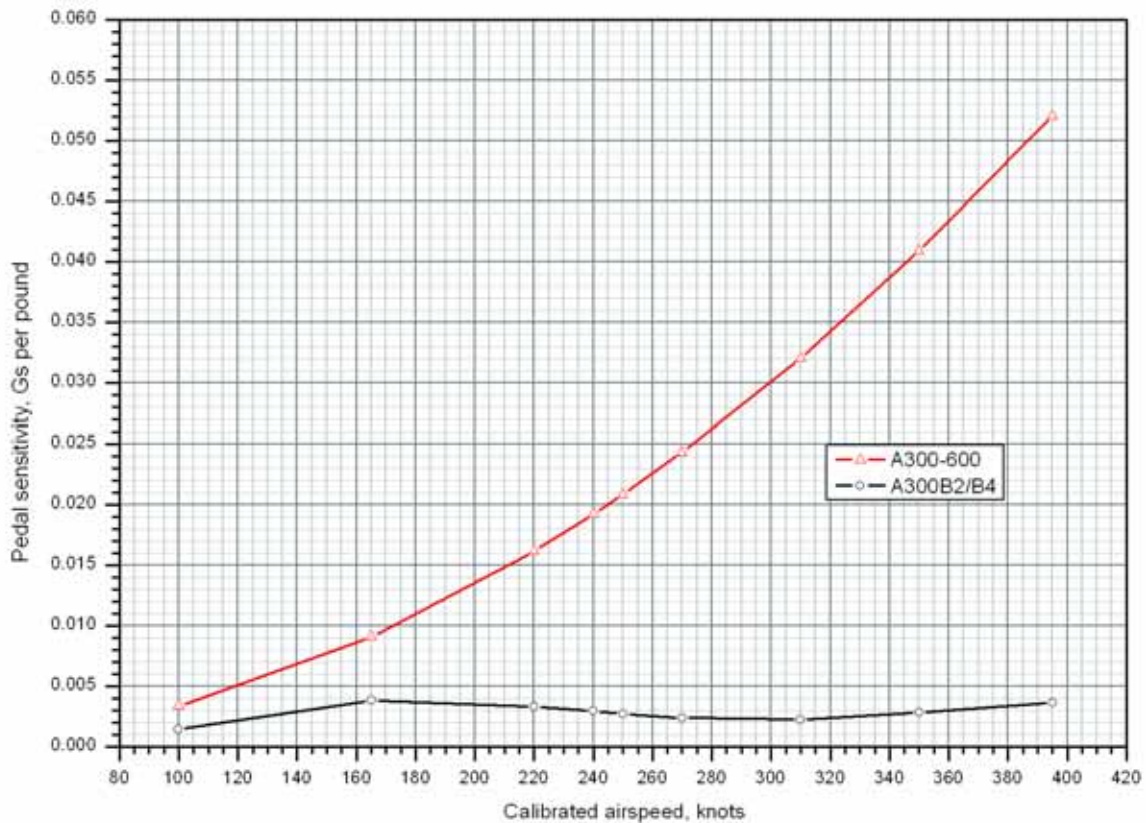
Figure 8. A300-600 and A300B2/B4 Rudder Pedal Sensitivities

The sensitivity of the rudder pedals, measured in this way, is proportional to the square of the airplane's airspeed, the amount of rudder deflection per pedal deflection, and the amount of pedal deflection per pedal force. With either variable ratio or variable stop rudder control systems, the amount of pedal deflection per pedal force remains constant. For airplanes with variable ratio systems, as airspeed increases, the amount of rudder deflection per pedal deflection decreases, which offsets the effect of increasing airspeed and keeps the pedal sensitivity relatively constant. For airplanes with variable stop

systems (such as the A300-600), the rudder deflection per pedal deflection remains constant, so the sensitivity of the pedals increases with the square of the airspeed. These characteristics are illustrated in figure 8, which compares the A300-600 and A300B2/B4 rudder pedal sensitivities as a function of airspeed and shows that the A300-600 is twice as responsive to a pedal displacement at 250 knots KCAS than at 165 KCAS.

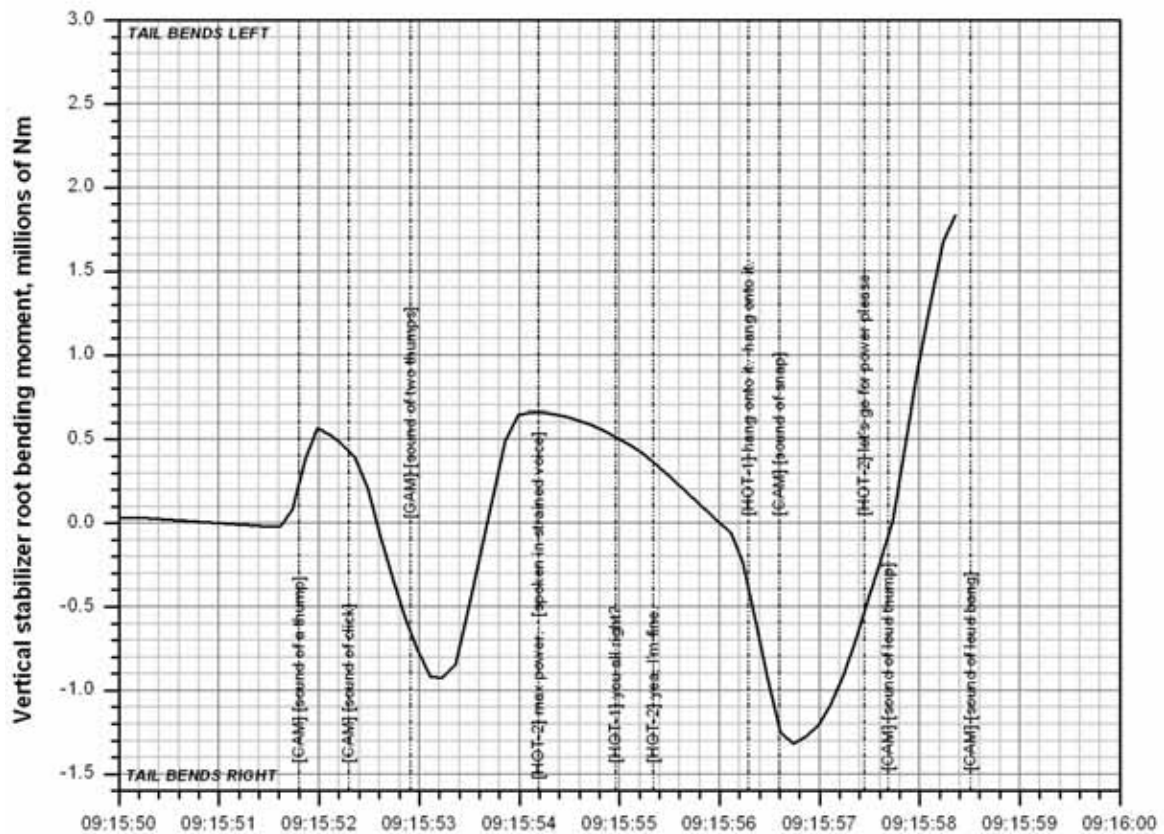
Figure 13. Bending Moment About the Root Chord in the Vertical Stabilizer Axis System

At any given altitude and airspeed, many parameters affect the loads on the vertical stabilizer;⁹⁸ the most significant of these parameters are sideslip angle and rudder angle. During the design of the A300-600, Airbus developed a model of the loads on the vertical stabilizer based on linearized wind tunnel data that described the effects of sideslip angle and rudder angle on the vertical stabilizer structural loads. With the use of this linear loads model, the Safety Board calculated the shear, bending, and torsion loads on the vertical stabilizer during the final seconds of flight 587's recorded FDR data (before the sound of the loud bang at 0915:58.5). Figure 13 shows the calculated bending moment about the root chord in the vertical stabilizer axis system.⁹⁹

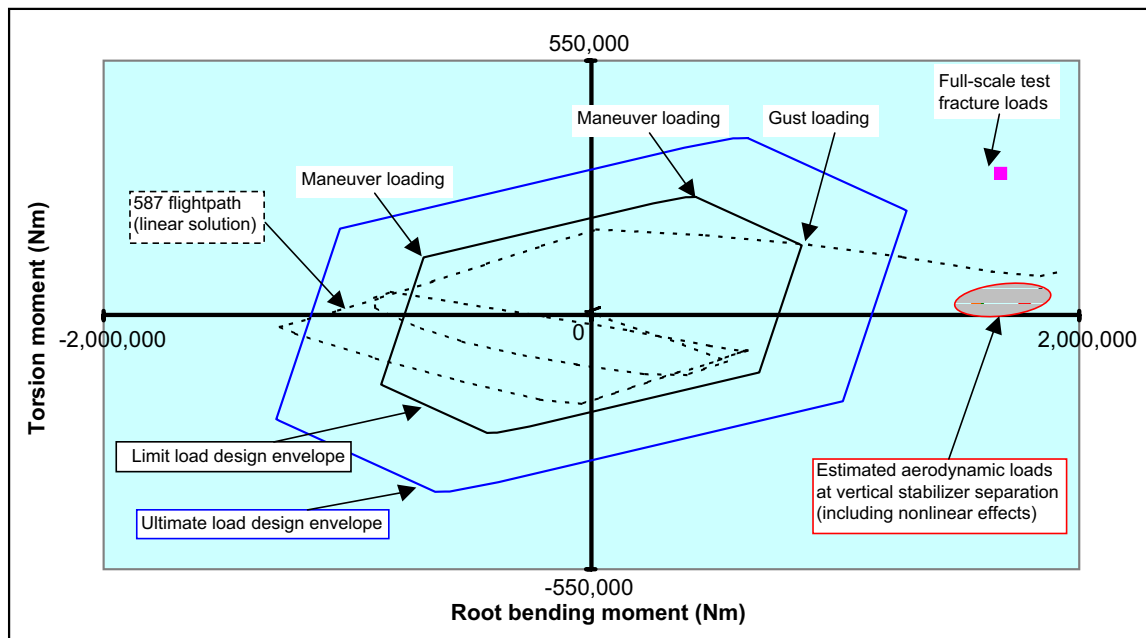
Figure 15. Estimated Aerodynamic Loads in Relation to the Torsion Versus Bending Correlated Shear Force Diagram

The bending moment load ranges shown in figure 14 are presented along with the “effective sideslip angle” range¹⁰¹ and the rudder range at the time that the vertical stabilizer separated from the airplane. Figure 15 compares the estimated aerodynamic loads with the A300-600 design envelopes (as defined by the torsion versus bending correlated shear force diagram).

Note: The four triangles correspond to the four points in figure 14. Specifically, the red triangle is point A, the gray triangle is point B, the green triangle is point C, and the orange triangle is point D.

Safety Board investigators conducted an airplane performance study to describe the motion of the accident airplane, identify the causes of the motion, and calculate the resulting aerodynamic loading on the vertical stabilizer.¹⁷⁷ The airplane performance study revealed that the first officer's cyclic rudder pedal inputs, which began about 7 seconds before the vertical stabilizer separation, led to increasing sideslip angles that, along with the continued rudder deflections, produced extremely high aerodynamic loads on the vertical stabilizer. The airplane performance study indicated that, at 0915:58.4, when the vertical stabilizer separation began, the aerodynamic loads on the vertical stabilizer were about two times the loads defined by the limit load design envelope (see figure 15).¹⁷⁸

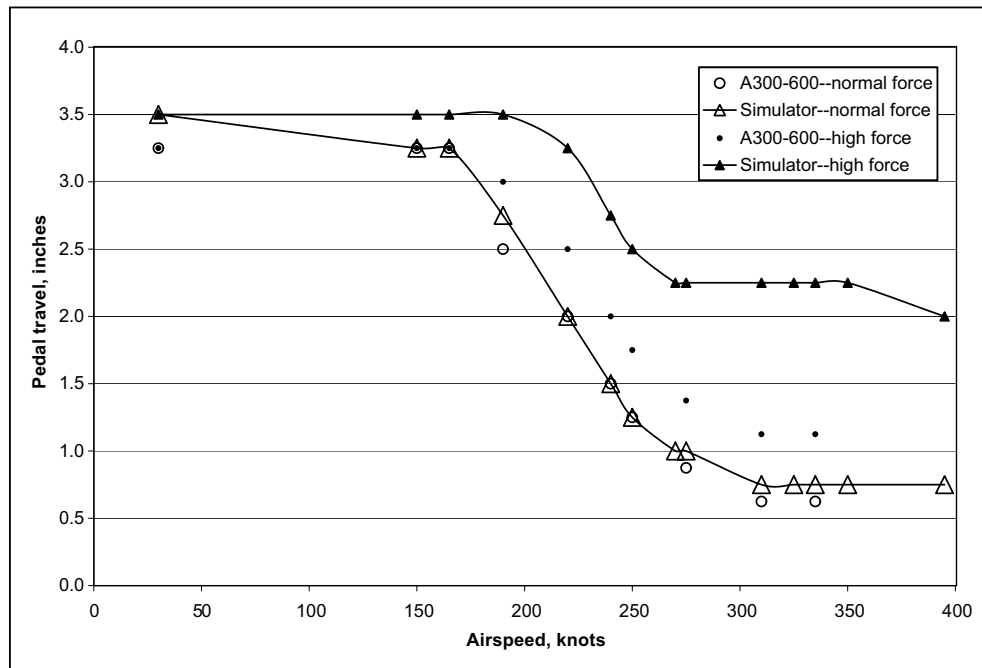
Figure 18. Rudder Pedal Motion With Normal and High Pilot Pedal Force in the A300-600 Airplane and the American Airlines A310/300 Training Simulator

From January 31 to February 2, 2002, Safety Board investigators performed tests on an American Airlines A300-600 airplane at American's maintenance facility in Tulsa. With the assistance of an American Airlines representative, the investigators measured rudder pedal limits at different airspeeds (30, 150, 165, 190, 220, 240, 250, 275, 310, and 335 knots), the travel of the control wheel, and the dimensions of the wheel. To measure the pedal limits, an investigator sat in the left cockpit seat and pushed the left pedal until the stop was contacted (normal force) while another investigator in the right cockpit seat recorded the actual pedal motion. The investigator in the left cockpit seat then pushed the left pedal as hard as he could (high force), and the actual pedal motion was again recorded.

Safety Board investigators repeated these tests on April 23, 2003, in the American Airlines A310/300 training simulator. With the assistance of two American Airlines representatives, the investigators assessed how the portrayal of rudder pedal characteristics in the simulator compared with those of the actual A300-600 airplane. The investigators found that the rudder pedal motion in the simulator and the airplane produced by normal and high pilot input forces resulted in different pedal displacements despite the pedal travel limits, as shown in figure 18. The differences were attributed to the software representation of the elastic cable stretch in the simulator, which was less stiff than the cable stretch on the A300-600 airplane.
