## Runway incursion between Airbus A321-211, G-SMTJ and Boeing 737-2E7, EI-CJI

**Micro-summary:** This Airbus A321 aborted its takeoff when a Boeing 737 crossed the runway ahead of it.

## Airbus A321-211, G-SMTJ and Boeing 737-2E7, EI-CJI

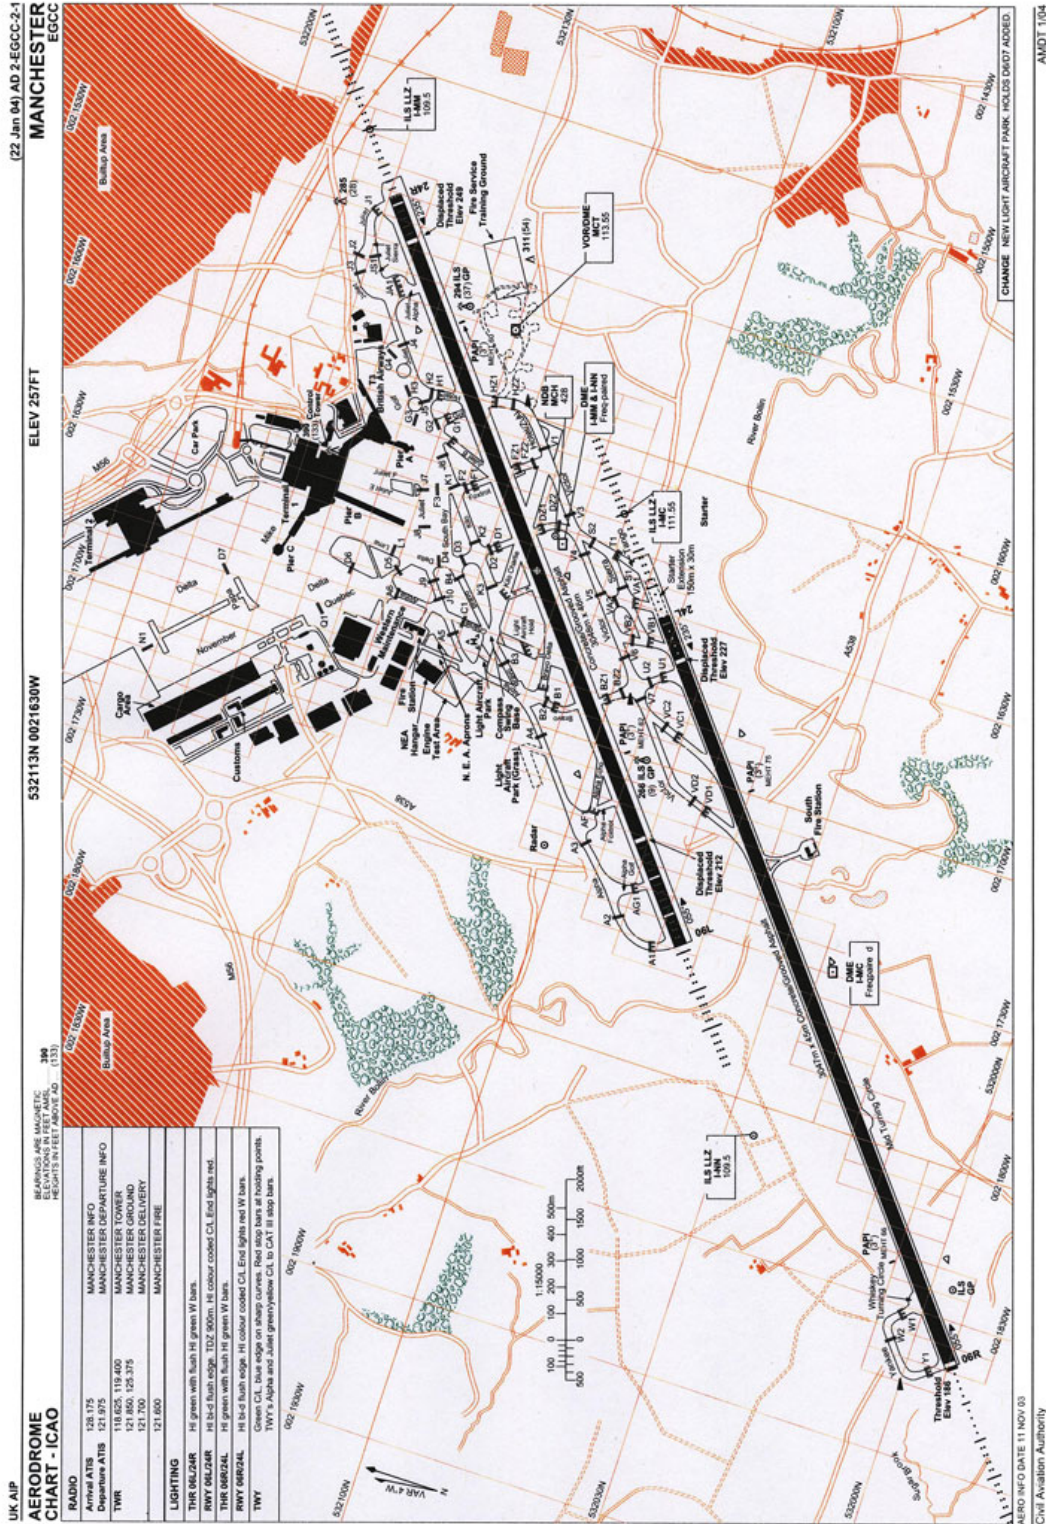
### **Figure 1 Manchester Airport**

On the morning of 29 February 2004, Manchester Airport had been using 'Segregated Operations' on both runways since 0645 hrs. This involved using Runway 06L for takeoff and Runway 06R for landing. Each runway had a controller using a dedicated VHF frequency. The two controllers were seated adjacent to each other in the Visual Control Room atop the 'Tower' and faced south towards the runways; 'Air 1', on the left, was controlling Runway 06L and 'Air 2' was controlling Runway 06R. Another controller, 'Ground Movement Control' (GMC) was seated at a desk behind them. 'GMC' had responsibility for the control of aircraft between the parking stands and Runway 06L and used a third discrete radio frequency. These controllers were part of a complete 'Watch' on duty in Air Traffic Control. A map of Manchester Airport is included at Appendix 1.
