**Contact with powerlines on takeoff, Continental Air Lines, Inc., Boeing 727-224, N32725 Tucson, Arizona June 3, 1977**

## **AIRCRAFT ACCIDENT REPORT**

**CONTINENTAL AIR LINES, INC.,  
BOEING 727-224, N32725  
TUSCON, ARIZONA  
JUNE 3, 1977**

**REPORT NUMBER: NTSB-AAR-78-9**

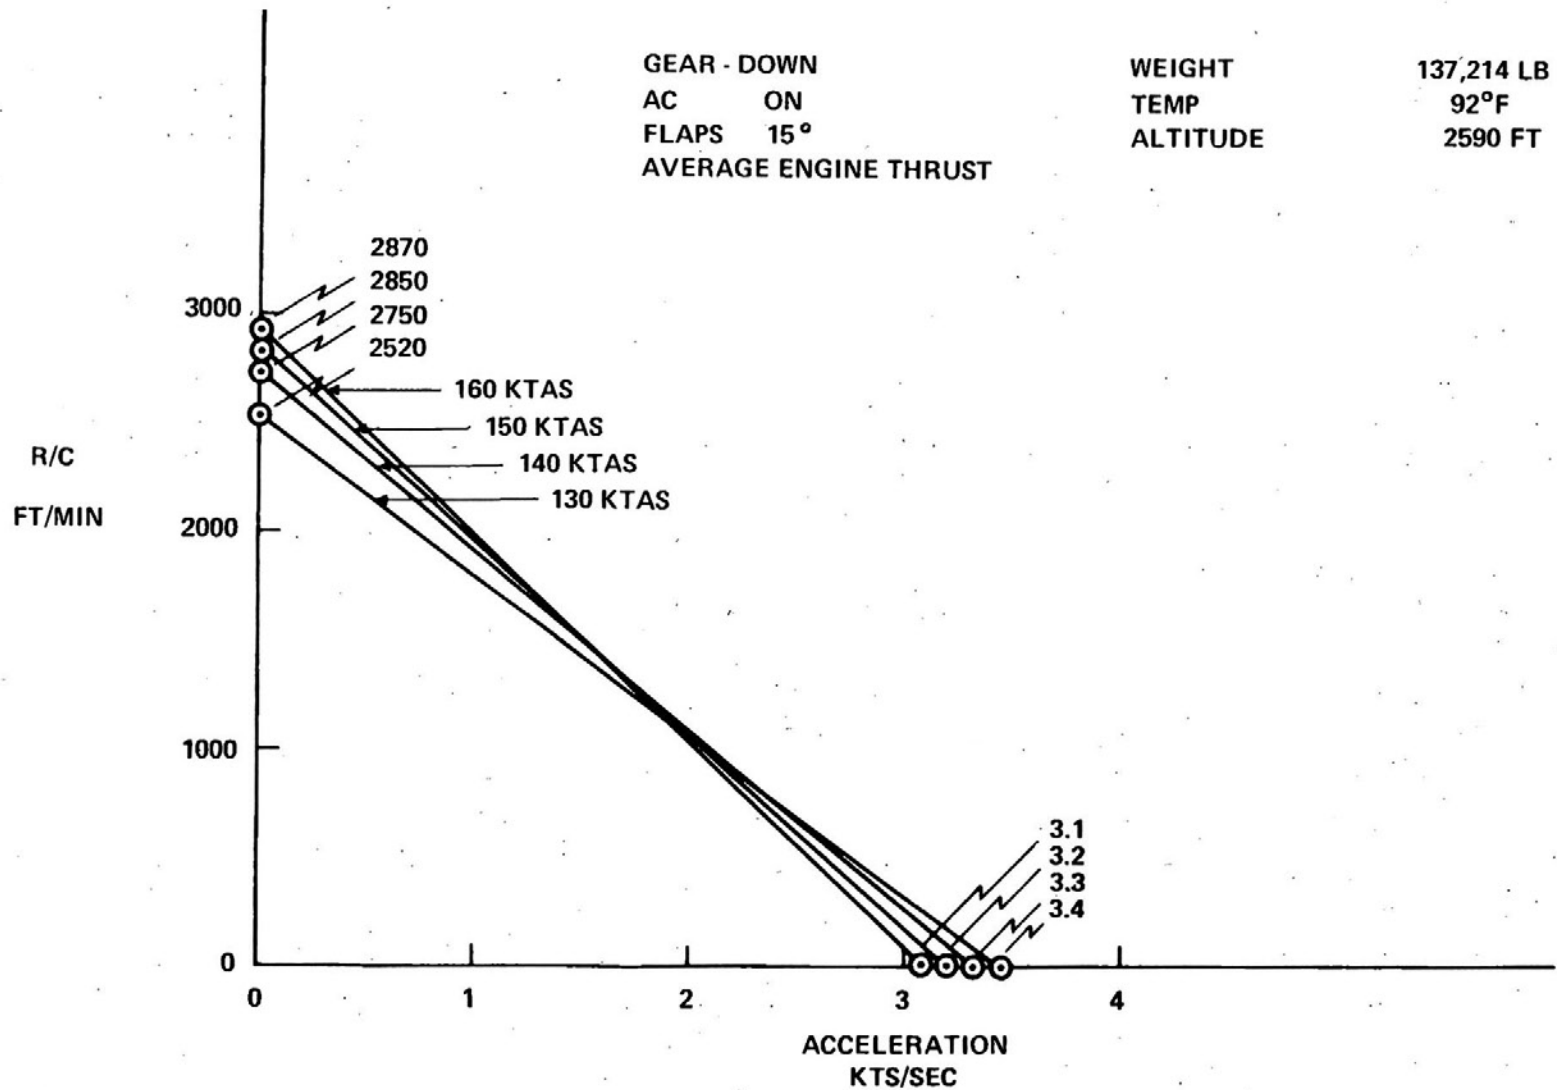
Figure 1. Acceleration vs rate of climb in ground effect Boeing 727-224.

Although the Board does not believe there were significant vertical winds affecting Flight 63 at 30 ft a.g.l., additional calculations were performed to explore the possibility that Flight 63 could have successfully flown through an even more severe total wind effect than that recorded by the FDR. Calculations were made for the two flight profiles previously described in which, in addition to the total wind effect recorded by the FDR, (assumed to be all horizontal winds), strong vertical downdrafts were also assumed to be present.
