**Control problems in icing, Serious incident occurring 14 December 1998, 15 km westlich Cottbus, to Aerospatale-Alenia/ATR 42-300.**

**Micro-summary: This ATR 42-300 experienced flight control difficulties in icing conditions.**

**Investigative Body: Federal Bureau of Aircraft Accidents Investigation (BFU), Germany**

# Final Report

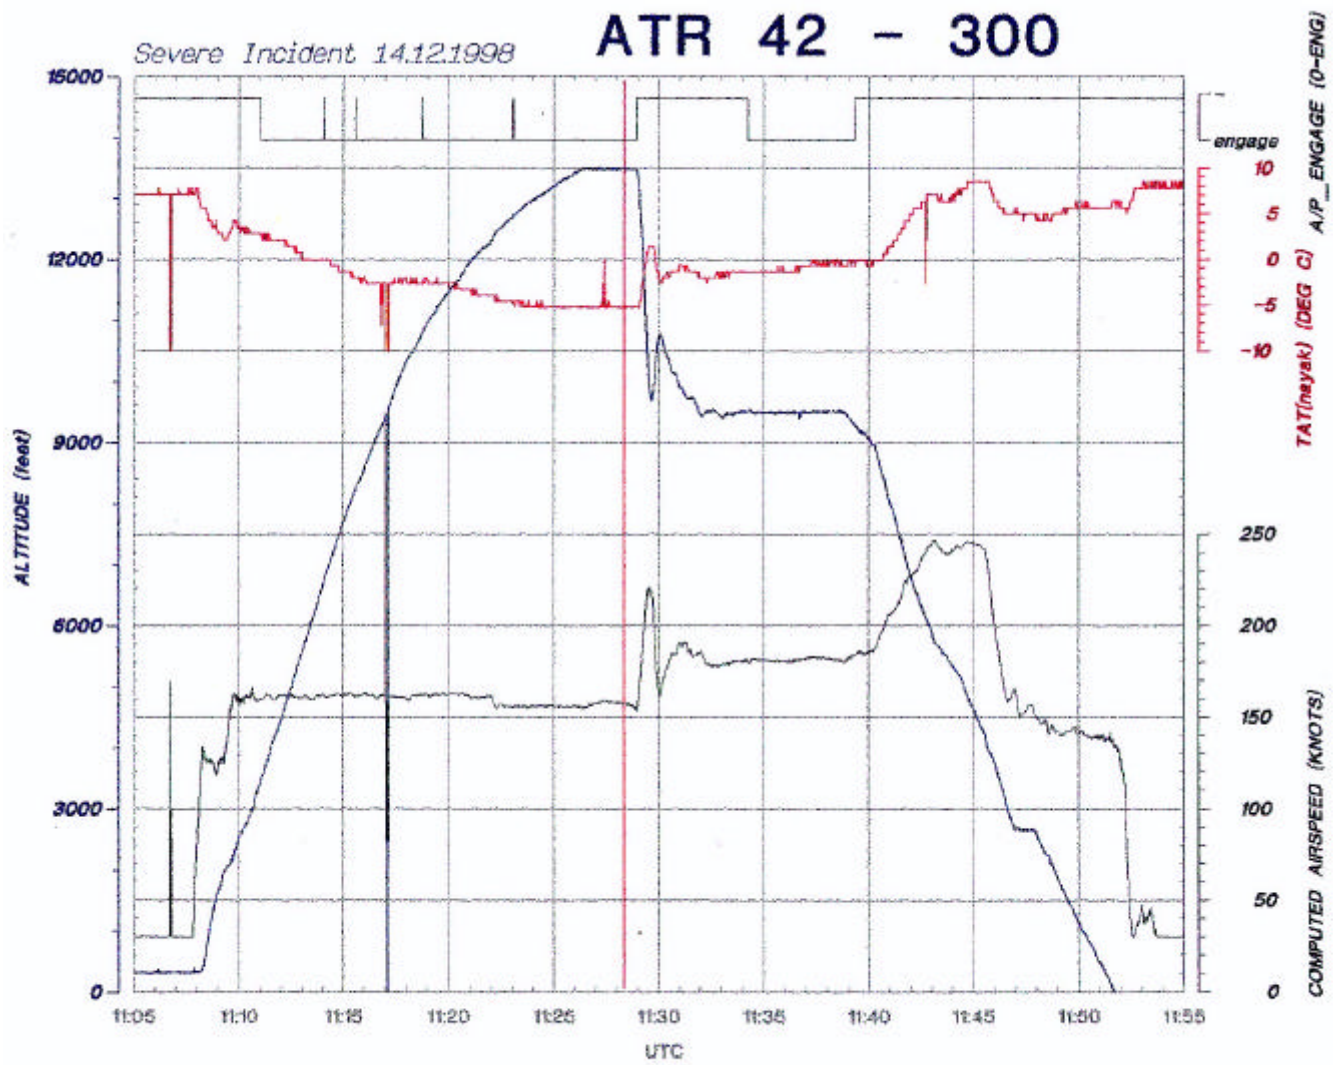
COMP. TIME UTC	FLIGHT LEVEL FL	TAT °C	COMP. AIRSPEED kt	CLIMB RATE ft/min	REMARKS
11:08:11	350	+6	120	---	LIFT OFF
11:09:00	1 642	+3	123	---	
11:10:00	2 541	+3	156	899	
11:11:00	3 425	+3	160	884	
11:12:00	4 443	+2	162	1 018	
11:13:00	5 553	+1	161	1 110	
11:14:00	6 634	0	162	1 081	
11:15:00	7 701	-1	163	1 067	
11:16:00	8 557	-2	163	856	
11:17:00	9 421	-3	162	864	
11:18:00	10 334	-3	160	913	
11:19:00	10 973	-3	162	639	
11:20:00	11 471	-3	162	498	
11:21:00	11 962	-3	161	491	
11:22:00	12 299	-4	161	337	
11:22:03	12 321	-4	161*	---	
11:23:00	12 700	-5	156	401	
11:24:00	12 980	-5	156	280	
11:25:00	13 198	-5	156	218	
11:26:00	13 437	-5	156	239	
11:26:20	13 479	-5	155	---	ALT HOLD MODE
11:27:00	13 493	-5	157	---	
11:28:00	13 479	-5	158	---	
11:28:54	13 479	-5	155	---	STALL WARNING
11:29:44	9 800	+1	209	---	RECOVERY

\* AT THIS TIME AIRSPEED IS REDUCED BY CREW BY 5 KT
