Crash after takeoff, Report of the Public Inquiry into the causes and circumstances of the accident near Staines on 18 June 1972

Micro-summary: This Trident crashed shortly after takeoff.

Event Date: 1972-06-18 at 1611 UTC

Investigative Body: Aircraft Accident Investigation Board (AAIB), United Kingdom

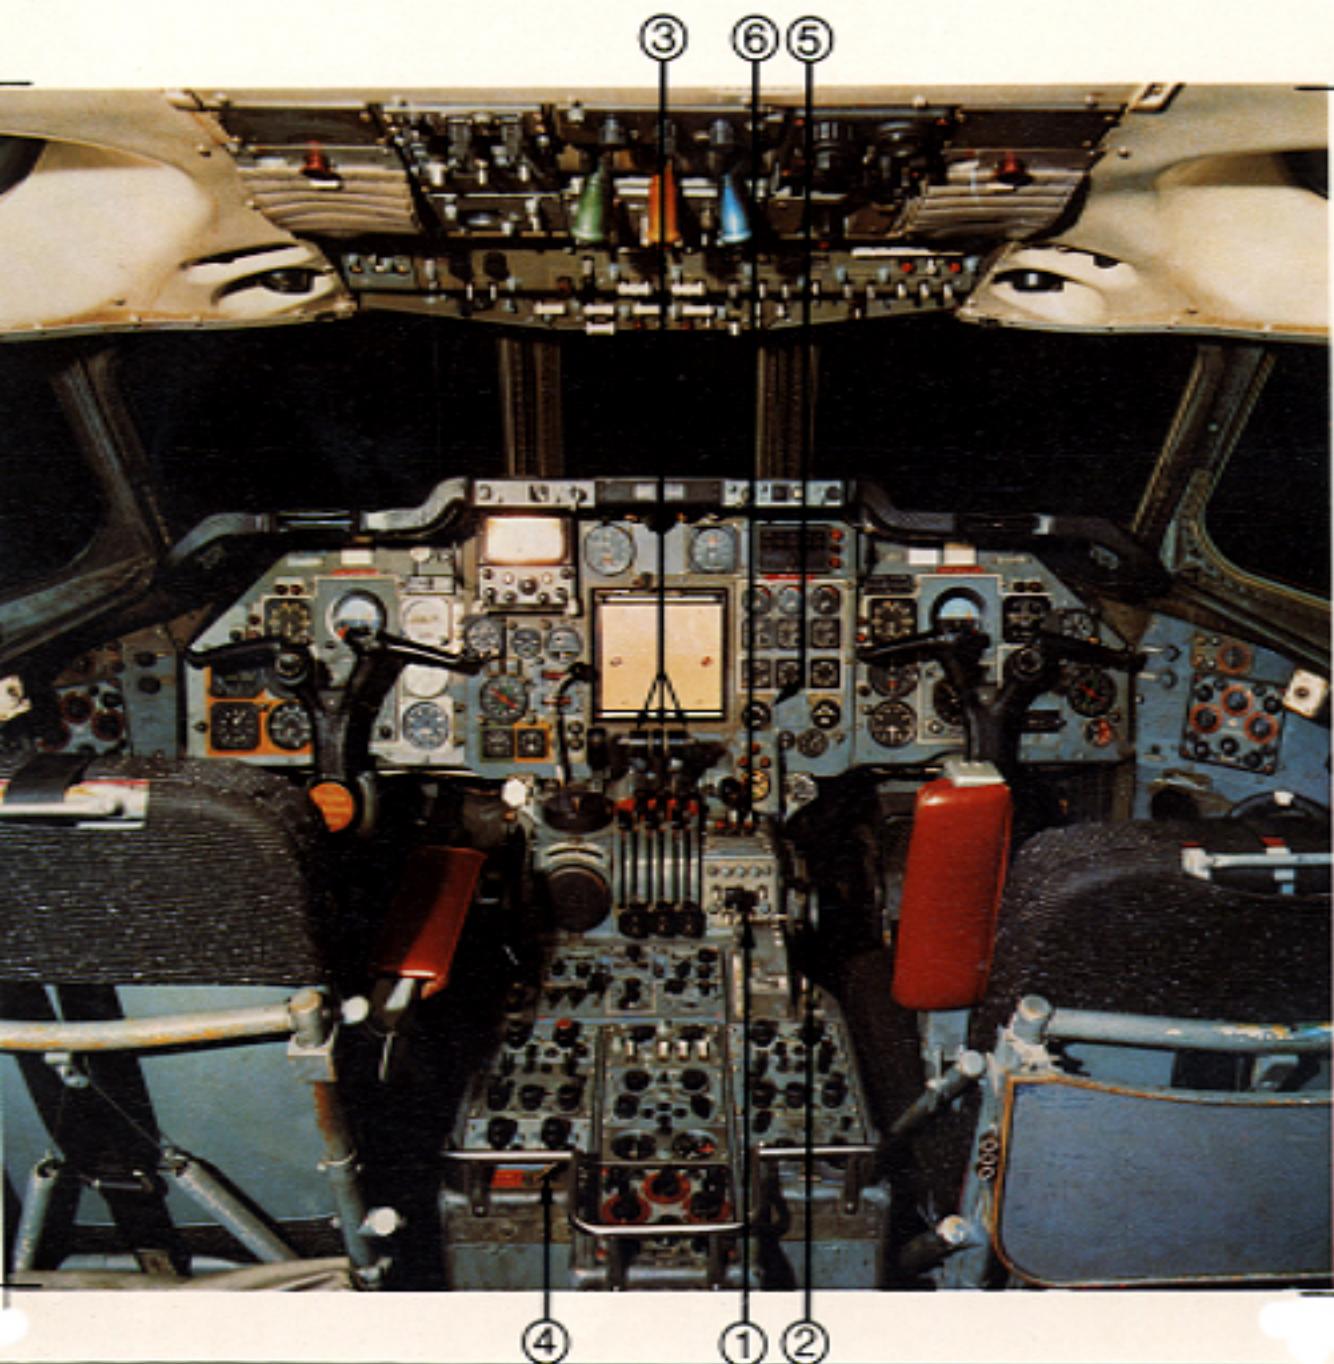
TRIDENT I FLIGHT-DECK

| 2. Flap lever | 5. Droop position indicator |
| 3. Thrust levers | 6. 'Stall recovery low pressure' and "droop out of position" warning lights |

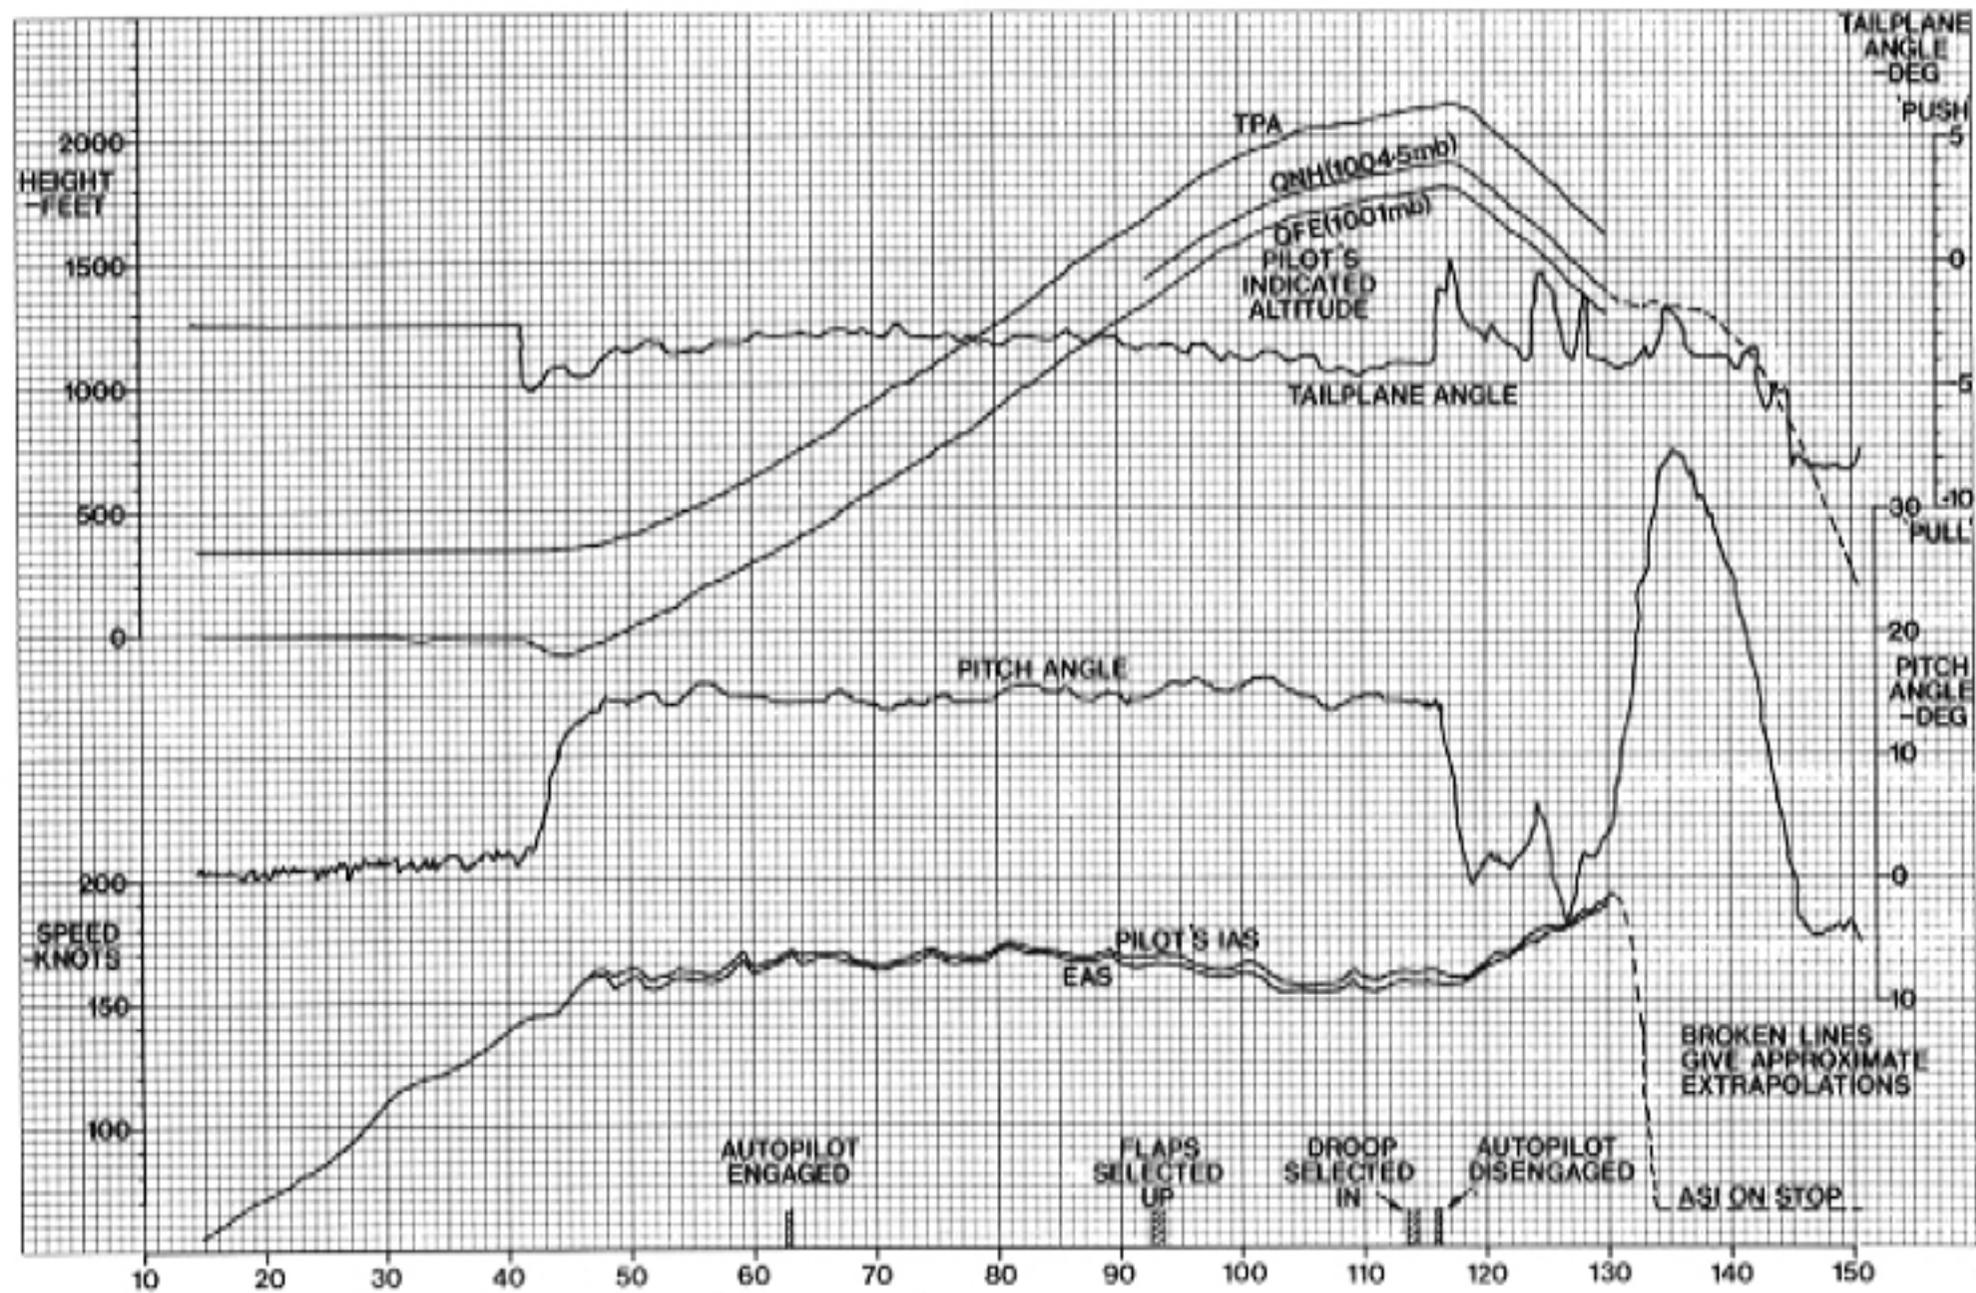
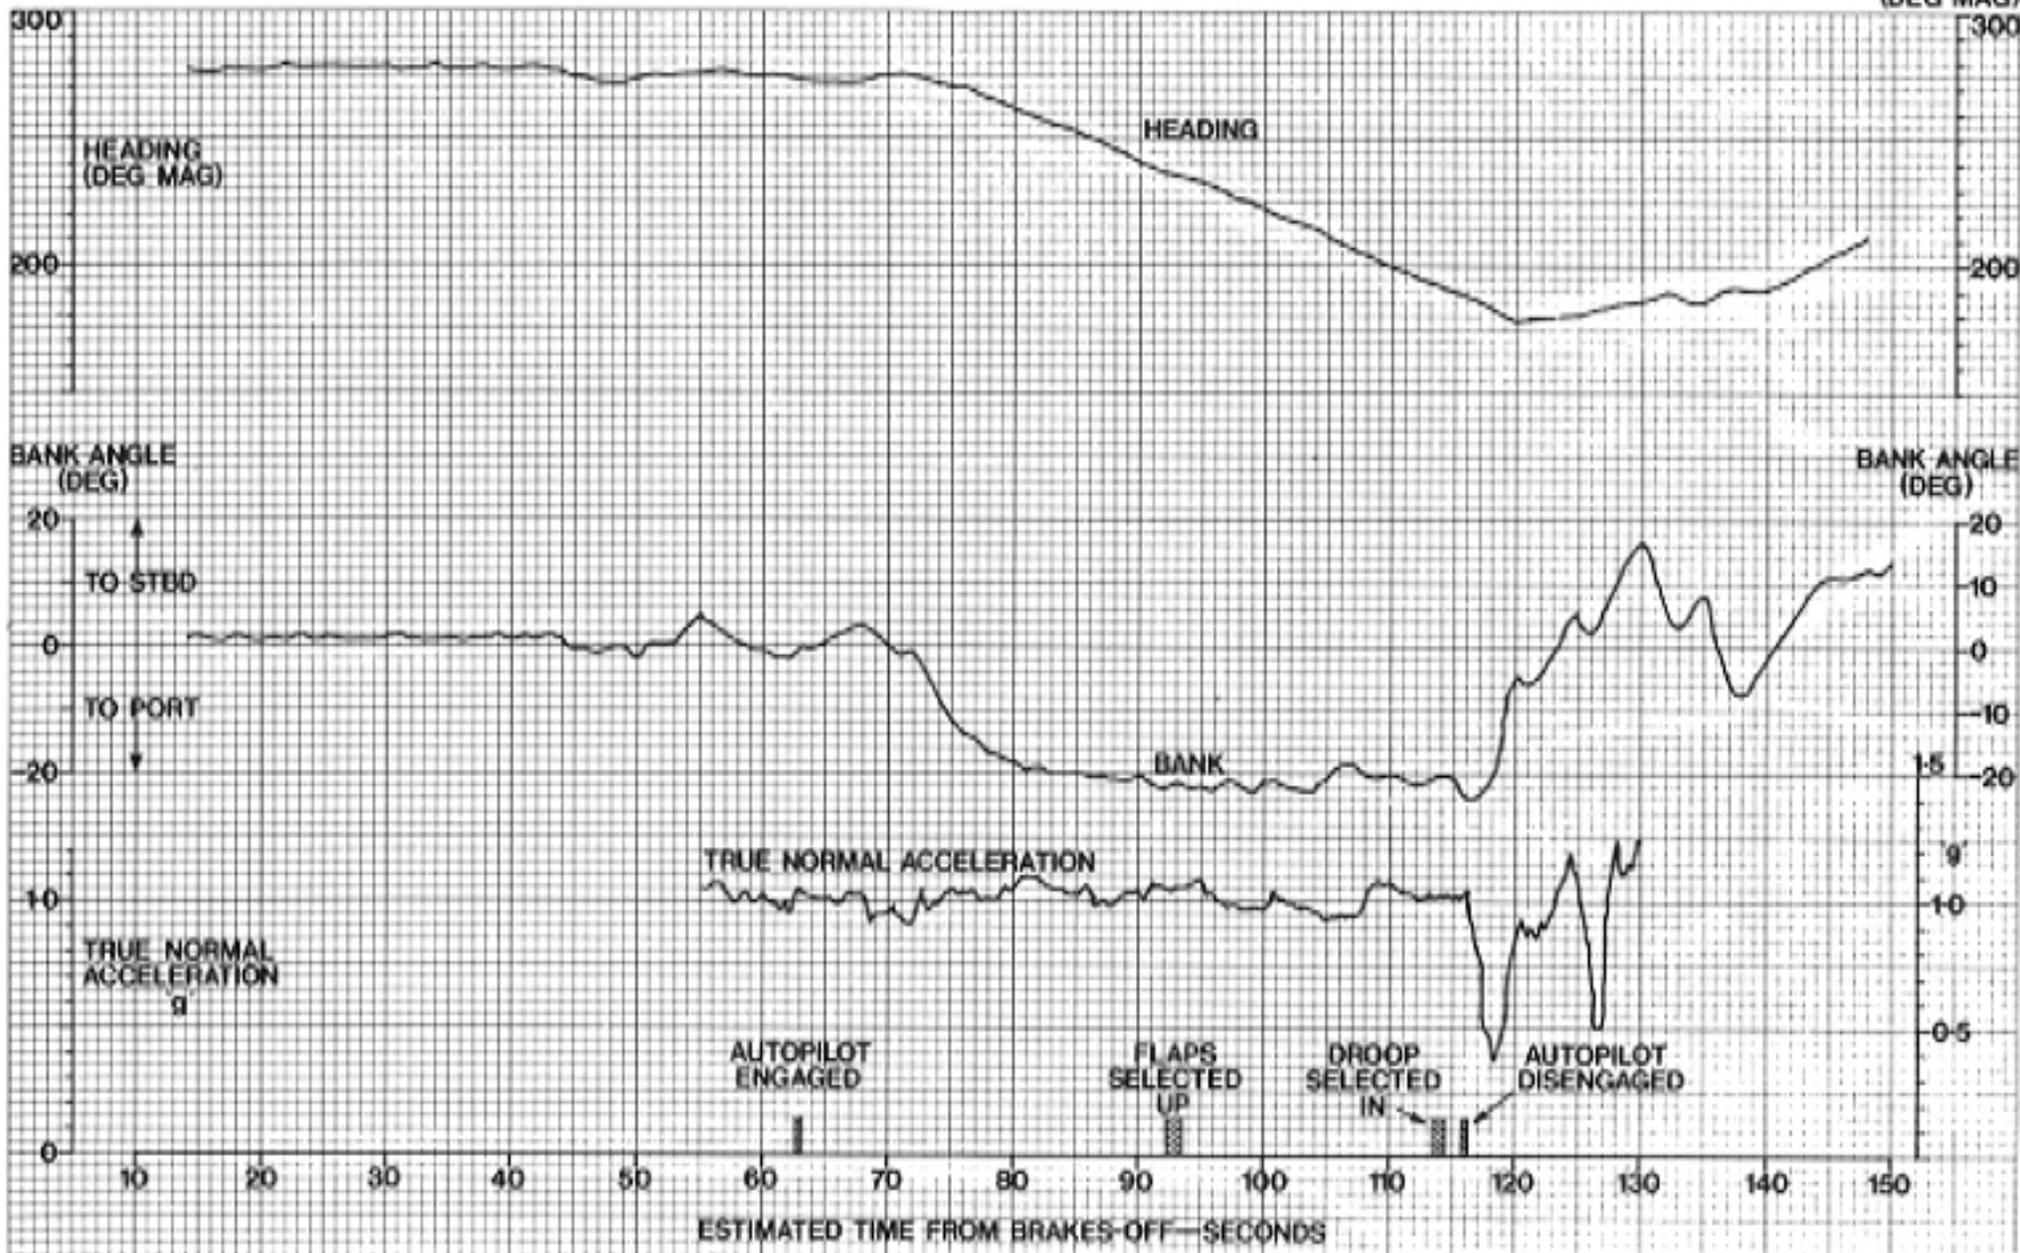
TABULATED CHRONOLOGY OF LAST FLIGHT OF TRIDENT G-ARPI 18 JUNE 1972

Derived from Flight Recorder and R/T transcription information
