Pilot incapacitation on China Airlines Flight Ci681, an A300-600R, B-18503, on 2000-05-08

Micro-summary: The captain of this airplane was discovered incapacitated during cruise.

Investigative Body: Aviation Safety Council (ASC), Taiwan

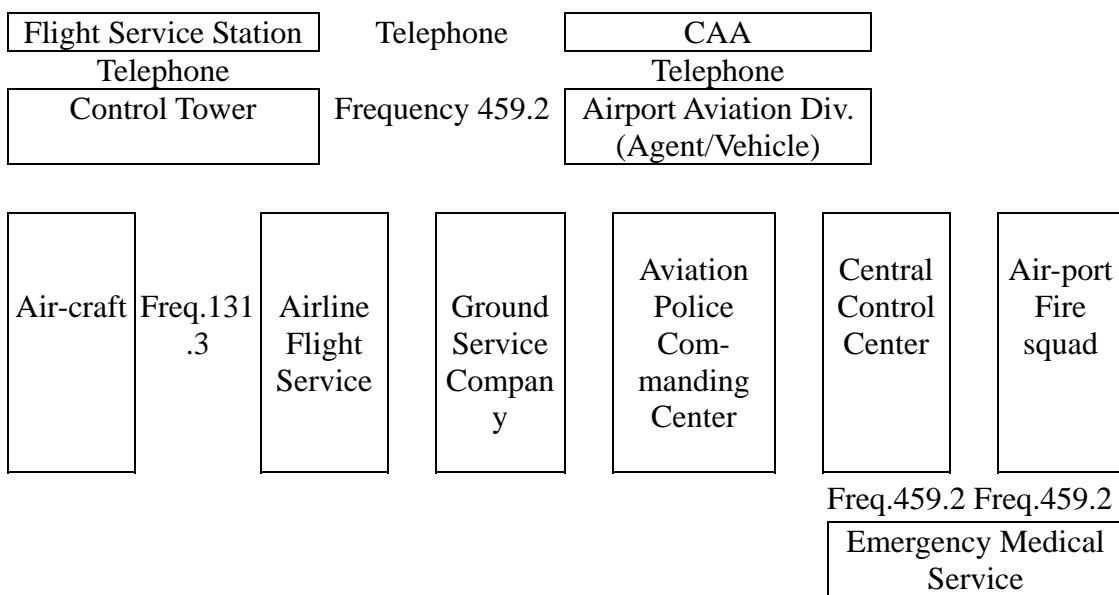
Fig. 1.9-1 Contacts between CKS Airport and all agencies

or direct telephones. The communications between CKS Airport and the related agencies was shown in Fig. 1.9-1.

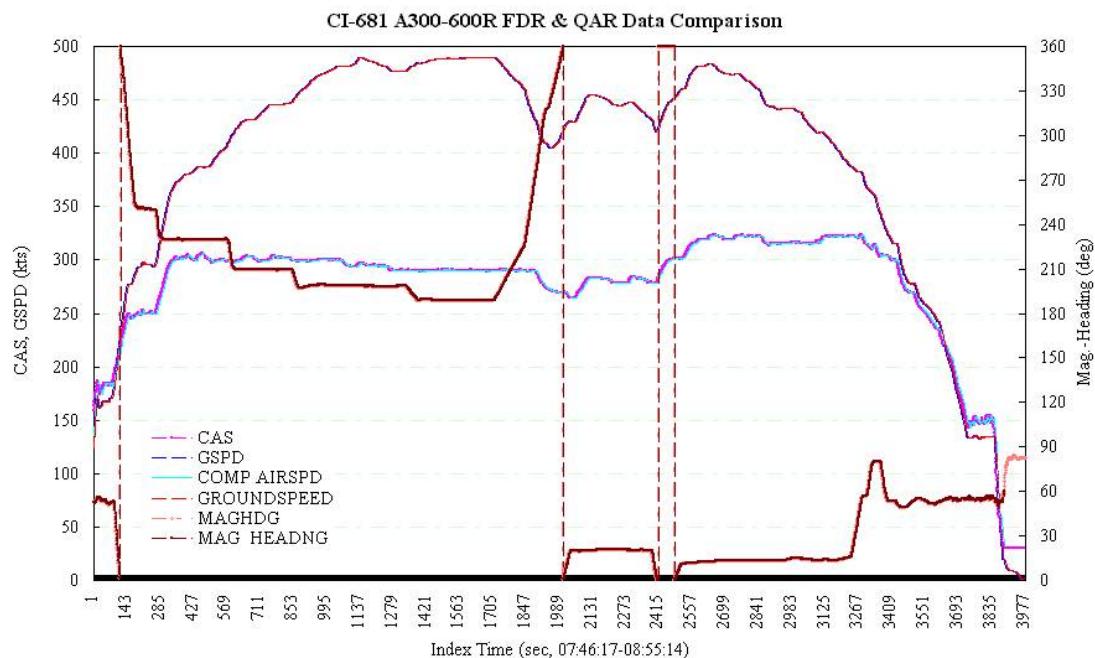
Fig. 1.11.2-1 FDR and QAR air speed, ground speed and heading angle

The solid-type Flight Data Recorder was a FAIRCHILD F1000, with Part No. S800-2000-00 and Serial No. 02008. The total flight data covered 61 hours, 5 minutes and 48 seconds. Of all the decoded key parameters, 9 (ALT, CAS, GSPD, HEADING, LAT POSITION, LONG. POSITION, NOSE WHEEL POSITION, PITCH and ROLL) were compared with the data in QAR. The results turned out to be identical, as shown in Fig. 1.11.2-1.

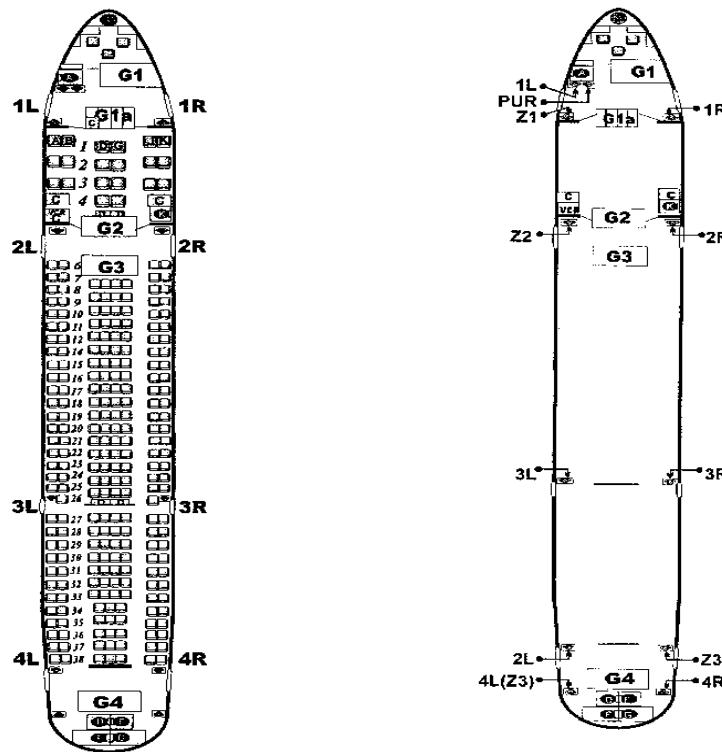
Figure 1.15.3-1 Main cabin and flight attendants' allocation

At about 0820, instructed by the doctor, the chief flight attendant and a flight attendant moved the captain to the forward galley (G1)(See Fig. 1.15.3-1 Main cabin and flight attendants' allocation) to conduct CPR. During the rescue, the doctor was trying to open the captain's throat and trachea to let the air into the lungs, to remove the vomit and asked for cardiac pads, laryngoscope, oxygen tubes and phlegm

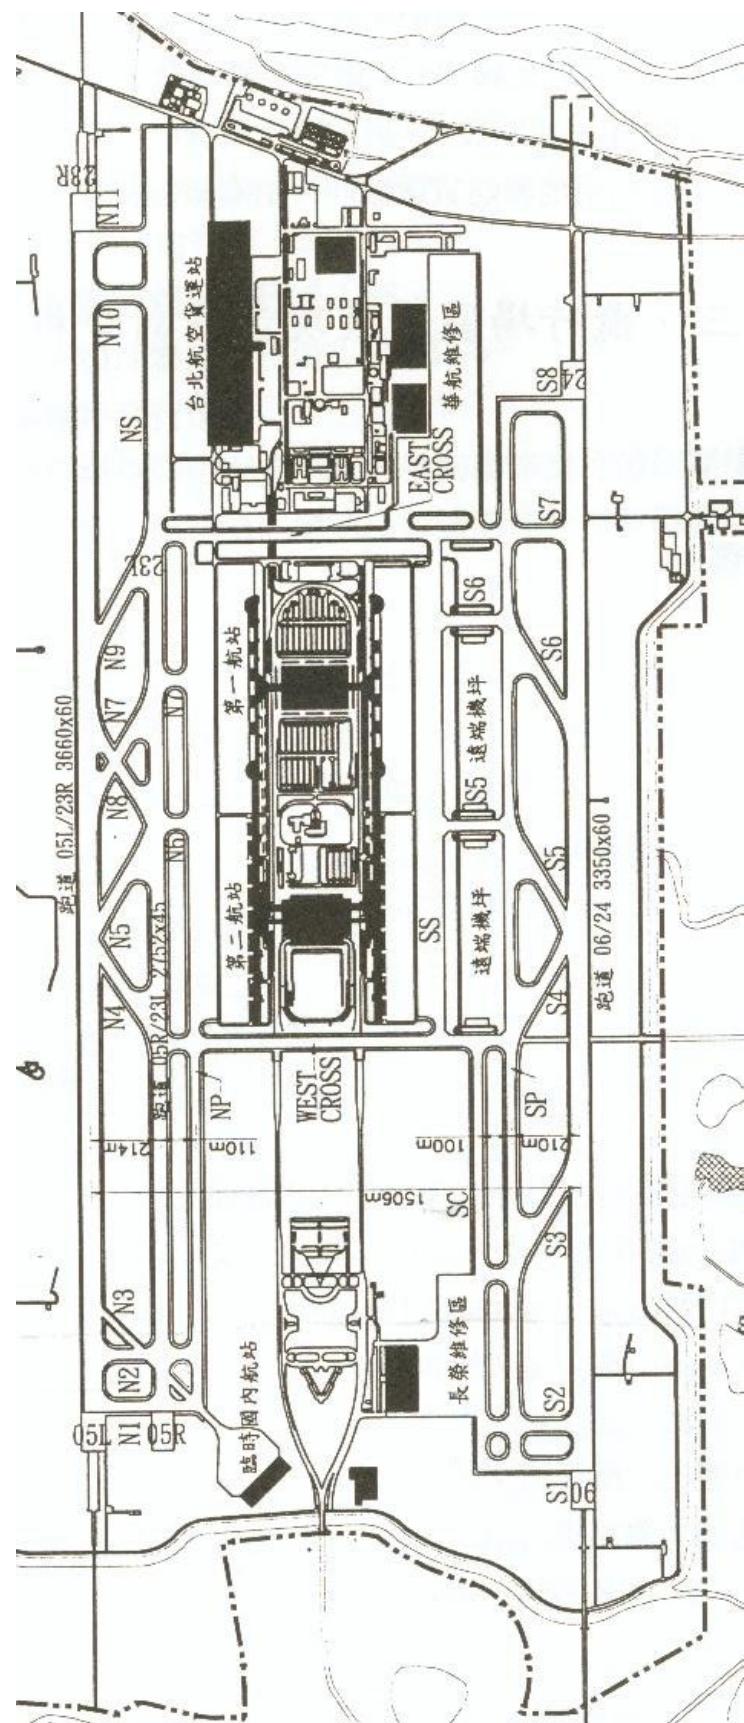
Fig.1.15.6-1 The fire truck Assigned Routs and Standby Positions at CKS International Airport

At 0835, the fire trucks were on S5 taxiway (fire trucks 1, 3, 5 and 16, ambulances and 108 fire-fighting commanding vehicle) and S8 taxiway (fire trucks 4, 6, 7 and 8). Flight Operations Section's No. 103 vehicle was then standby on S1 taxiway. See Fig. 1.15.6-1 and Fig. 1.15.6-2 for CKS International Airport Fire Fighting gridiron.

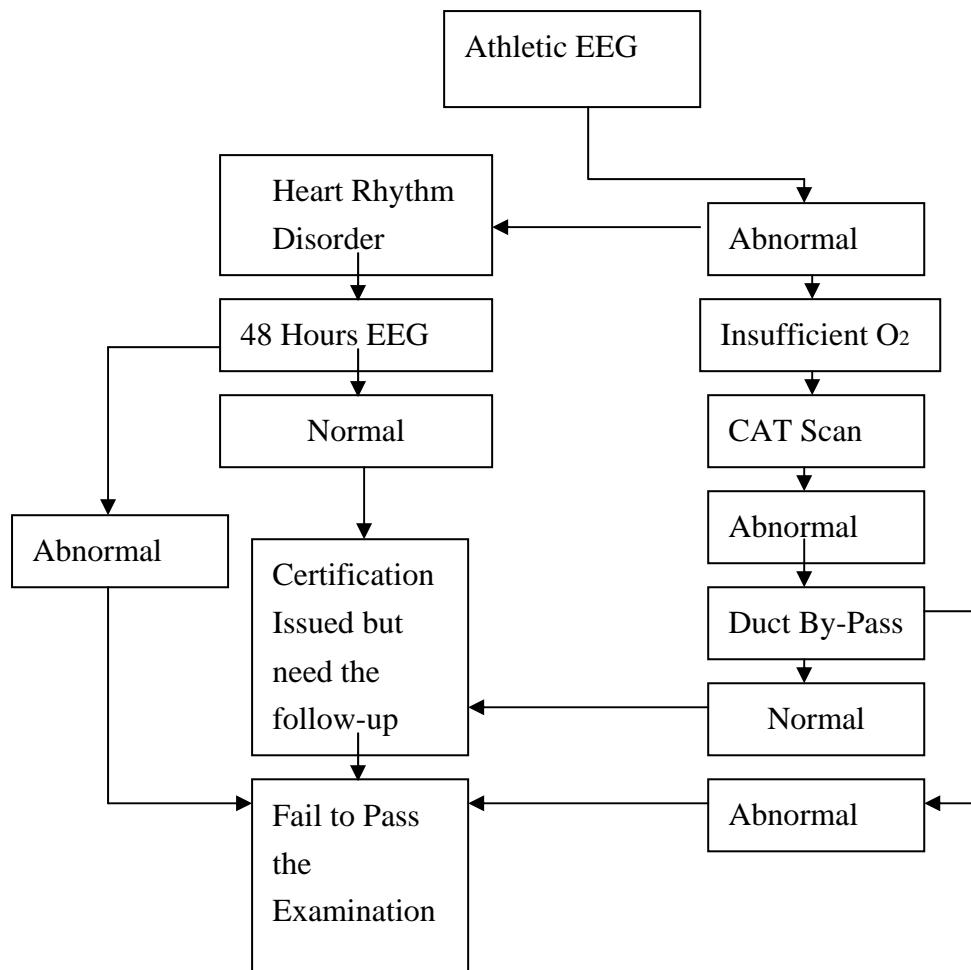
圖 2.2.6-1 The EEG process of Aviation Medical Center

There were no irregularities found in the athletic EEG of the pilot in this incident. Therefore, no further examination was made to examine the narrow condition of the coronary artery. The Aviation Medical Center's examination procedures of the athletic EEG is shown in Fig. 2.2.6-1

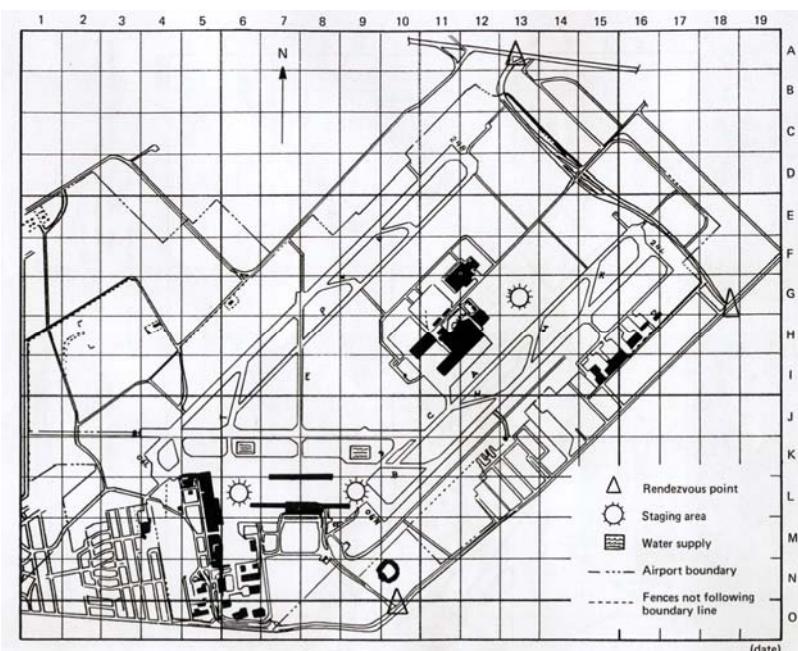
Fig. 2.3.11-1 First ICAO Graph Map of the Airport and Off-Airport Areas

Section 7.1 of the ICAO Airport Emergency Procedure Handbook states that the emergency center should provide the tower, firefighting station, firefighting/rescue vehicles as well as all vehicles carrying support groups with graph maps of the airport and the outlying areas. It must provide two types of graph maps: 2.3.11-1 describes the airport roads and all other roads leading to the outside, water supply locations, waiting points, and staging areas; 2.3.11-2 shows at least 8 km. of land around the airport, which includes its topography, its road systems, hospital locations, materials, waiting points, and other information. The hospitals shown in the graph maps must also show the number of beds that can be utilized, fields of specialization, manpower, and other information.

A look at the CKS Airport medical rescue support group and capabilities' form of the "Implementation Highlights of CKS Airport Aircraft Accident and Incident Handling Procedure" described that its graph map did not show the abovementioned water supply locations, preplanned waiting points, and staging areas, at least 8 km. of land around the airport, which included its topography, its road systems, hospital locations, materials, waiting points, and other information. The hospitals shown in the graph maps might also show the number of beds that could be utilized, fields of specialization, manpower, and other information.

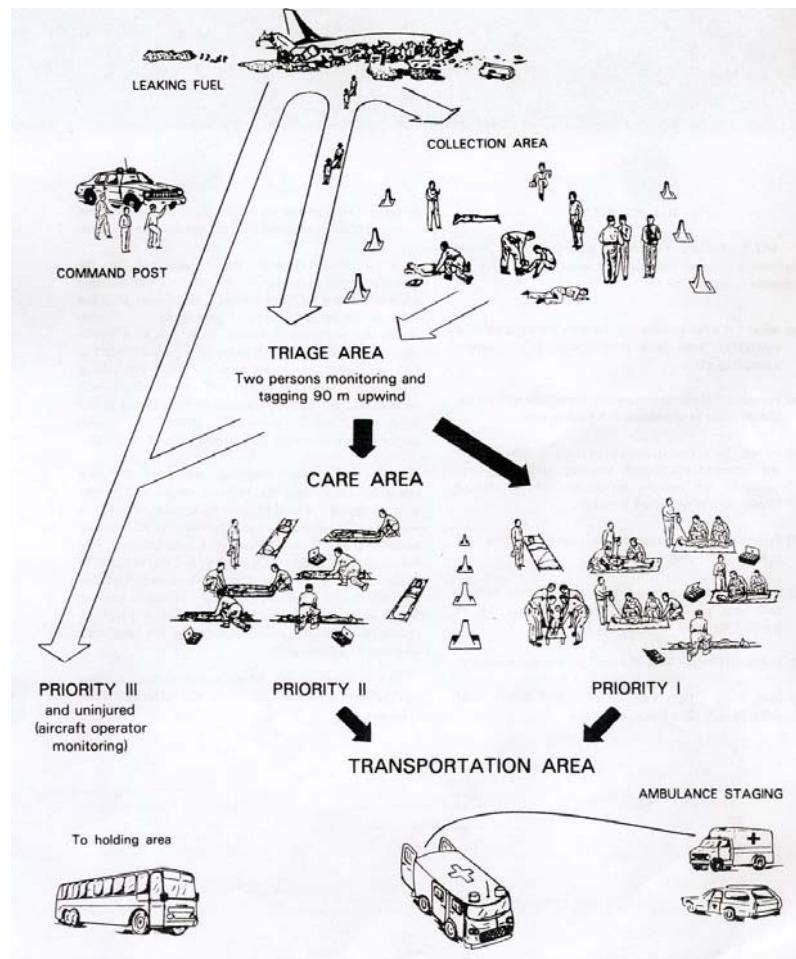
Fig. 9-1 Flow chart of categorization of injuries as well as medical care

9.5.1 Four care areas should be established as in Fig. 9-1

- a) Assembly area—The seriously injured should be housed in this area where the paramedics will turn them over to medical personnel.
- b) Injury categorization area— should be at least 90m from the site and may be put up in different areas.
- c) Care area—After categorization, the injured shall be placed in respective care areas, which will be divided into three levels:
 - 1st level: Shall be identified via a red banner or stremer.
 - 2nd level: Shall be identified via a yellow banner or streamer.
 - 3rd level: Shall be identified via a green banner.
- d) Transportation area— Shall be placed between the exit and care areas. There shall only be one transportation area or else a communication network should be put up.
