CFIT, Campbell-Ewald Advertising Company, Rockwell Turbo Commander 690A, N847CE, Nemaocolin, Pennsylvania, September 12, 1975

Micro-summary: This Rockwell Turbo Commander 690A crashed on approach to Farmington.

Event Date: 1975-09-12 at 1058 EDT

Investigative Body: National Transportation Safety Board (NTSB), USA

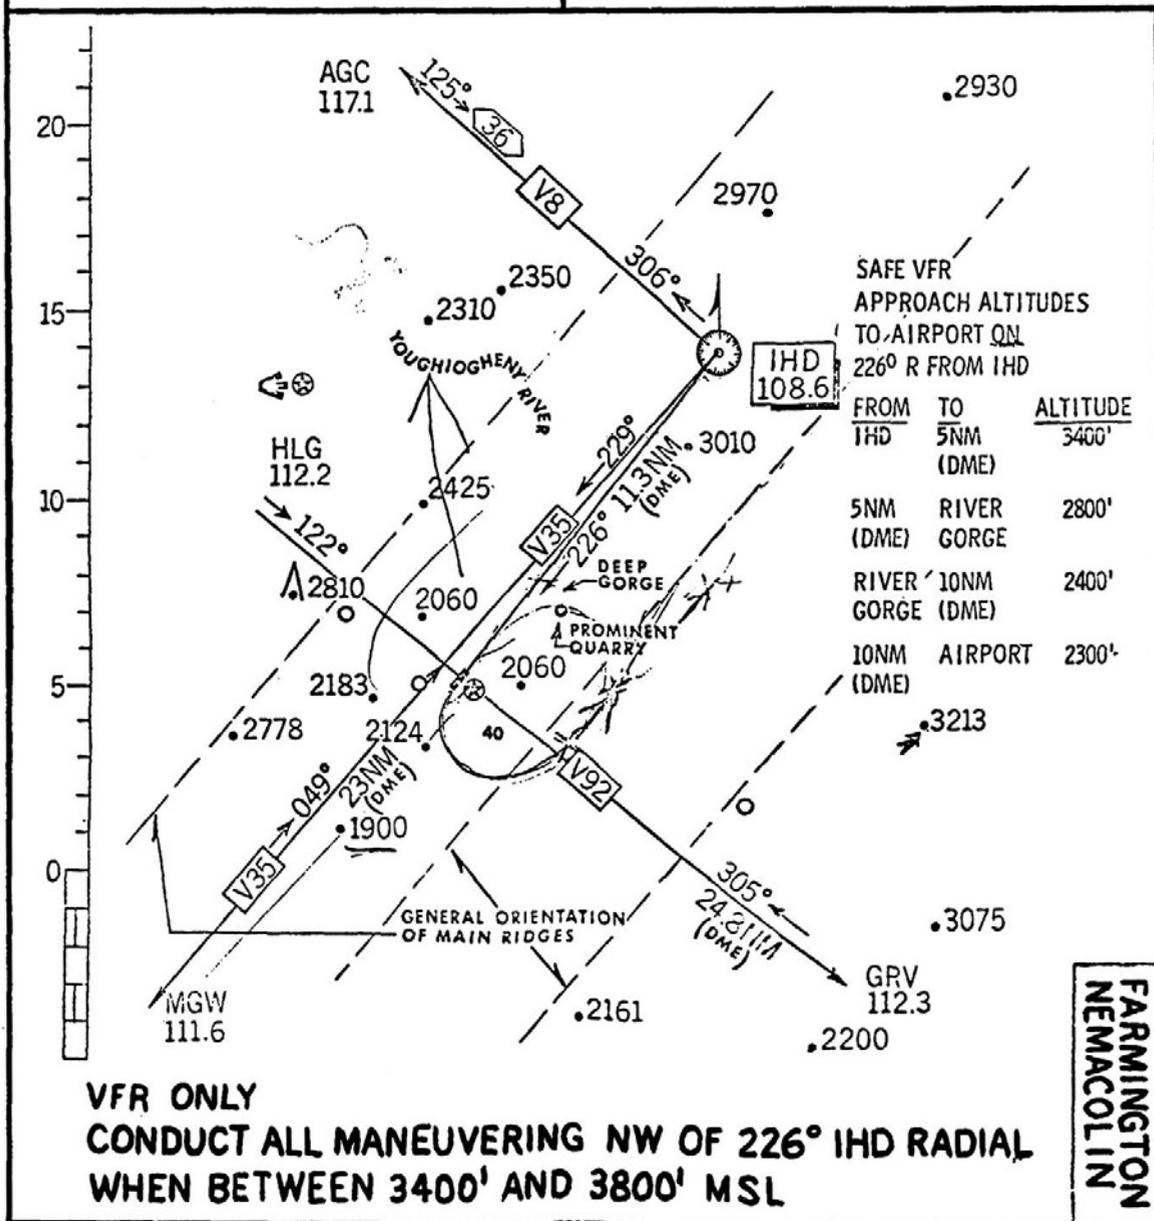
NEMACOLIN UNICOM 122.8
 LIGHTS CONTROL 121.8
 AIRPORT ELEVATION 2,000
 VAR 05 W

FARMINGTON, PA.
 NEMACOLIN AIRPORT
 VFR RWY 22
 VOR 108.6 IHD
 SAFE VFR ALTITUDE
 WITHIN 20 NM 3800'
