Stall and loss of control on final approach, Atlantic Coast Airlines Inc dba United Express Flight 6291, Jetstream 4101, N304UE, Columbus, Ohio, January 7, 1994

**STALL AND LOSS OF CONTROL ON FINAL APPROACH
ATLANTIC COAST AIRLINES, INC./
UNITED EXPRESS FLIGHT 6291
JETSTREAM 4101, N304UE
COLUMBUS, OHIO
JANUARY 7, 1994**

Abstract: This report explains the crash of United Express flight 6291, a Jetstream 4101 airplane, while on approach to runway 28L at Port Columbus International Airport, Columbus, Ohio, on January 7, 1994. The safety issues in the report focused on aircraft safety belts, training programs for Part 135 pilots that emphasize stall warning recognition and recovery techniques, and that lead to proficiency in both high speed and coupled approaches. Safety recommendations concerning these issues were made to the Federal Aviation Administration.

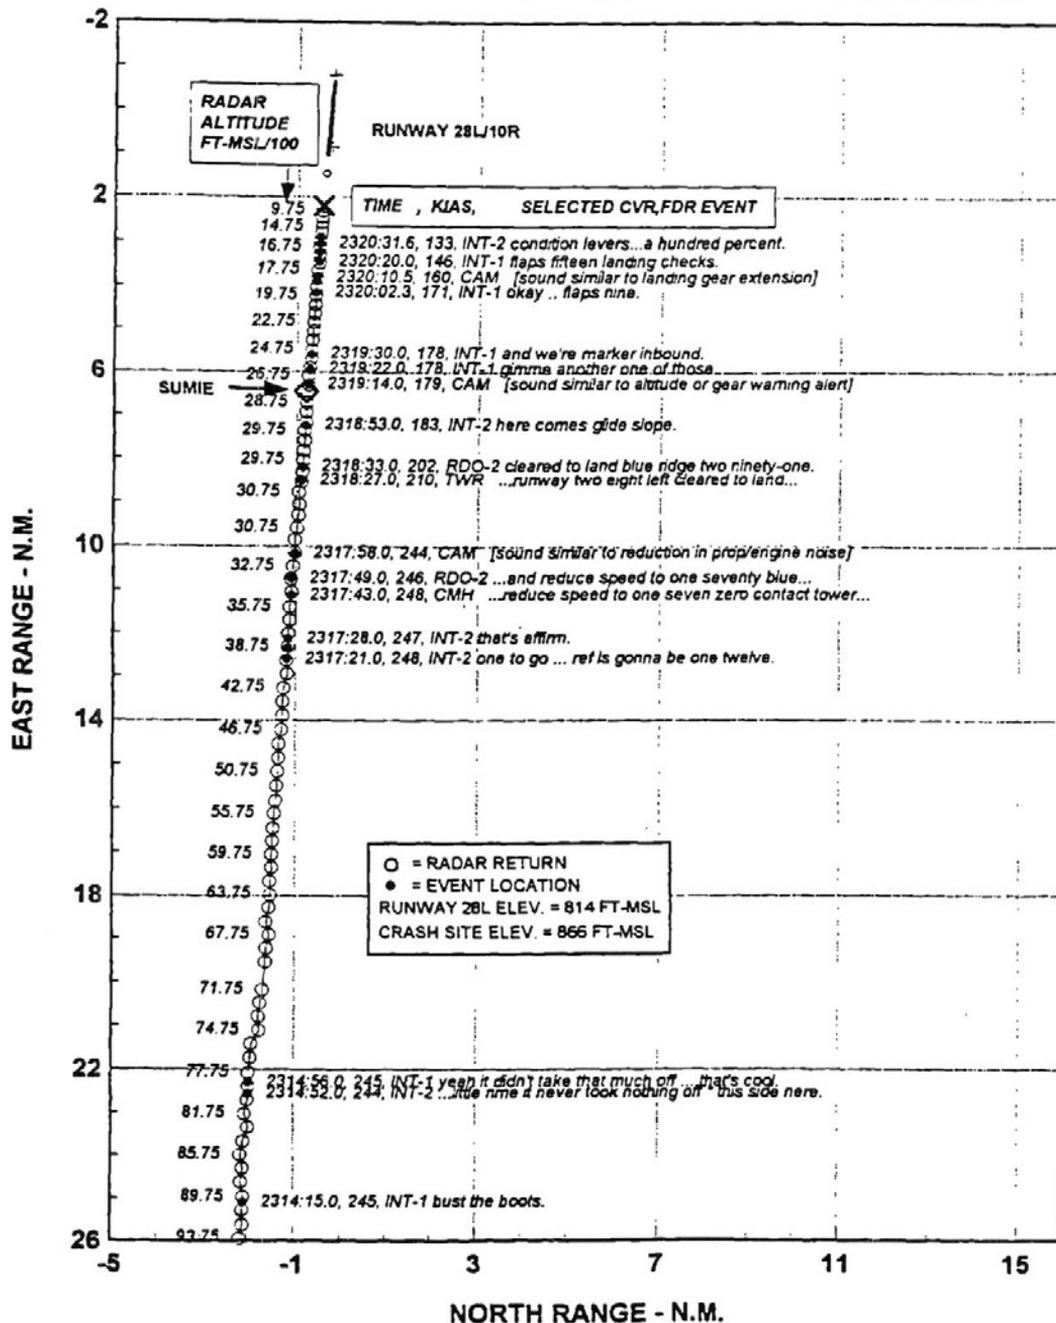
UNITED EXPRESS FLT#6291 GROUNDTRACK

Figure 2.--Selected events from the CVR and FDR.

The location of selected events from the CVR and FDR are overlaid on the radar data plots in figures 2, 3, and 4. Each event location (dot) was interpolated from the nearest radar data (circles). Radar altitudes were increased 75 feet to reflect actual altitude in feet msl.

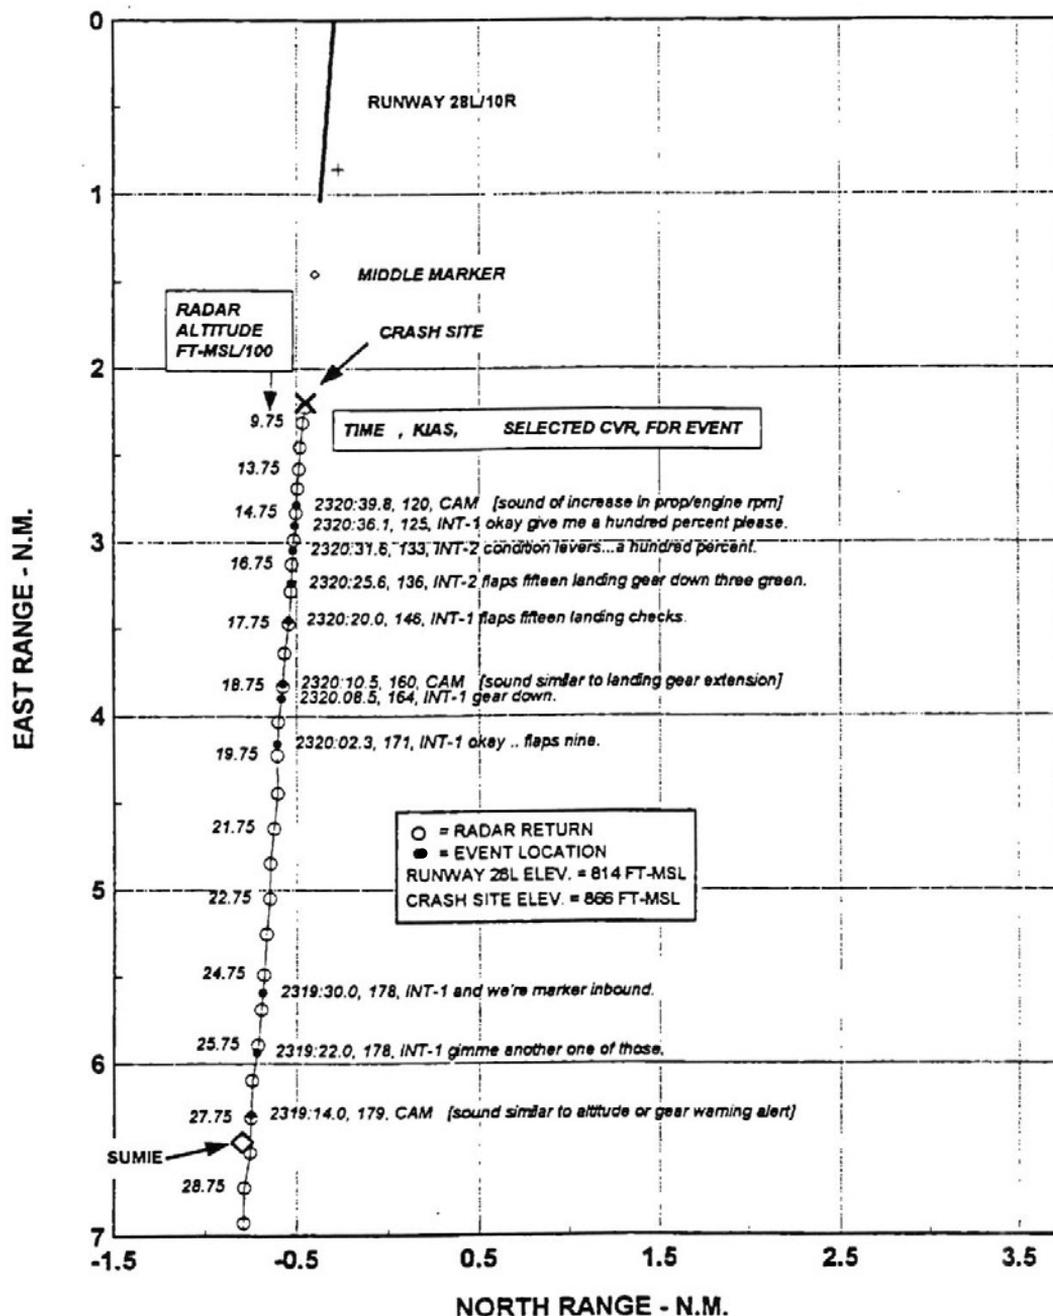
UNITED EXPRESS FLT#6291 GROUNDTRACK

Figure 3.-- Selected events from the CVR and FDR.

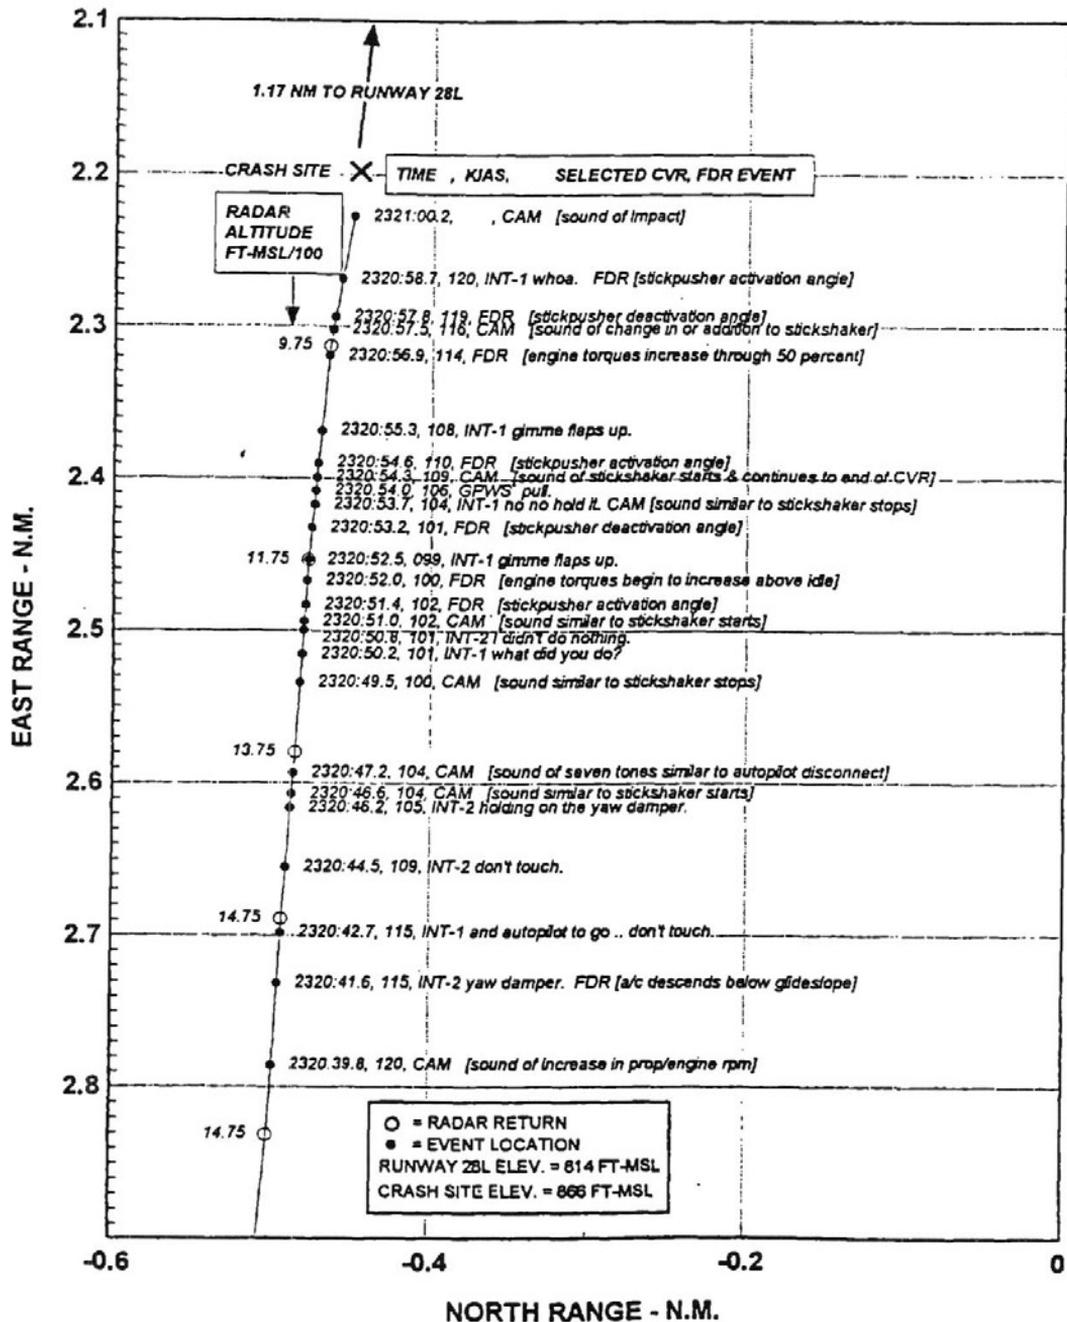
UNITED EXPRESS FLT#6291 GROUNDTRACK

Figure 4.-- Selected events from the CVR and FDR.

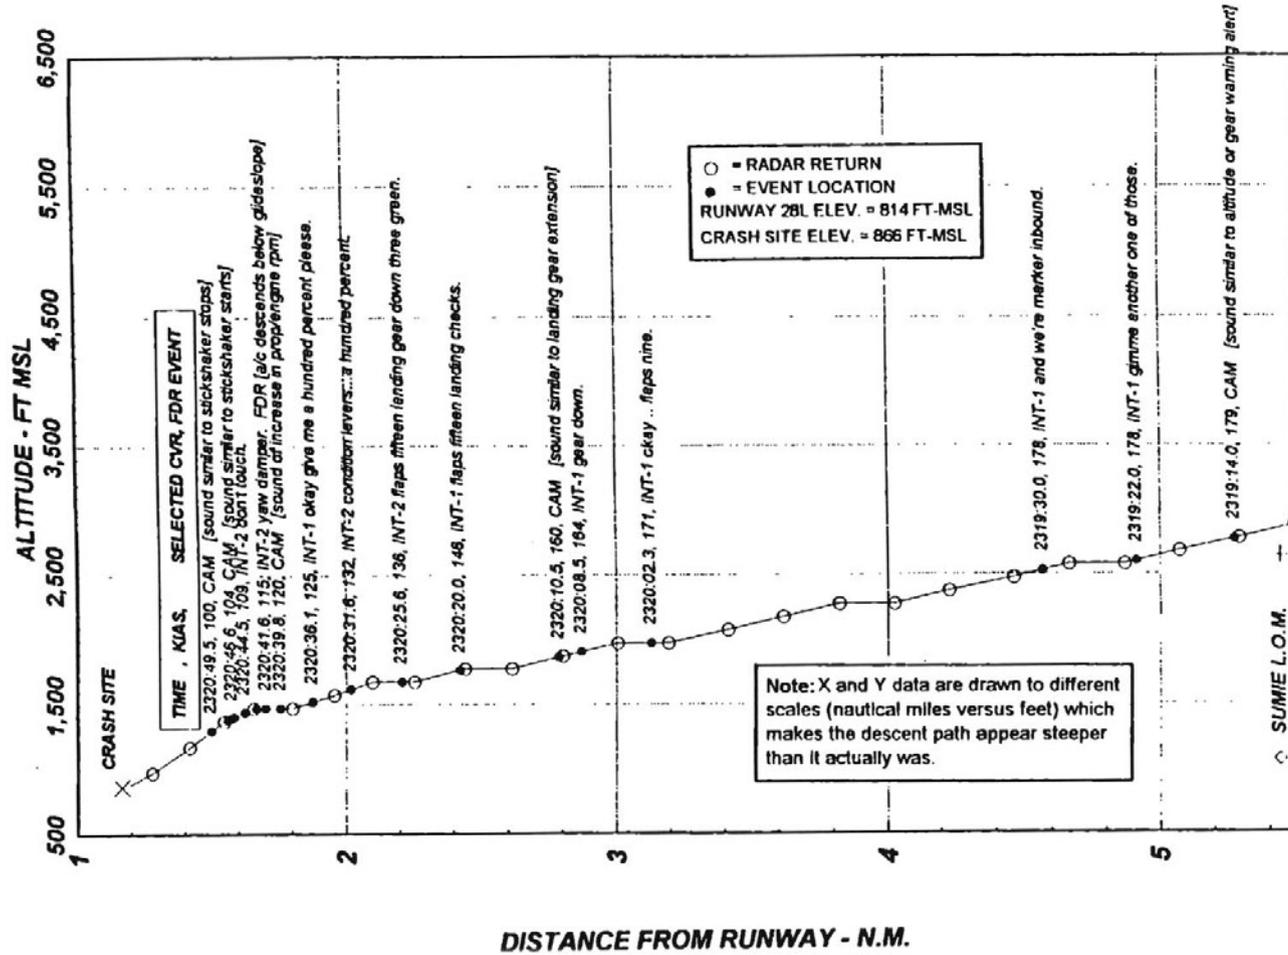
UNITED EXPRESS FLT#6291 DESCENT PATH

Figure 5.--Profile view of approach.

Starting at the outer marker, the profile view of the approach is plotted in figures 5 and 6. The local time, processed recorded radar altitude, FDR indicated airspeed, and dialogue from the CVR are also shown on these plots. The ILS glideslope deviation recorded by the FDR is shown with the triangle symbol on the plot. Because only selected events are shown, some FDR events or CVR sounds in the cockpit are not shown on these plots.

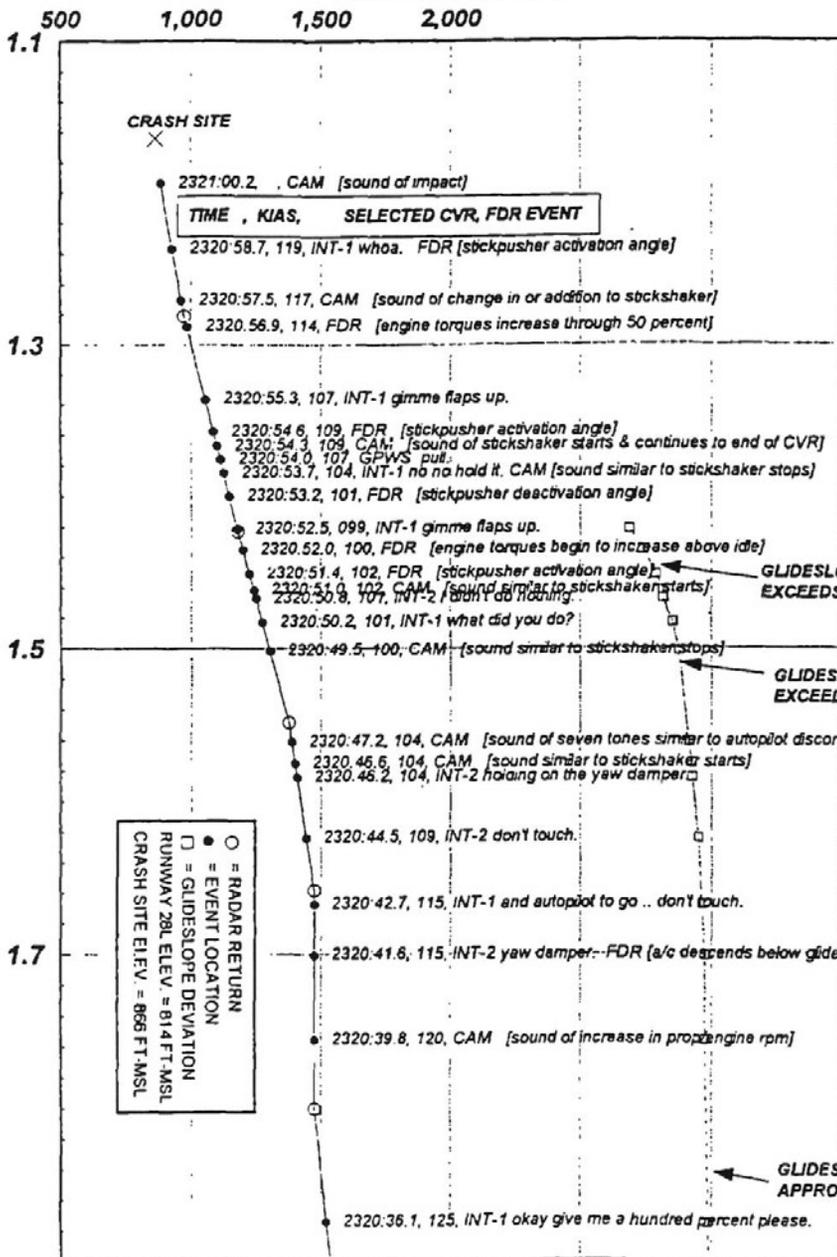
GLIDESLOPE DEVIATION (ZERO = -0.8, 1 DOT = -0.71, 2 DOTS = -0.63)

ALTITUDE - FT MSL

Figure 6.--Profile view of approach.

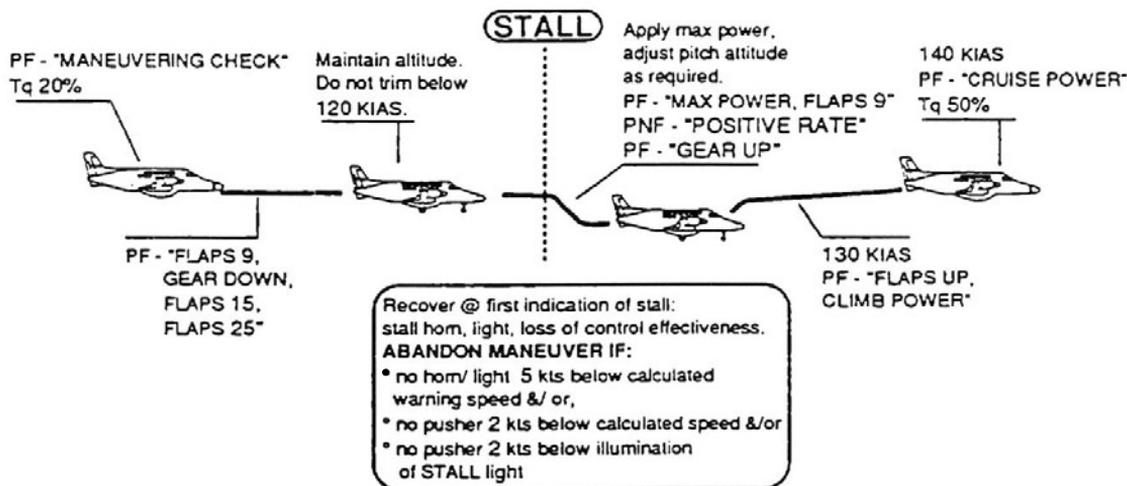
Approach to Stall - Landing Configuration

Figure 7.--J-4101 approach to stall -- landing configuration.

Figure 7 contains a graphic depiction of a J-4101 in landing configuration encountering a stall condition. It contains the procedure used to recover from such a situation.

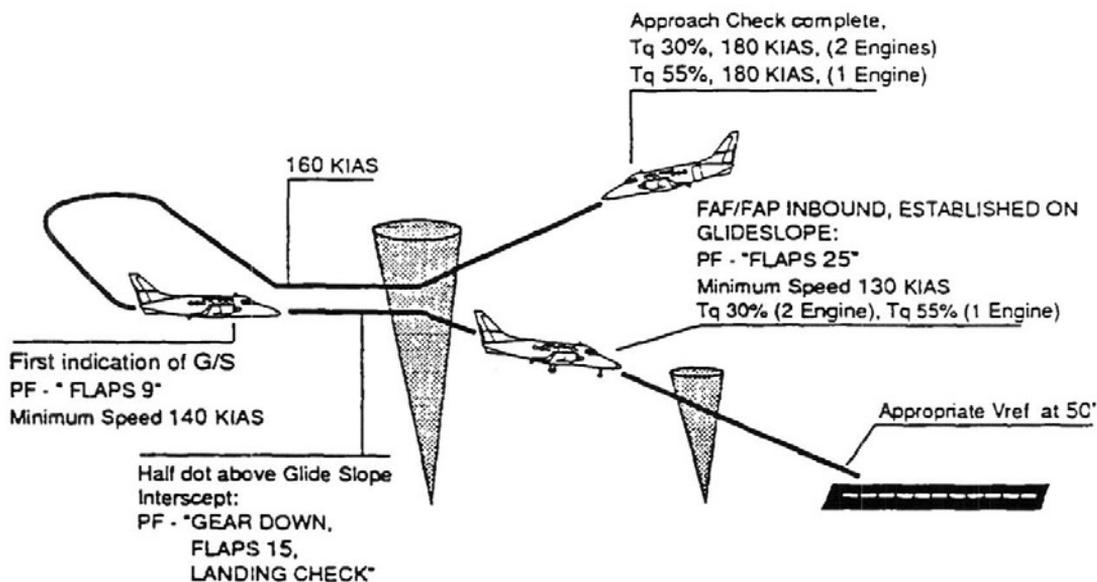
Single / All Engines Operative ILS Approach

(IF APPROACH NOT STABILIZED BY 1000' HAA IMC OR 500' HAA VMC - GO AROUND)

On a precision approach, the initial procedure should be flown at 160 KIAS, no flaps. When established inbound and within 3 NM of the FAF (DME available) or when first indication of glide slope movement is called (DME not available), flaps are lower to 9 degrees. When the glide slope is intercepted, select landing gear down, flaps 15 degrees. FAF inbound established on the glide slope select flaps 25 degrees, call for Landing checklist. At DA, reduce speed to obtain the appropriate Vref at 50 feet.

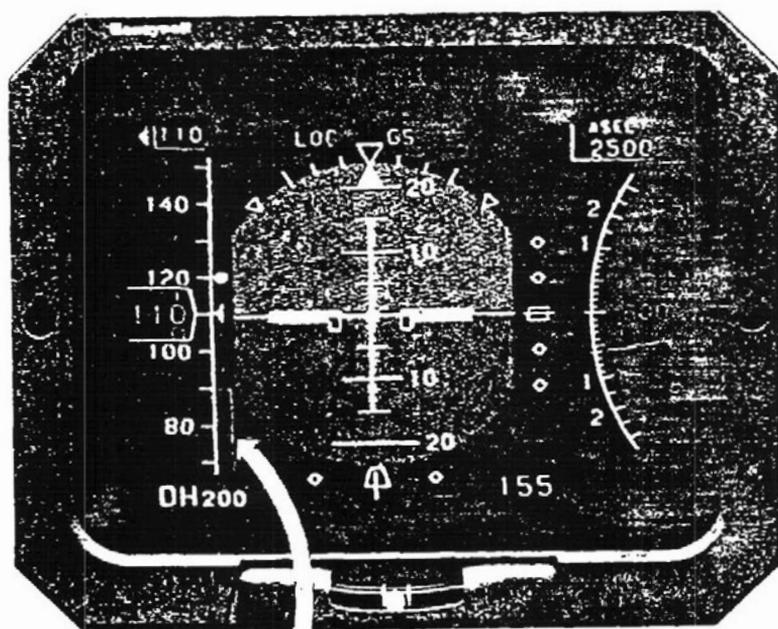
low airspeed
awareness indicator [red color]

Figure 9.--Electronic attitude director indicator.

The Safety Board examined the display of airspeed within the airplane's electronic attitude director indicator, a cathode ray tube or CRT, to determine if the manner in which the information was presented could have hampered the ability of either pilot to perceive and integrate the critical information. Airspeed data on the J-4100 is presented digitally on a vertical moving display, with the airplane's indicated airspeed centered within the display. As the airspeed increases or decreases, the displayed airspeeds move up or down correspondingly. (See figure 9).
