**Controlled Flight Into Terrain, Era Aviation, Sikorsky S-76A++, N579EH,
Gulf of Mexico, About 70 Nautical Miles South-Southeast of Scholes
International Airport, Galveston, Texas, March 23, 2004**

Aircraft Accident Report

NTSB/AAR-06/02

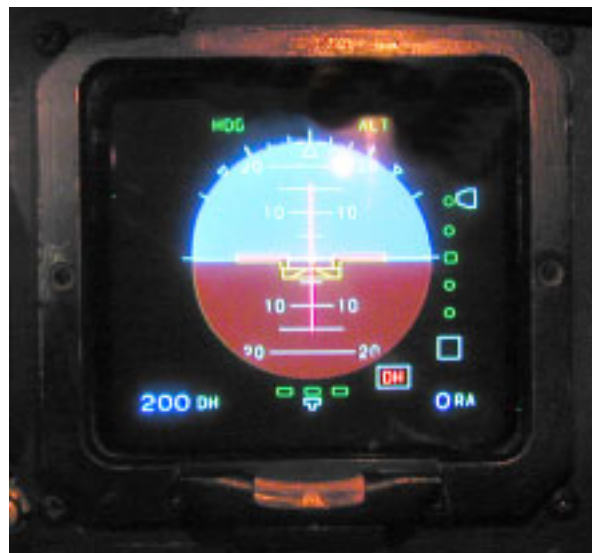
Figure 5. Indications of Descent on the Attitude Direction Indicator

flight crew. As shown in figure 5, the following indications of descent were seen on the pilots' ADIs during the scenarios:

- The radar altitude appeared in blue at the bottom right of the ADIs followed by an "RA" indication in white.
- The decision height was displayed in blue at the bottom left of the ADIs followed by a DH indication in white. A white square box appeared above the radar altitude (at the bottom right of the ADIs) when the helicopter was 100 feet above the decision height (based on the radar altimeter). When the decision height was reached, an amber DH indication appeared inside the box and remained there as the helicopter continued to descend.
- A yellow rising runway symbol appeared at the bottom center of the ADIs at 180 feet (based on the radar altimeter). As the helicopter's altitude decreased, this symbol ascended until it met the aircraft symbol at 0 feet.

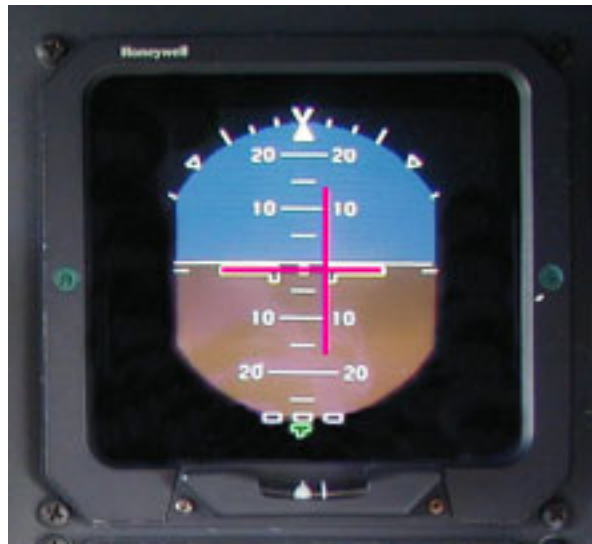
Figure 7. SPZ-7000 Dual-Cue Format

Both the SPZ-7000 and the SPZ-7600 have the capability to display pitch and roll command cues in either a dual- or a single-cue format. With the dual-cue format, pitch attitude is represented by a horizontal line, and roll attitude is represented by a vertical line, as shown in figure 7. With the single-cue format, angular bars integrate pitch and roll guidance, as shown in figure 8. When both pitch and roll commands are selected in either mode, the guidance provided by the command cues is intuitive and well understood by pilots who have been trained on either flight control system.

Also, both the SPZ-7000 and the SPZ-7600 have the capability for the pilot to select a command cue for only one axis, either pitch or roll, at a time. The displayed cue for the selected axis is functionally the same as when command cues for both axes are selected. However, depending on the system and the command cue format, the command cue for the unselected axis may or may not be displayed. In addition, no annunciation appears on the ADIs regarding the source of guidance for the unselected command cue presented in the SPZ-7000 dual- and single-cue formats and the SPZ-7600 single-cue format.
