Near miss, Report on an incident near London Heathrow Airport on 27 August 1997 - AIRPROX (C) : Boeing 737-200 and Boeing 757

Aircraft Incident Report No: 5/98 - (EW/C97/8/11)

Report on an incident near London Heathrow Airport on 27 August 1997 -
AIRPROX (C) : Boeing 737-200 and Boeing 757

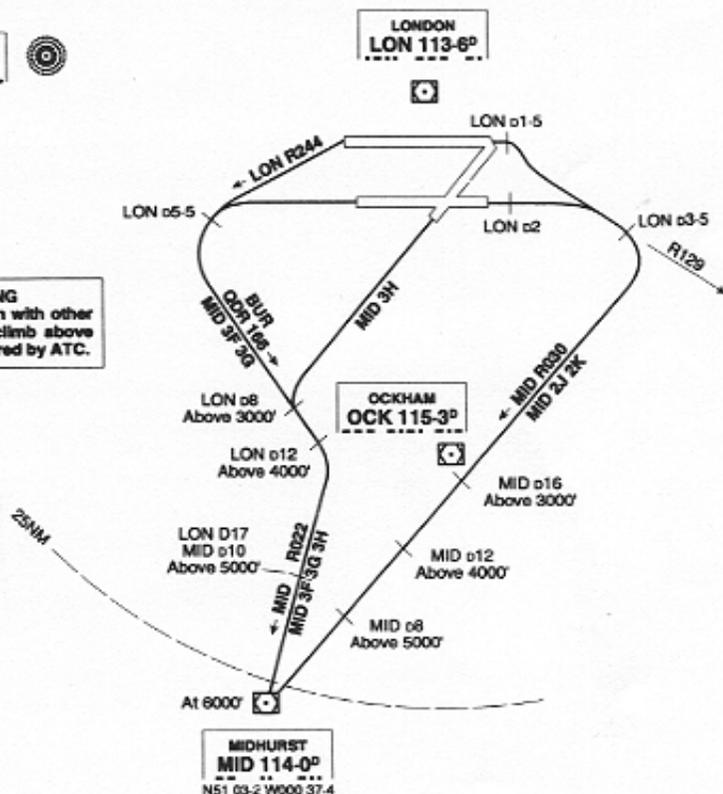
WARNING

Due to interaction with other routes do NOT climb above 6000FT until cleared by ATC.

AVERAGE
TRACK MILEAGE
TO MID VOR

MID 3F	30
MID 3G	30
MID 3H	28
MID 2J	29
MID 2K	29

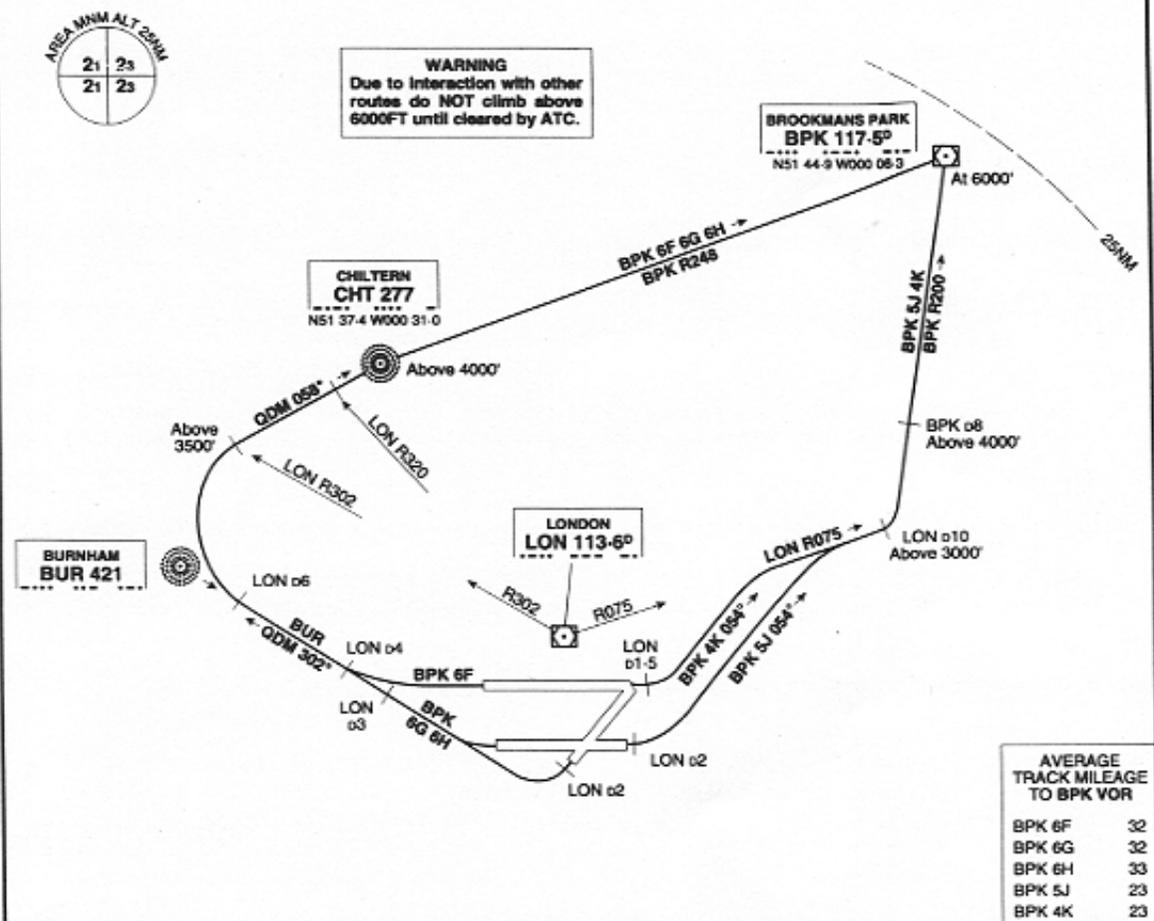
TRANSITION ALT 6000'

NOT TO SCALE

SID	RWY	ROUTEING (Incl. Noise Preferential Routing)	ALTITUDES	AIRWAY ROUTE
BPK 6F 118-825	27R	Straight ahead to be established on BUR NDB QDM 302° by LON 04. At LON 06 turn right onto QDM 058° to CHT NDB, then turn right onto BPK VOR R248 to BPK VOR.	Cross LON VOR R302 above 3500' LON VOR R320 above 4000' BPK VOR at 6000'.	Via BPK R123 R12- Eastbound
BPK 6G 118-825	27L	Straight ahead to be established on BUR NDB QDM 302° by LON 03. At LON 06 turn right onto QDM 058° to CHT NDB, then turn right onto BPK VOR R248 to BPK VOR.		
BPK 6H 118-825	23	Straight ahead to LON 02, then turn right onto BUR NDB QDM 302°. At LON 06 turn right onto QDM 058° to CHT NDB, then turn right onto BPK VOR R248 to BPK VOR.	Cross LON D10 above 3000' BPK D8 above 4000' BPK VOR at 6000'.	508
BPK 5J 118-825	09R	Straight ahead to LON 02, then turn left onto track 054°M to intercept LON VOR R075. At LON 010 turn left onto BPK VOR R200 to BPK VOR.

BPK 4K 118-825	09L	Straight ahead to LON 01-5, then turn left onto track 054°M to intercept LON VOR R075. At LON 010 turn left onto BPK VOR R200 to BPK VOR.

Instructor (OJTI, referred to as the Mentor throughout this report), who was supervising the training of the Air Departures controller. At around the time that SAB 603 was between two and three miles from touchdown, the Air Departures controller had given an Air France aircraft (AFR 813) clearance to take off on a 'Midhurst 3 Foxtrot' departure; this departure involves a left turn onto the London 244° radial and a subsequent crossing of the extended centre-line of Runway 27L (see Appendix A). Then, after the required interval, the Air Departures controller cleared a British Airways Boeing 757 (BAW 818) to take off on a 'Brookmans Park 6 Foxtrot' departure; this departure involves a northerly turn at approximately 3 miles from the airport (see Appendix B).
