Uncontained engine failure, Aircraft Accident Report, Garuda Indonesia Flight GA 880, Boeing B747-200 PK-GSD, In flight (21 minutes after takeoff from Denpasar, Bali), 23 November 2001

KNKT/01.27/03.01.009

AIRCRAFT ACCIDENT REPORT

Garuda Indonesia Flight GA 880

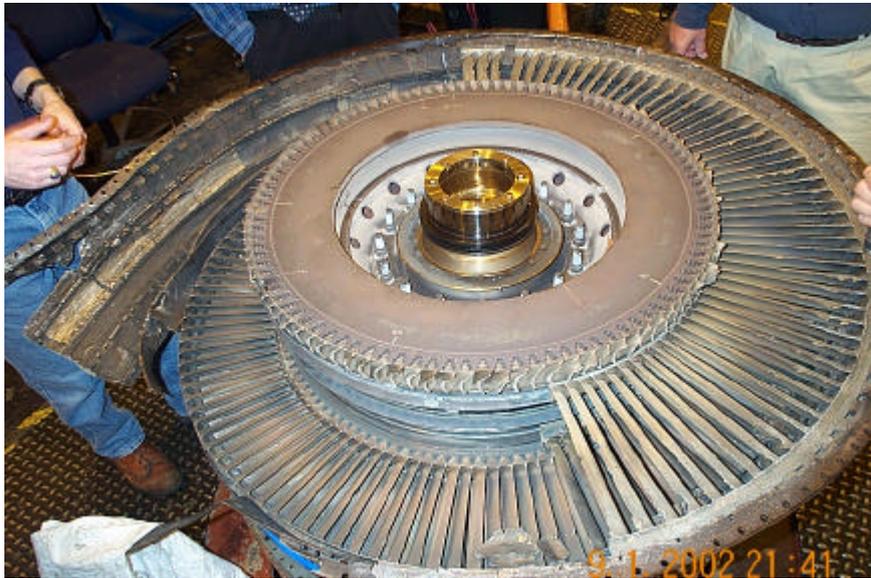
Figure B1. Engine #2 LPT Module (1) - 6th stage disc on top

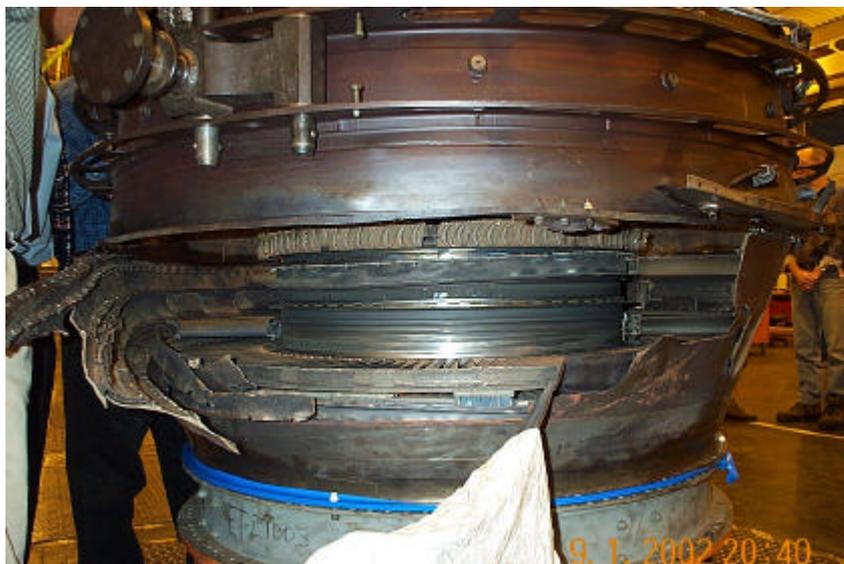
Figure B2. Engine #2 LPT Module (2)

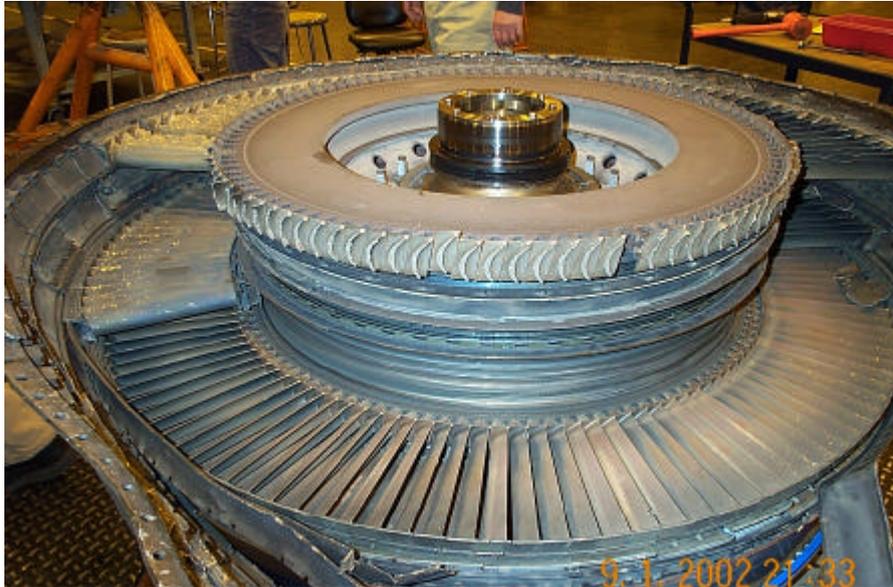
Figure B3. Engine #2 LPT Module

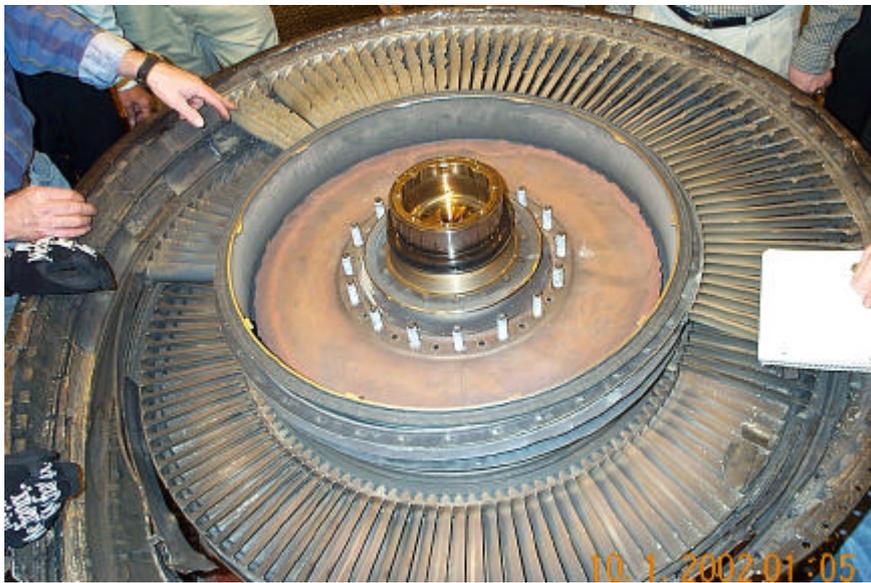
Figure B4. Engine #2 LPT Module - 5th stage disc revealed

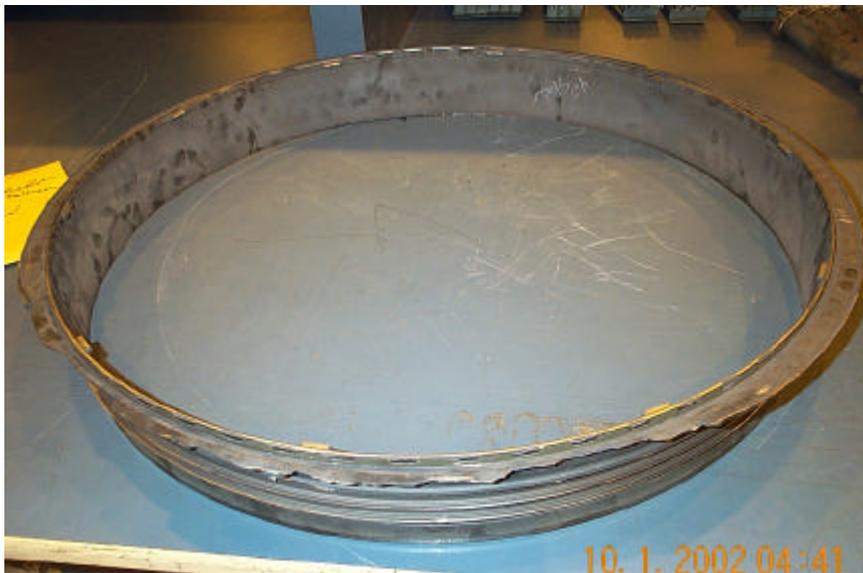
Figure B8. 5th stage inner airseal
